**UK AIRPROX BOARD**

**Analysis of  
Airprox in UK Airspace**  
Report Number 3  
July 1999 to December 1999

Report by the UK Airprox Board,  
'Analysis of Airprox in UK Airspace'  
(July 1999 to December 1999)

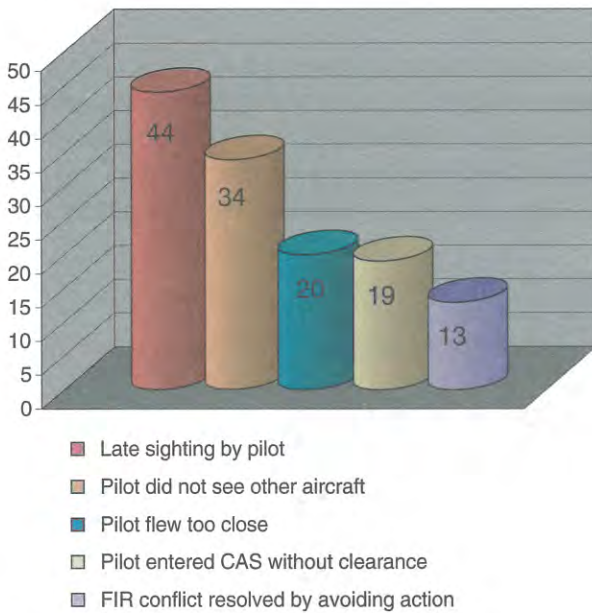
Figure 9: GA Airprox causal factors 1999

190 causes emerged from the 135 Airprox in which GA aircraft were involved and the most common ones are shown at Fig 9 (left). Ineffective 'lookout' was the largest single factor and accounted for 41% of all the causes in Airprox featuring GA aircraft.

The next most common cause was attributed to pilots 'flying too close' when passing another aircraft that has been seen. This could easily be rectified simply by giving a wider berth.

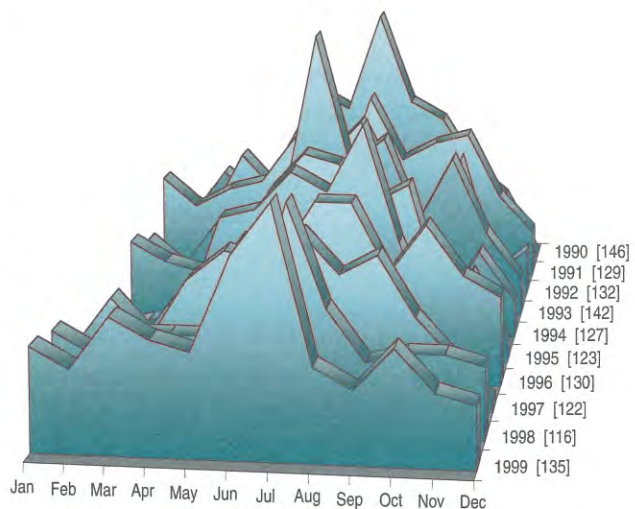
Figure 10: GA Airprox profiles

The answer to reducing these GA 'peaks' lies in tackling their cause, as listed above.

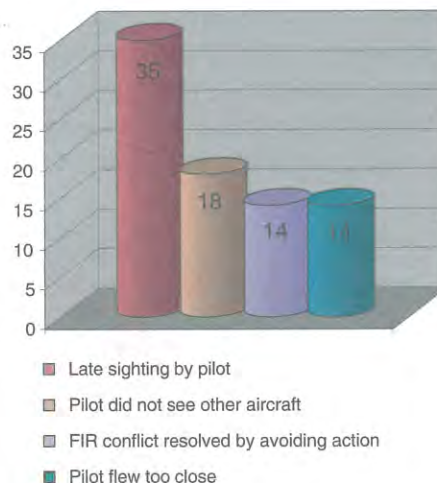
Figure 12: Military Airprox causal factors 1999

A total of 142 causal factors lay at the root of the 94 Airprox involving Military aircraft last year. Fig 12 (right) shows the top 4 reasons – all of the other causes had less than 10 examples in each group. Most encounters were with GA aircraft, so it is unsurprising to see the same factors appearing in both charts.

'Lookout' related causes led the field and figured prominently in some 37% of Military incidents. Next came straightforward conflicts in the open FIR, resolved safely by the pilots concerned.

The fourth most common cause reflects a feature of many incidents. These cases could easily be reduced if pilots were more sensitive to the concerns of other airspace users.

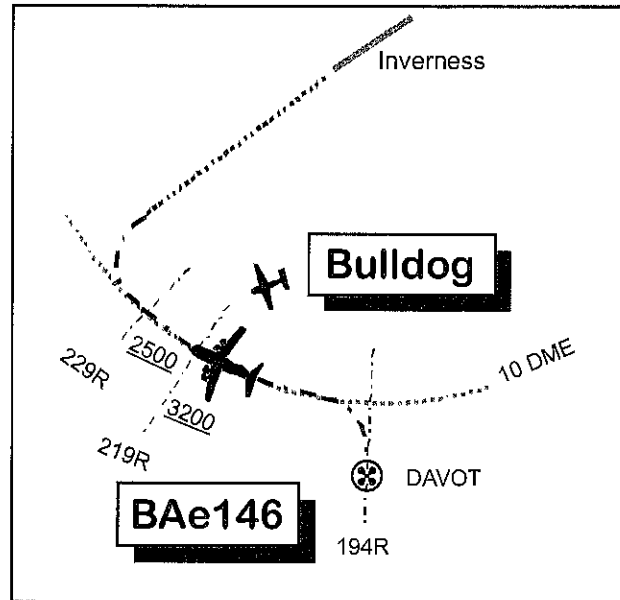
**THE BAE146 PILOT** reports descending into Inverness at 180 kt, cleared for the 10 DME arc for RW 06. Before joining the arc he was advised by Lossie radar of a Bulldog operating 7 NM SW of Inverness up to 5000 ft which caused him to comment that that was not a very sensible place to operate in view of the Inverness approach procedures. At 13 DME, just before joining the arc, he was handed over to Inverness TWR who advised him of the Bulldog operating to the SW, VFR. He turned onto the arc and descended in accordance with the procedure. After passing the 219 radial, just before turning onto finals, he broke out of cloud at 3200 ft to see a Bulldog 3-400 m away on his right, heading towards him at the same level. He disengaged the autopilot and turned to the left about 15°, increasing his rate of descent, to get away from the closing ac which passed behind and slightly above him. He considered the risk of collision was high and reported the incident to ATC. TCAS was not yet fitted to Company ac.

The LOS controller stated that the BAe146 was transferred to INV for the arc procedure just before it reached the reporting point DAVOT (193° INS/12 NM). At the point of transfer, the Bulldog was observed in a position about 5 NM S of Inverness. These positions were confirmed by the Lossiemouth Supervisor, who had a clear view of the Director's radar display whilst overseeing a busy recovery wave at Lossiemouth. Once the BAe146 had taken up the procedure, the Supervisor then concentrated on the Lossiemouth traffic situation and did not witness the Airprox. The arc procedure for RW 06 from DAVOT involves the ac turning L and flying a 10 NM DME arc until the 229° radial, from which the ac then turns R to intercept the 240° radial at 8 NM DME. Throughout, the ac is in a descent which intercepts the FAF (5 NM DME) at 1540 ft QNH. At the time of release to INV therefore, the procedure ensured separation from the Bulldog; the LOS controller was positive that the BAe146 was 'clean' and that the Bulldog did not constitute a confliction. On the procedure however, separation cannot be guaranteed from ac flying VFR and once the BAe146 was released, the Bulldog began to track SW towards the BAe146. DAVOT is 33 NM SW of Lossiemouth; it would not be practicable to continue RAS beyond this point as the ac would be descending out of solid radar cover.

Cause: Conflict of flightpaths in Class G airspace.

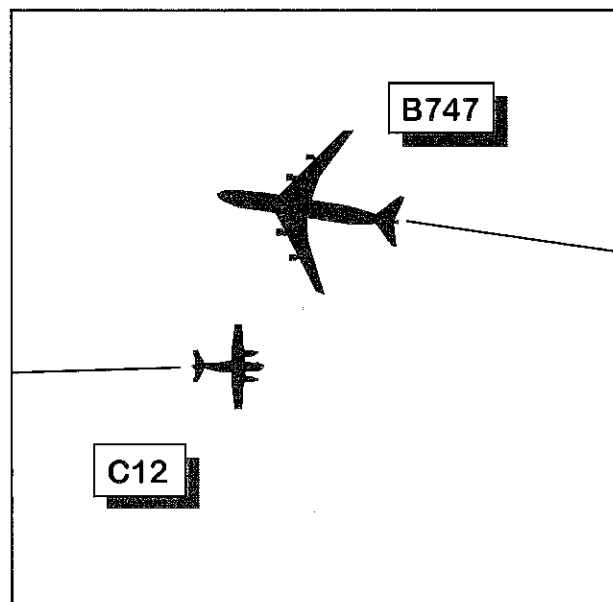
**THE B747 PILOT** reports heading 290° at 190 kt in broken cloud while making an approach to Cambridge RW 23; he was on an intercept heading, level at 2000 ft and receiving a service from Cambridge ATC. Cambridge warned him of traffic 12 o'clock at 5 NM and at about that time TCAS indicated traffic 1000 ft above but

Shortly after the flight had been turned onto left base-leg, the controller called a pop-up contact in the "1 o'clock, range 4 miles, if not sighted turn left heading 260". Avoiding action was also passed. The pilot reported seeing a contact on TCAS against which he then reported conducting a "TCAS descent". A visual sighting was then achieved during which the pilot stated the traffic was "*a twin going over the top a King Air*". This traffic was subsequently found to be

Investigations suggest that Cambridge's failure to notify Lakenheath about traffic for a radar approach may not have been an isolated event as, it appears, traffic information is not routinely exchanged between the two units. Consequently, the appropriate Inspector of ATS (Southern) was asked by ATSI to discuss the subject with the Cambridge SATCO. The subsequent meeting prompted the issue of an operational notice to ATC staff reminding them to adhere to the LOA with regard to co-ordination. Also, an assurance was obtained that the SATCO would discuss with Lakenheath the current LOA and explore whether any changes needed to be made.

Some members suggested that in class G airspace, 500 ft of vertical separation was adequate and that the incident was no more significant than a 'TCAS event'. However the view prevailed that in IMC under a RIS the C12 pilot should have advised the controller of his departure from 3000 ft, and that his departure from this level was the cause of the Airprox. The Board noted that the C12 had dipped 400 ft below 3000 ft before regaining the cleared level. This resulted in a vertical separation of 600 ft. The existing lateral separation was some 400 yd and the Board concluded that there had not been a risk of the ac actually colliding.
