UK AIRPROX BOARD

**Analysis of
Airprox in UK Airspace**
Report Number 5
July 2000 to December 2000

Report by the UK Airprox Board,
'Analysis of Airprox in UK Airspace'

(July 2000 to December 2000)

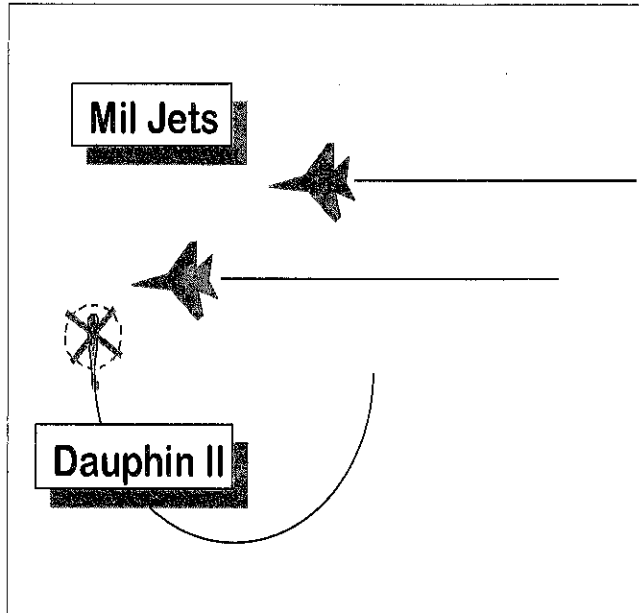
AIS MIL reports that an initial tracing action lasting several weeks produced no military ac which had been in the area at the time. It was then discovered that the incident time given by the reporting pilot was one hour out and so the whole process had to be repeated, but again without result. (Initially a pair of F18s, visiting from overseas, was thought to have been involved, but at the reported incident time they were on the ground.) No military ac was booked into that part of the LFS at the time, so whichever ac they were, they were illegally low flying. The incident area is below recorded radar coverage, but no military ac could be seen on tracks which would take them into the area, and the only

UK based twin-finned jets that were airborne at the time and N of 55 N could be seen on radar; they did not descend below 18000 ft. Foreign (NATO) air forces did not have any ac in the area and USN ac were discounted after confirming that none of their carriers was this side of the Atlantic N of Gibraltar at the time. Unfortunately no RAF, USAF or NATO AWAC ac were in a position to cover the area. The possibility that the incident had occurred on a date other than that reported was put to the company; the pilot flies this route on most days. The company researched the matter thoroughly and confirmed that it occurred on 5 Jul. Having searched all conceivable avenues, AIS (M) tracing action was discontinued.

pilots to ask them what they could remember about a flight 4 months earlier. It was regrettable that the tracing had failed but no discrepancy could be found in the timings recorded; this was one of only 8 Airprox out of 2246 involving military ac in the last 10 years in which a military ac remained untraced. Members commented on how important it was to report quickly and accurately to facilitate a successful trace, particularly if overseas based ac were involved.

Cause: Confliction of flightpaths.

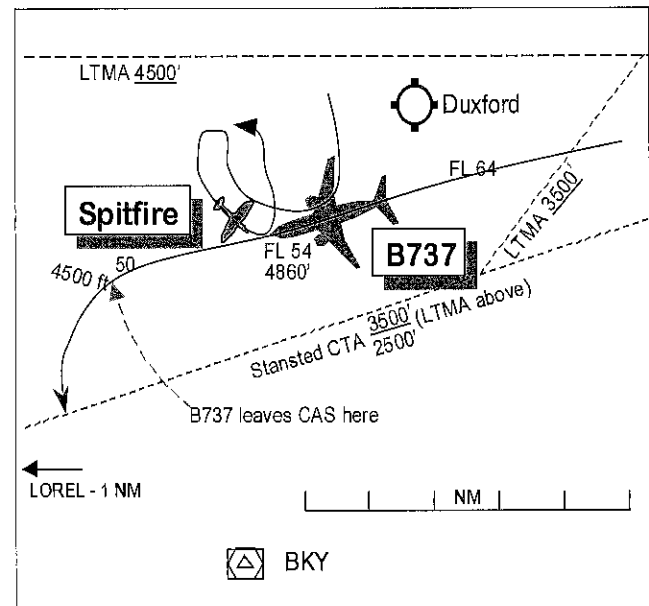
<u>Reporting Aircraft</u>	<u>Reported Aircraft</u>
<u>Type:</u>	B737	Spitfire
<u>Operator:</u>	CAT ↓	↑ Civ Pte
<u>Alt/FL:</u>	4700 ft (QNH 993 mb)	4400 ft (QNH)
<u>Weather</u>	IMC CLBL	VMC CLBL
<u>Visibility:</u>	NK	
<u>Reported Separation:</u>	200 m/NK	
<u>Recorded Separation:</u>	NK

Cause: The Luton APR descended the B737 to an inappropriate altitude which resulted in a confliction near the base of controlled airspace.

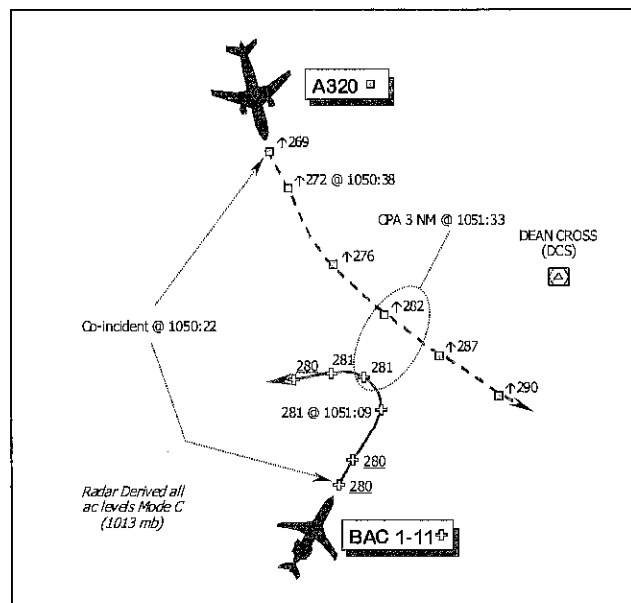
THE DEAN CROSS SECTOR CONTROLLER (DCS SC) reports that when the previous controller handed over the sector he pointed out a 6453 squawk (the BAC 1-11) operating in the vicinity of Eskmeals Range (EGD 406) and manoeuvring up to 10 NM SW of DCS. She was also advised that the LJAO controller was using an outside telephone

line for co-ordination, but she was not given any contact number. Consequently, she believed that LJAO NW (LOW) would co-ordinate any potential conflict with DCS Sector traffic individually and that the military ac would maintain FL 280.

THE BAC 1-11 PILOT reports he was conducting an experimental radar trial that required a LHD racetrack pattern at FL 280, to the southwest of DCS whilst in transit to the trials area. This pattern was briefed to LOW who instructed him to establish the racetrack, with the proviso that the northerly extent might have to be restricted because of civil traffic. The trial required very accurate track keeping on the northbound legs, using a GPS display mounted on the centre console, which degraded the crew's visual lookout. Following several racetrack patterns, at about 9 NM SW of DCS, LOW issued an avoiding action L turn onto 270°. He immediately abandoned the trial profile and complied. Once established on 270° he queried the position of the conflicting traffic and believed the controller responded "2 N of you heading S climbing through FL 278", but the other ac was not seen at all. They were then cleared to resume the trial profile.

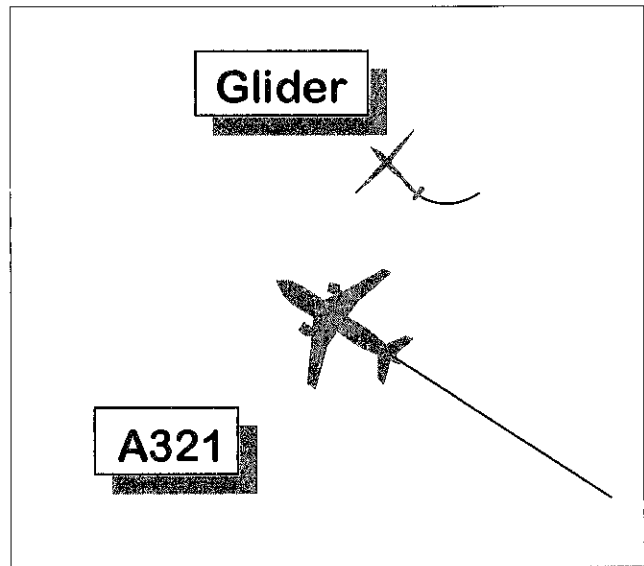
THE A321 PILOT reports heading 290° at 220 kt, levelling at 4000 ft on a wide left base to RW 23 at Stansted. The weather was good, clear with shallow scattered Cu below. His F/O shouted a warning and he saw a glider in a climbing steep right turn at the same level and very close (150-200 ft) on the right. He reported an Airprox to Essex radar on 120.62. He thought the risk of collision was high. His F/O confirmed that he had seen the glider in his 2 o'clock for a few seconds as it flashed past; it was in a climbing right turn and level with or just above a good horizon. There was a scattering of shallow Cu cloud below but none within half a mile on his right. He pointed out (to the suggestion that the glider may have been below their level) that his Captain would not have seen it had this been so. In a later telephone conversation the captain explained that he was wings-level and from the left hand seat had seen the glider at the same level, pulling up to, if anything, above his level, and flashed past to his right about as far away as an ac parked on an adjacent stand. It was a particularly frightening experience which affected both pilots and which was still distracting them as they flew their next sector. At the time of the incident they were in clear air somewhat above the tops of the

shallow clouds. He confirmed that the glider was not a powered glider; it was grey with orange bands on the wings and fuselage.

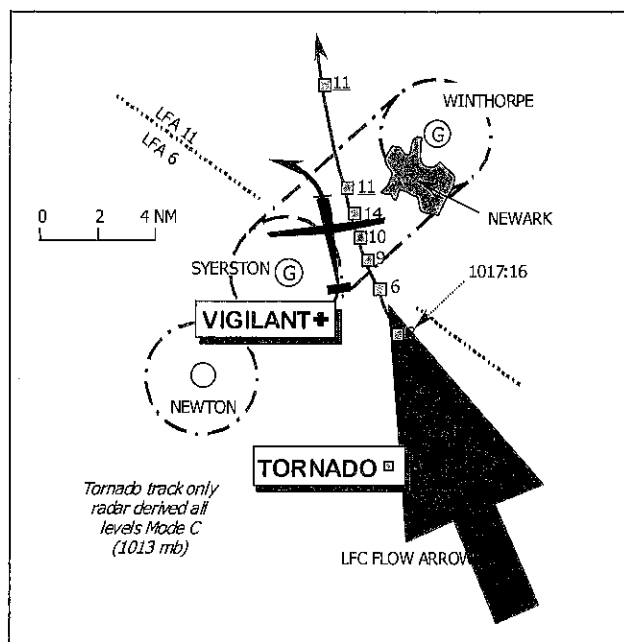
THE VIGILANT MOTOR GLIDER PILOT reports he was instructing a student in the circuit at Syerston and in communication with Syerston Radio on 125.425MHz. The ac colour scheme is red/white and HISLs were on. After take-off from RW07, he levelled at 800 ft QFE (1010 mb) and carried out a standard lookout search to the R before commencing a 15° banked L turn onto the downwind leg. In the turn at 60 kt, passing 350° a Tornado was spotted as it appeared from "under the raised right wing". The jet passed about 1-200 m away to the R and slightly below their height. No avoiding action was taken as he was already turning away from it. He thought that the Tornado had penetrated the circuit pattern to RW07 as it crossed the climb-out at approximately 90°, heading N; it was almost certainly on the southern edge of LFA 6, which is adjacent to the Syerston ATZ. Light winds had extended his climb-out to circuit height, taking his ac closer to the eastern edge of the ATZ. He added that the Vigilant crews had been informed of low level flying activity at the morning brief, but the Vigilant is very difficult to spot from some aspects and may not have been seen by the Tornado crew.

THE TORNADO GR1 PILOT reports cruising at 1000 ft Rad Alt on a low-level sortie through the Newark/Syerston gap heading 330° at 420 kt. HISLs were on and a squawk of 3/A 7001 was selected with Mode C. He first spotted the Vigilant Motor Glider at the 1130 position, slightly L of the nose about 1 NM away as they closed on it from astern. The Vigilant was flying straight and level, he thought, so to give it a wider berth he manoeuvred his ac to pass "several hundred yd to the R" of the motor glider and climbed 2-300 ft to avoid it, thereby increasing horizontal and vertical separation. He waggled the wings for several sec as they overtook the Vigilant, but saw no form of acknowledgement. It was very difficult to see the motor glider as they approached from almost directly astern and he added that it took a few sec to realise that it was in fact another ac and that they were overtaking it. The motor glider pilot did not appear to manoeuvre as they flew past, but he considered there was no risk of a collision because both he and his navigator believed that they had seen it in time to take appropriate avoiding action.
