UK AIRPROX BOARD

Analysis of Airprox in UK Airspace

**Report Number 25
July 2010 – December 2010**

Twenty-Fifth Report by the UK Airprox Board:

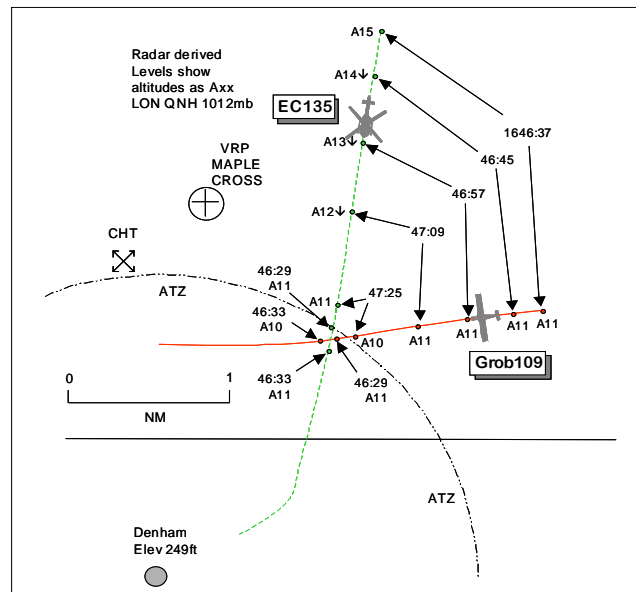
Date/Time: 2 Jul 2010 1647Z
Position: 5137N 00029W
(1.9nm NE Denham - elev 249ft)
Airspace: ATZ (Class: G)
Reporting Ac Reported Ac
Type: EC135 Grob 109
Operator: Civ Comm Civ Pte
Alt/FL: 1000ft 1000ft
(QNH 1012mb) (QNH 1012mb)
Weather: VMC CLBC VMC CLBC
Visibility: >10km >10km
Reported Separation:
20ft V/30m H 50ft V/250ft H
Recorded Separation:
<100ft V/<0.1nm H

The Board noted that the Grob pilot did not comply with the requirements of Rule 45 of the Rules of the Air. Had the Grob pilot called on the Denham frequency he probably would have heard the EC135 pilot's transmissions and therefore improved his SA with respect to any potential conflicts. Members agreed that this element had contributed to the Airprox. That said, without this additional information the crux of this incident boiled down to both pilots being responsible for their own separation from other traffic through see and avoid. The EC135 flight had right of way and its pilot received a traffic warning on TCAS of the approaching Grob in his 11 o'clock range 1nm. However he was unable to visually acquire the Grob until very late. As the ac were approaching on a line of constant bearing, the Grob may well have been obscured by part of the EC135's cockpit structure; however, best practice to mitigate this known degradation to lookout is for the pilot to move his head or move the ac's flightpath. The Grob pilot reported that he was flying into sun and concentrating on looking ahead when he saw the helicopter very late in his 2 o'clock. The opportunity for both pilots to see each other's ac was there for some time prior to the CPA; however, it was not to be and it was these late sightings that had caused the Airprox.

Cause: Late sightings by the pilots of both ac.

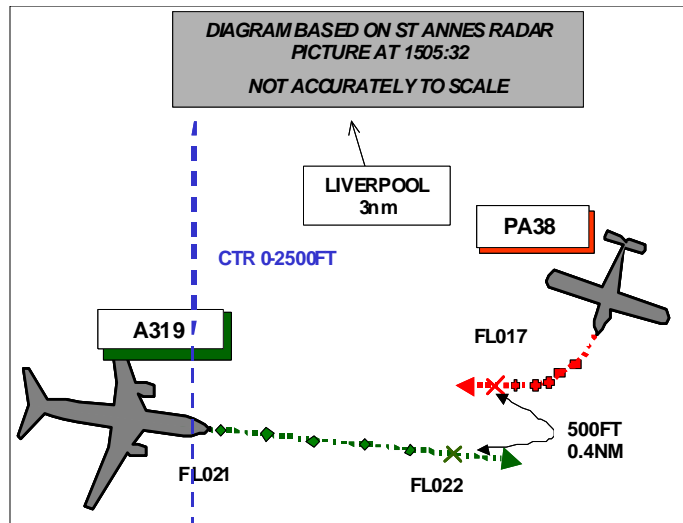
Members noted that the pilots of both ac had been complying with the respective IFR and VFR arrival procedures for Liverpool Airport. Although the altitude of the PA38 on the radar recording appeared about 100ft higher than that instructed by APR, it was within both prescribed Mode C and altimeter tolerances. Members noted that there had been minor altitude deviations during the PA38's orbit but considered these to be reasonable for a student pilot and they did not breach the ATC altitude restriction. That being the case, Members agreed that it had been the very small climb as the PA38 was pointing towards the A319 in the orbit that had triggered the TCAS RA in the A319; controller Members also agreed that in situations where 500ft separation is used, such RAs are not uncommon. A controller Member noted that the Airspace at Liverpool and the procedures are complex, but it was pointed out that this was necessarily so due to the proximity of Manchester and the associated CTA.

Cause: Sighting report (TCAS).

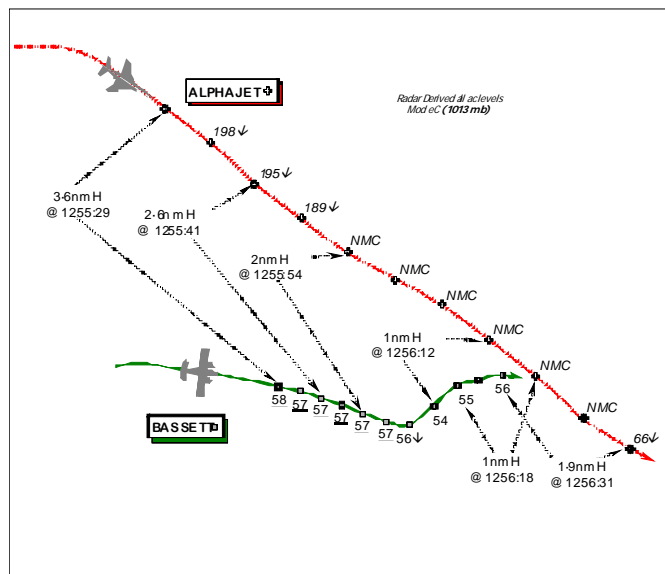
Date/Time: 1 Jul 2010 1256Z
Position: 5110N 00208W (14nm W of Boscombe Down A/D - elev 407ft)
Airspace: London FIR (Class: G)
Reporting Ac Reporting Ac
Type: Basset CC1 Dornier Alphajet
Operator: MOD ATEC MOD ATEC
Alt/FL: FL55 ↓FL50
SAS SAS
Weather: VMC CLOC VMC CLOC
Visibility: 30km 30km
Reported Separation:
1000ft V Not seen
Recorded Separation:
1nm H

THE BEAGLE BASSET CC1 PILOT reports he was conducting a local dual training flight from Boscombe Down whilst in receipt of a TS from Boscombe RAD. A squawk of A2611 was selected with Mode C; neither Mode S nor TCAS are fitted. He was operating in a block between FL40-100 on a discrete frequency of 243.4MHz [Stud 15] in VMC with excellent horizontal visibility and visibility to the ground. Heading 100° at 135kt, he observed an Alphajet directly overhead and overtaking, about 1000ft above his ac on the same course. No avoiding action was necessary, but no TI had been passed about the Alphajet. The controller was challenged three times, but no reply was received to either transmission. A channel change to Stud 5, the common RAD frequency, was made and contact regained. At the same time, a Tornado reported airborne and eventually crossed overhead 1000ft above his ac without being called out either. After challenging RAD, the controller replied, 'we are busy', so an Airprox was filed.

then a better reporting mechanism was that of a Hazard Report on a DFSOR. As it was, given the geometry of this encounter and the separation evident, the Board agreed that this report had been the result of a sighting by the Basset pilot and no Risk of a collision had existed.
