UK AIRPROX BOARD

Analysis of Airprox in UK Airspace

**Report Number 14
January 2005 – June 2005**

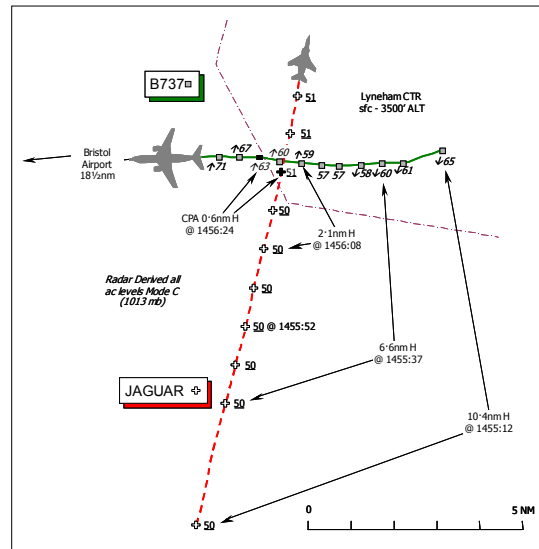
THE BRISTOL APPROACH CONTROLLER (APR) reports that the B737 was established on the RW27 localizer (LLZ) for Bristol Airport at 20 DME, E of Bristol passing FL70 in the descent for the assigned level of FL40, under a RAS. Another ac squawking A2603 indicating FL50 Mode C was observed 8nm SSW of the B737, tracking northbound at high speed. Traffic information was passed to the B737 crew, who were instructed to level-off at FL60. He almost immediately revised this to an avoiding action climb to FL80. The A2603 squawk passed ½nm behind the B737, still indicating FL50, as the B737 was passing FL60 in the climb. The B737 crew identified the ac visually as a Jaguar.

Cause: Conflict in the FIR resolved by the Bristol APR.

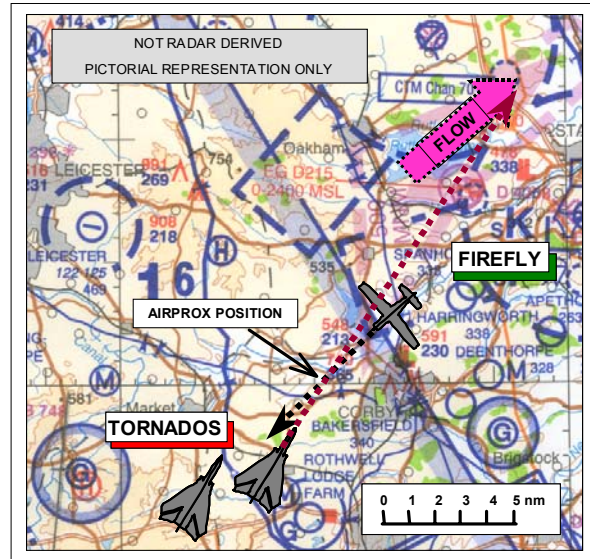
Date/Time: 6 Jan 1042
Position: 5229N 00047W (4nm E Market
 Harborough)
Airspace: UKDLFS (Class: G)
Reporting Ac **Reported Ac**
Type: Firefly Tornado GR4X2
Operator: HQ PTC HQ STC
Alt/FL: 500 agl 850 agl
 (RPS 1013 mb) (Rad Alt)
Weather VMC CAVOK VMC CAVOK
Visibility: >10km >10km
Reported Separation:
 30ft V/10ft H 200ft V / 0H
Recorded Separation:
 Not recorded (See UKAB Notes 1&2).

THE TORNADO GR4 PILOT reports that he was No2 of a 2-ship tactical low-level sortie in a grey ac with HISLs selected on, squawking 7001 with Mode C and in receipt of a FIS from Cottesmore DIRECTOR (DIR) [on UHF]. The formation was in loose arrow formation (0.2nm apart, co-alt with the No2 ac swept back on the left) and heading NE at 414kt. They had climbed to above 500ft agl and contacted Cottesmore DIR at 1041:53 for a low-level transit through the MATZ. DIR placed them on a FIS and restricted them to not below 500ft agl over Rutland Water and informed them that North Luffenham Danger Area was active with explosives. The transmissions between his leader and Cottesmore DIR were completed at 1042:13. No further transmissions were received from Cottesmore prior to the Airprox at 1042:45. The leader saw an ac 200ft away, later identified as a Firefly, pass in front and below of his ac and instructed No2 to climb as it passed 200ft below No2's flight path. He assessed the risk of collision as being high and the incident was reported to Cottesmore DIR.

Cause: Very late sighting by the Firefly pilots of the No2 Tornado and non-sighting of the No1 Tornado and an effective non-sighting by the Tornado crews of the Firefly.

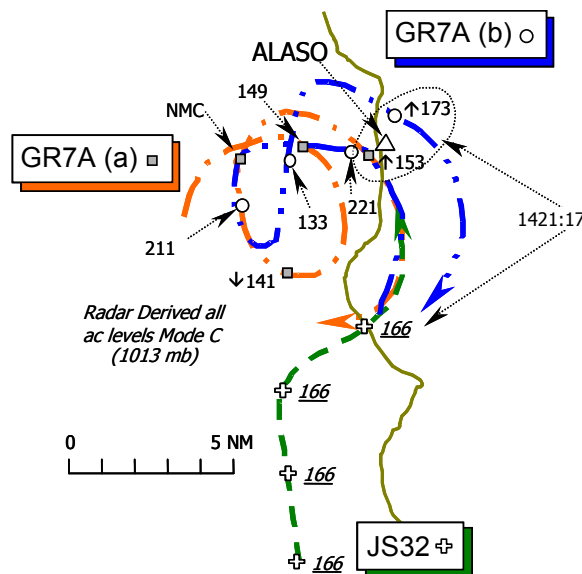
THE ScACC TAY SECTOR CONTROLLER (TAY SC) reports that the JS32 was routing via NEW to the ATF within Class G airspace under a RIS. Traffic information was given to the JS32 crew on military targets and they were subsequently given 3 traffic updates. The JS32 crew reported turning onto 060° so he advised them that the contacts had also turned E: consequently, the JS32 crew turned N again. However, the JS32 crew did report visual contact as one of the other ac turned onto an opposite direction heading at the same level so a further update was given. The contact turned and passed 500ft underneath the JS32 whose crew asked to file an Airprox, identifying the other ac as a Harrier. The crew was asked to pass the details of the Airprox to Scottish INFORMATION on 119.87MHz.

UKAB Note (3): The small scale Great Dun Fell Radar recording shows the Harrier GR7 pair’s (both squawking A7001) convoluted manoeuvres in the vicinity of ALASO at medium level as the JS32 approaches the vicinity from the S maintaining FL166 Mode C throughout. The JS32 is shown turning R onto a NE’y course at 1420:26, as reported by the pilot, whilst the Harrier pair manoeuvre in tight turns. At 1421:17, the JS32 executes a L turn back onto track for the ATF as reported; meanwhile the larger scale picture shows the Harrier pair both turning R as GR7A (a) some 5.4nm away climbs through FL153 and 2000ft below GR7A (b) whilst passing ALASO. GR7A (a) turns directly toward the JS32 climbing steadily towards it as GR7A (b) maintains a R turn displaced about 1nm away just abaft GR7A (a)’s port beam and gradually drawing aft. The closest of the pair - GR7A (a) - is on the inside of the turn in a climb to FL160, some 600ft below the JS32 at a range of 1.7nm. The minimum recorded horizontal separation occurs at 1421:49, with GR7A (a) about 0.3nm NE of the JS32 and subsequently passing just to the E of the latter. GR7A (a) then opens astern and crosses behind the JS32 at a range of 1.2nm as the jet climbs through FL161, whilst GR7A (b) closes to a minimum of 1.7nm some 1600ft above the airliner. The maximum level that GR7A (a) ascended to was FL163 and GR7A (b) to FL190; although Mode C indications are then lost from the GR7A pair for a short period thereafter, a rapid descent is subsequently evident by both jets as they continue the tight R turn astern of the JS32 which continues on course through ALASO.

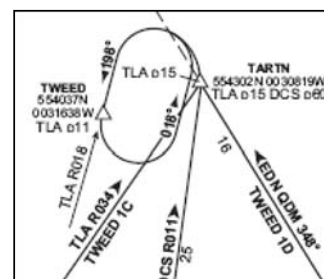
The B737 was in the hold at FL130 and the Do328 was descending towards TARTN from the SE to join the hold at FL140. Just before the Airprox happened the London D and D telephone rang; it was unanswered by anyone else so he answered it to find that it was an enquiry about emergency traffic well outside his sector. While he was handling this call his Planner took a few RT calls and descended one ac in the hold before starting to hand over his position. He (Tactical) then cleared the Do328 to FL120 from FL140 but annotated the FPSs to show that he had cleared the B737 from FL130 to FL120.

He believes he must have seen another ac vacating FL120 before clearing the Do328 to descend and when he returned to monitoring the FPSs he would not have noticed his error. When he observed the Do328 approaching FL130 in close proximity to the B737 and at the same level, he told the B737 to continue his heading as he wanted to stop the ac turning toward the Do328. He told the Do328 to turn right and the pilot replied that they were visual with the B737 and below it. He turned the B737 right to increase separation; the pilot replied that they were visual with the Do328. With the Do328 reporting visual and below, he felt there was no need to use the words 'avoiding action'.
