UK AIRPROX BOARD

Analysis of Airprox in UK Airspace

Report Number 2

January 1999 to June 1999

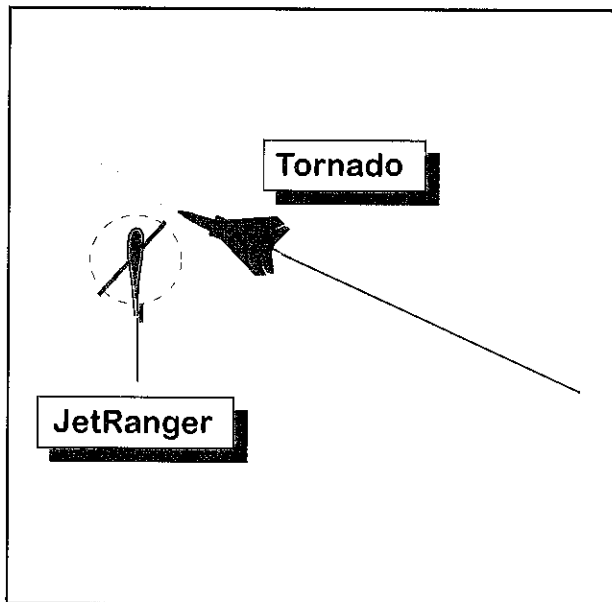
Note: LATCC radar recordings show the helicopter, identified by its 0036 squawk, manoeuvring for some minutes in the general area of the Airprox but it disappears as the Tornado coasts in near Southwold. The Tornado closes on the Airprox location at 500 ft

Mode C and climbs to 700 ft in a right turn just before reaching its simulated target. The local QNH was 1008 mb; taking local terrain elevation into account, 500 ft Mode C equates to 200 ± 100 ft agl.

Cause: Conflict of flightpaths in Class G airspace resolved by the Tornado pilot.

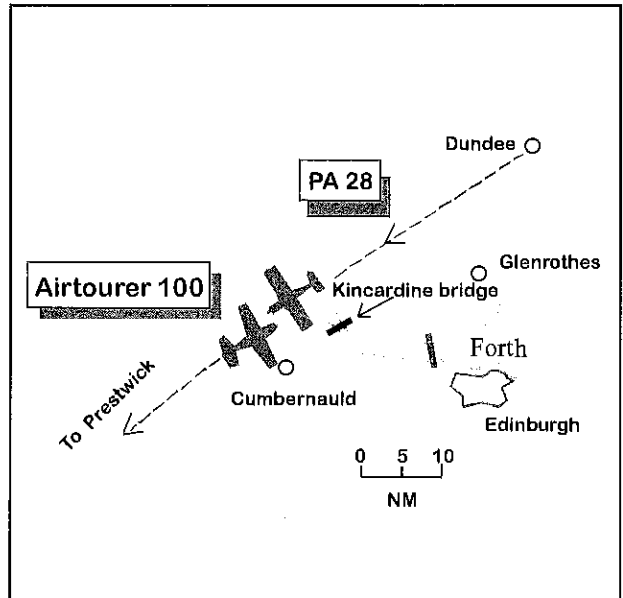
UKAB Note: A video replay of the Lowther Hill radar shows the PA 28, identified by its 4522 squawk, heading SW from the Dundee area. The ac tracks slightly to the N of the Kincardine bridge at 2300 ft Mode C and at 1618 is about 4 NM W of it and about to merge with a faint intermittent opposite direction primary return believed to be the Airtourer. The actual encounter cannot be seen clearly on the radar because of label overlaps with adjacent squawking ac, but by 1618:20 the primary return appears about 0.5 NM in trail of the PA28.

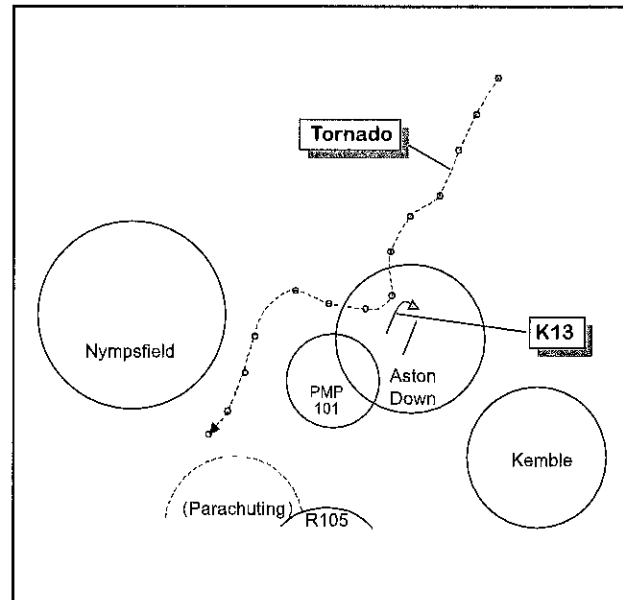
the recording is transcribed in the diagram. Its track starts to turn away to the W but then reverses into the airfield avoidance area (AAA). It then reverses its turn again, sharply, and exits the AAA to the W before turning S to avoid Nympsfield.
