UK AIRPROX BOARD

Analysis of Airprox in UK Airspace

**Report Number 28
January 2012 – December 2012**

Twenty-Eighth Report by the UK Airprox Board:

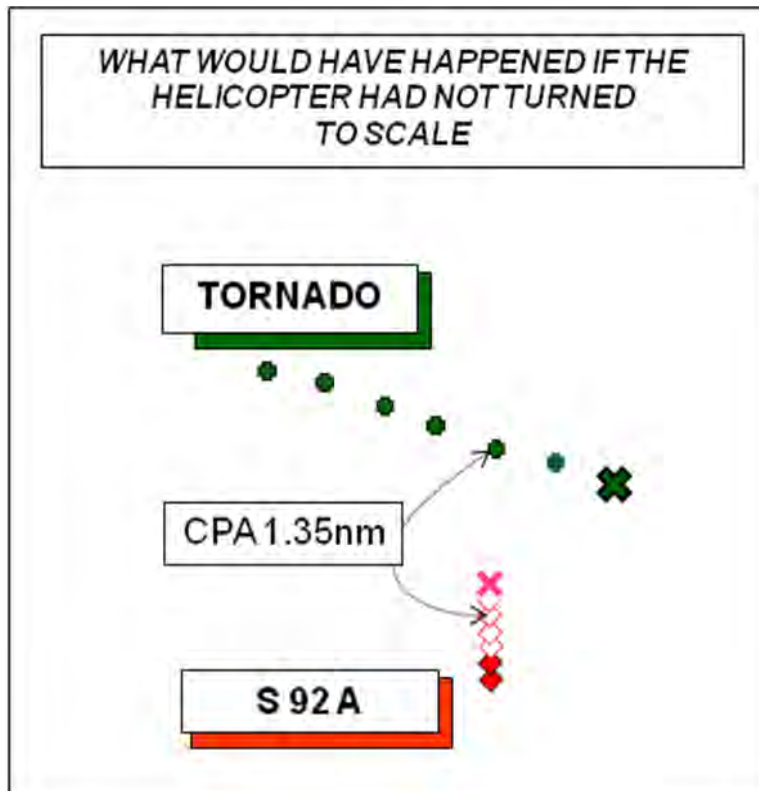
The Board was shown a diagram (below) depicting what would have happened had the S92 not turned to the right (using actual G/S and headings taken from the Stornoway SSR). It showed that the Tornado would have passed from left to right through the S92's 12 o'clock at a distance of 1.3nm at the same alt (2000ft amsl). That being the case Members agreed that the S92's turn had not had the desired effect of increasing the separation between the ac.

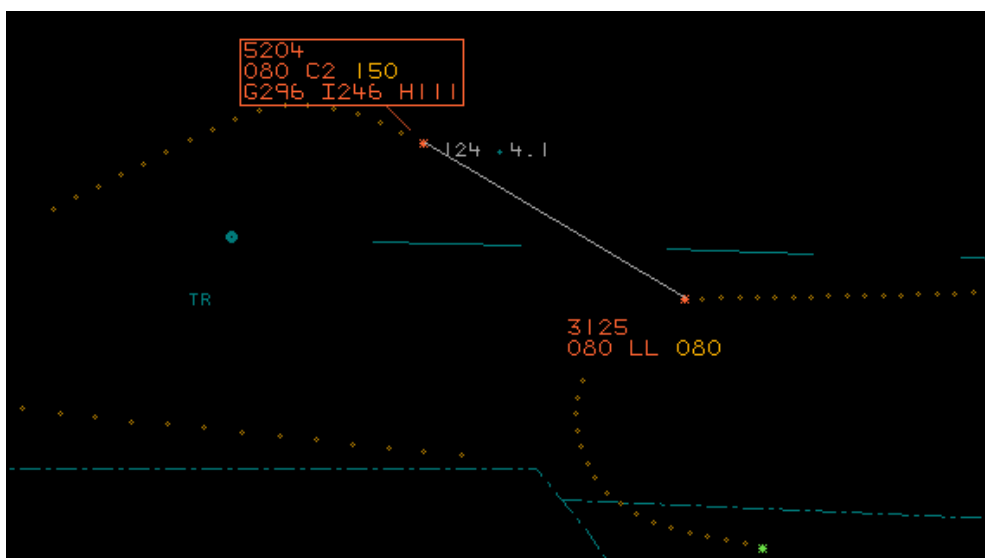
Figure 2: (Swanwick MRT) 1435:21

High Level STCA was activated at 1435:21 as the A340 passed FL080, Mode S heading 111°, 4.1nm NW of the A320. (See Figure 2). On the next update of the surveillance replay the STCA down-graded to Low Level and the A340 was observed to have turned L from a Mode S heading of 111° to 102°.

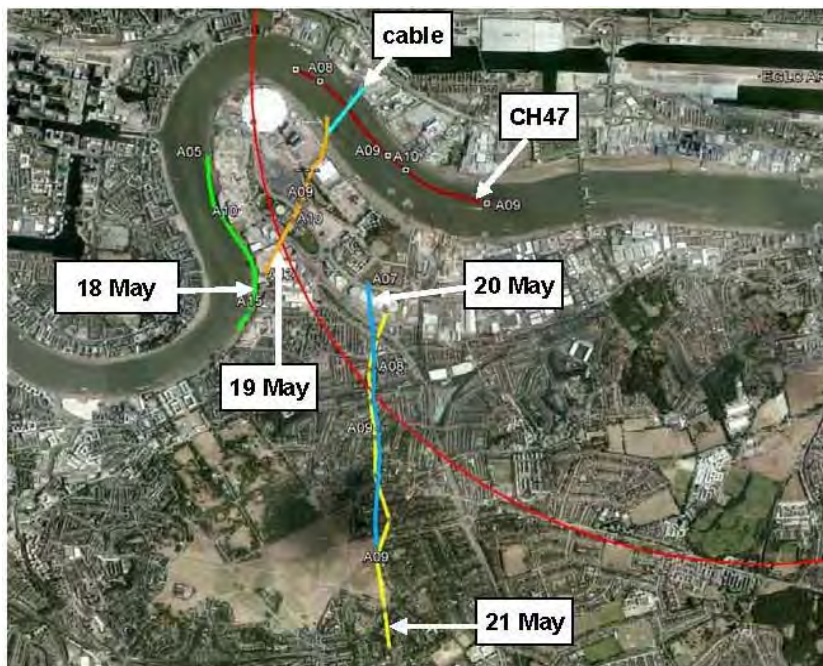
Figure 3: EC155 flight paths on 18, 19, 20 and 21 May together with plot of CH47 flight path

On 21 May 2012, the EC155 appeared as a primary position indication symbol at 2208:57 bearing 144° at 1.06nm from the helipad. The ac continued on a S'y track and no Mode C was detected until 2211:25. Two-way communication was established with Heathrow Director at 2210:00 and the EC155 pilot left the confines of the London City CTR at 2210:15. [EGLC met: BKN012///].

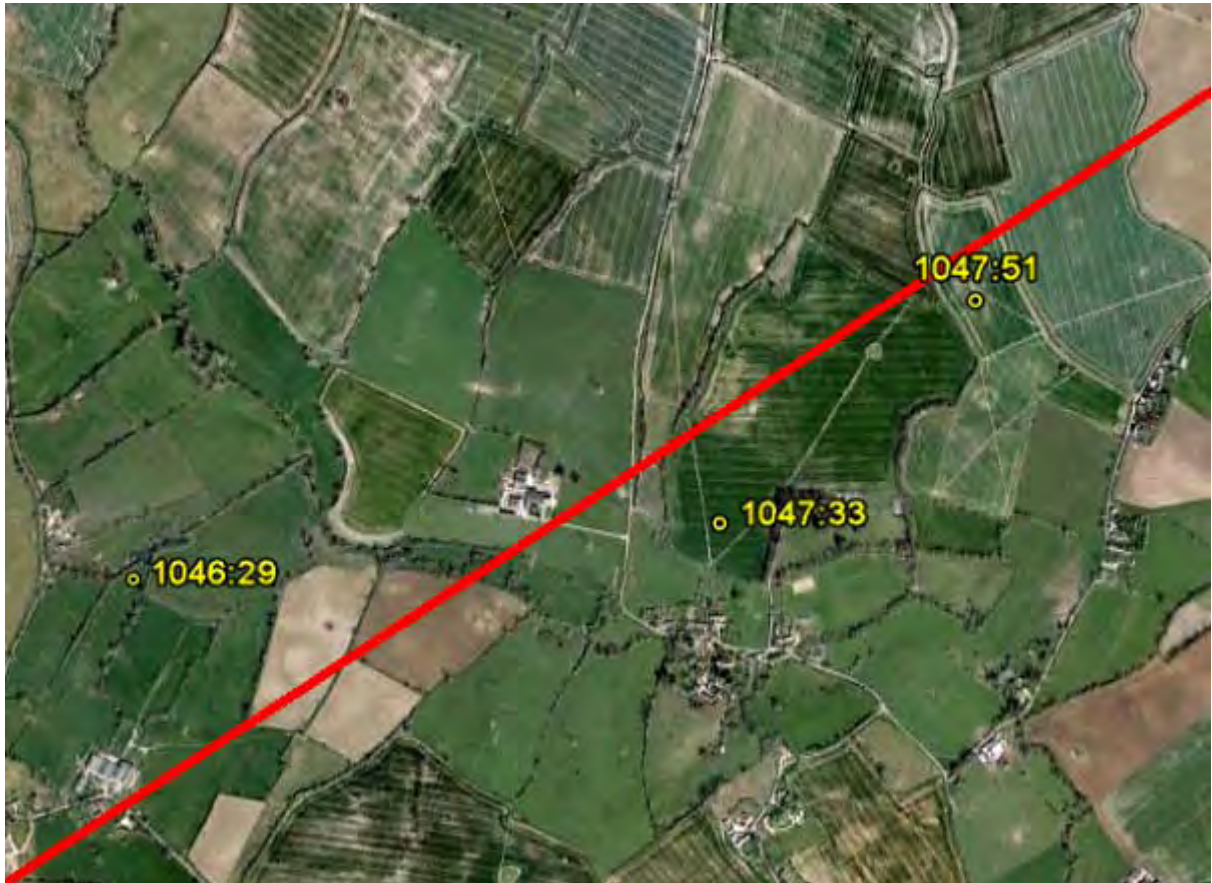
Figure 2 shows the position of the primary returns relative to the southern boundary of the Silverstone RA(T) (in red) at the times indicated.

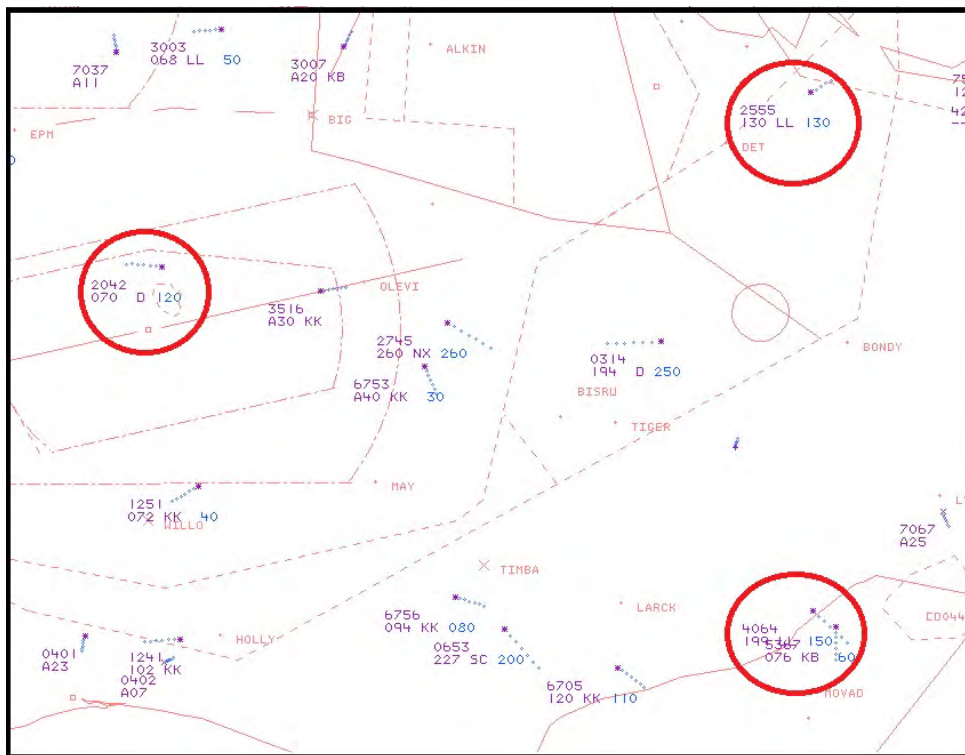
Print 1 – 0958:33

At 0958:33, the A321 flight squawking 4064, contacted the BIG Sector and reported descending to FL150. The BIG controller acknowledged, “(A321 c/s) Roger.” The relative positions of the 3 ac are shown in print 1 below.

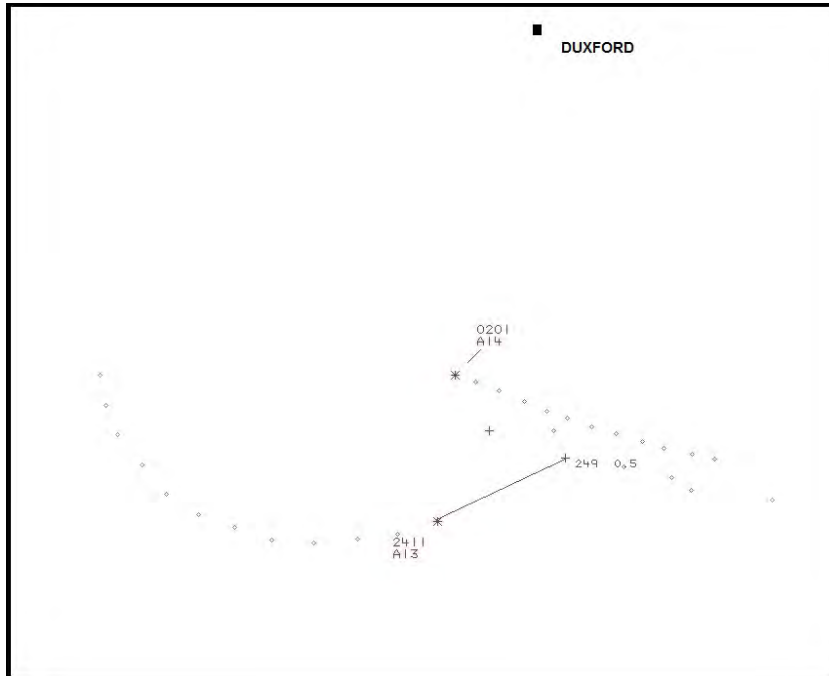
Radar print 1 - 1515:21

At 1515:21, the radar recording shows the primary contact of the third helicopter [R22(B)] crossing the C172 from R to L at a range of 0.5nm as shown in radar print 1 below. The pilot reported sighting the third helicopter slightly below.

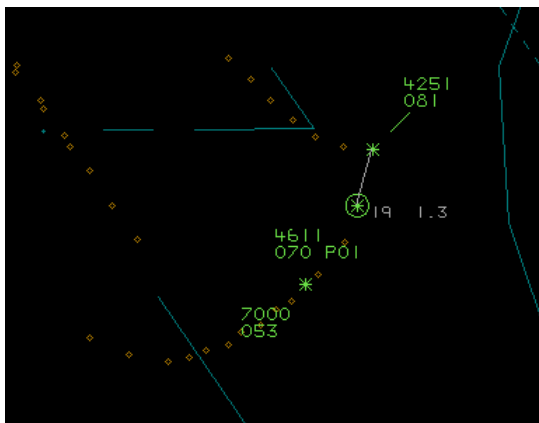
Figure 2: Claxby Radar 1224:14.

The JS41's turn onto 090° was observed to take full effect at 1224:14. The JS41 was now at FL81 with F-15E (Ldr) in its 4 o'clock, range 1.3nm, and indicating 1100ft below the JS41 - see Figure 2.

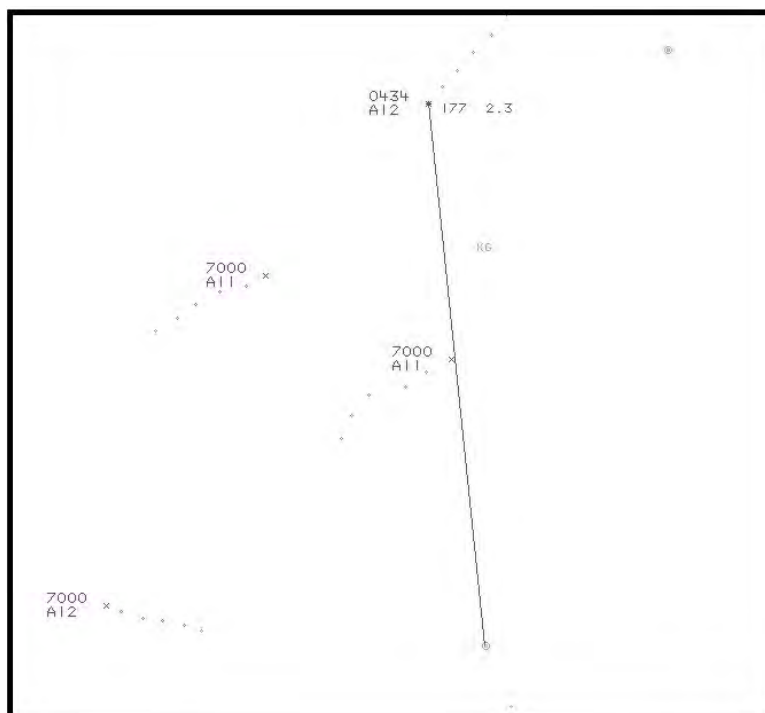
Print 1 – 1502:57

At 1502:57 the C172 reported tight DW, turning onto base leg in front of an ac [the subject PA28] turning onto base leg for RW24. The FISO acknowledged and reported sighting the southbound unknown ac. The PA28 was 2.3nm N of Goodwood, approaching the ATZ at 1200ft as shown in radar print 1.

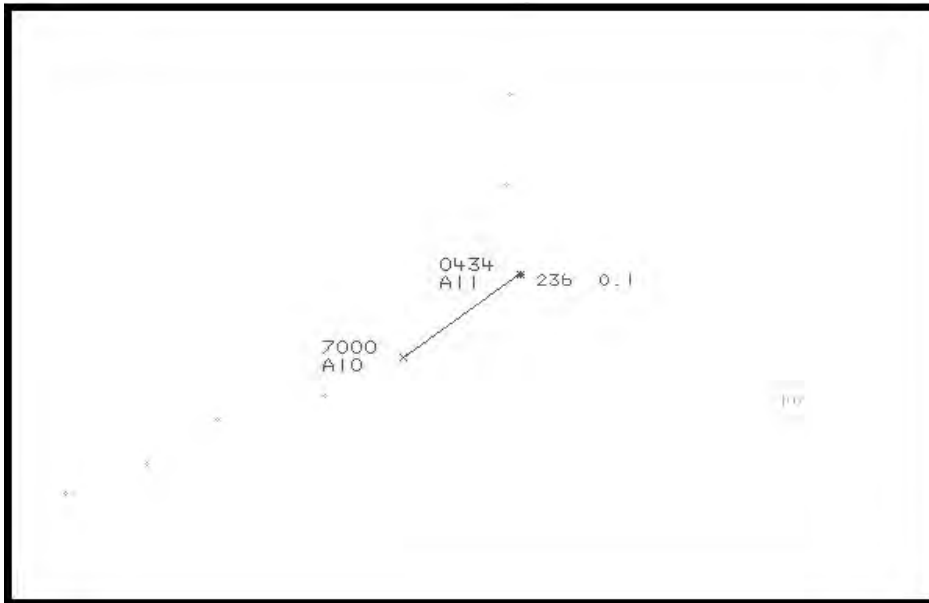
Print 2 – 1503:14

At 1503:14 radar print 2 (below) shows that the PA28 pilot had turned onto a S'ly track, inside the ATZ, and crossed 0.1nm ahead of the DR400.
