UK AIRPROX BOARD

Analysis of Airprox in UK Airspace

Report Number 12
January 2004 - June 2004

Twelfth Report by the UK Airprox Board:

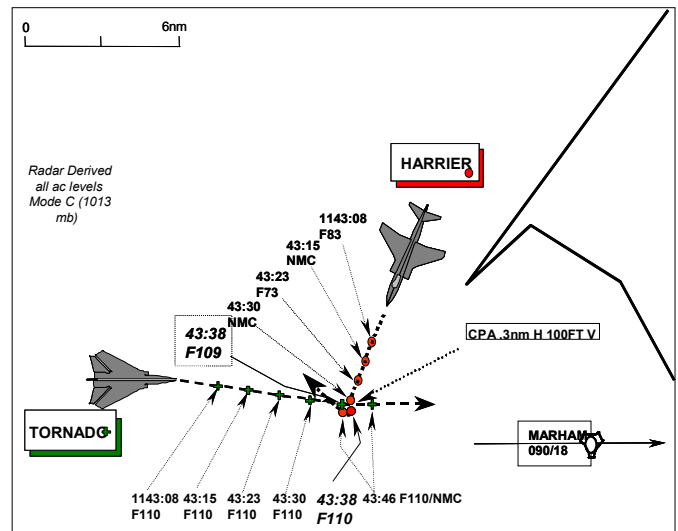
Date/Time: 7 Jan 1143
Position: 5250N 00004W
 (27nm WNW Marham)
Airspace: London FIR (Class: G)
Reporting Ac **Reported Ac**
Type: Tornado GR4 Harrier GR7
Operator: HQ STC HQ STC
Alt/FL: FL110 11300ft
 (QNH 1013 mb)
Weather VMC CLAC VMC CLAC
Visibility: >10km >10km
Reported Separation:
 0.3nm H low 200yd H 200ft V
Reported Separation:
 0.3nm H 100ft V

Cause: A conflict in the FIR resolved by both pilots.

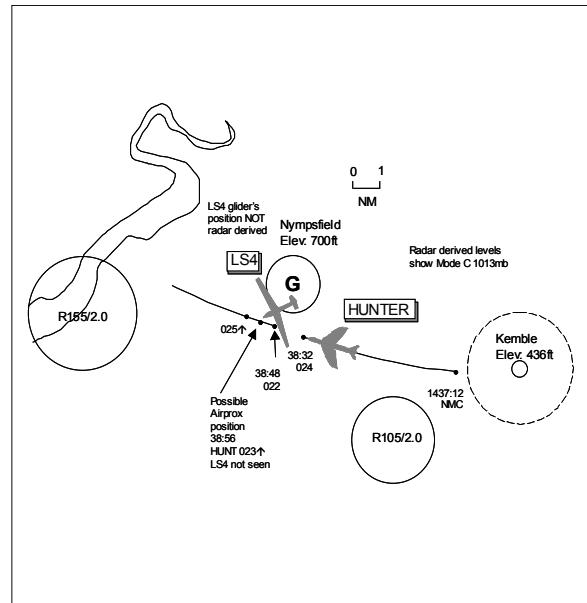
Date/Time: 24 Jan 1439 (Saturday)
Position: 5142N 0219W (2nm SW Nympsfield G/S - elev 700ft)
Airspace: FIR (Class: G)
Reporting Ac Reported Ac
Type: LS4 Glider Hunter
Operator: Civ Pte Civ Pte
Alt/FL: 2000ft↑ (amsl) (RPS)
Weather VMC CLBC VMC CLBC
Visibility: 10km
Reported Separation:
 50ft V 100m H not seen
Recorded Separation:
 not recorded

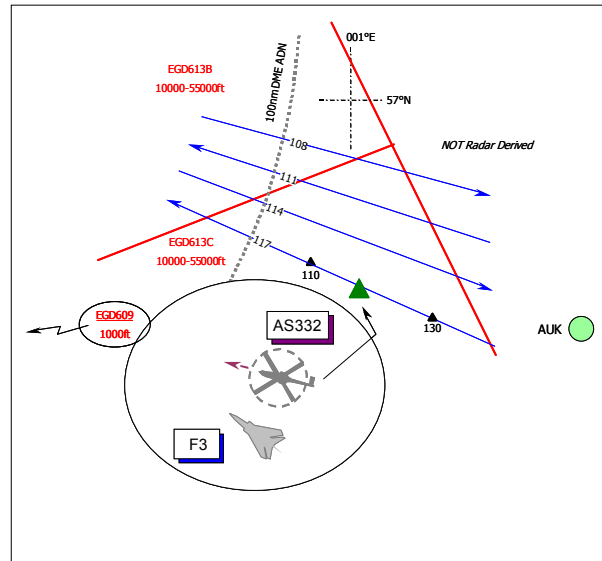
Date/Time: 5 Feb 0941
Position: 5630N 0103E
 (117°R ADN 119nm DME)
Airspace: Scottish FIR (Class: G)
Reporting Ac Reporting Ac
Type: Tornado F3 AS332L
Operator: HQ STC CAT
Alt/FL: 1000ft 1000ft
 (RPS 999mb) (RPS 999mb)
Weather VMC CLOC VMC CLOC
Visibility: 8km 6nm
Reported Separation:
 100ft V 50ft H/nil V
Recorded Separation:
 Not recorded

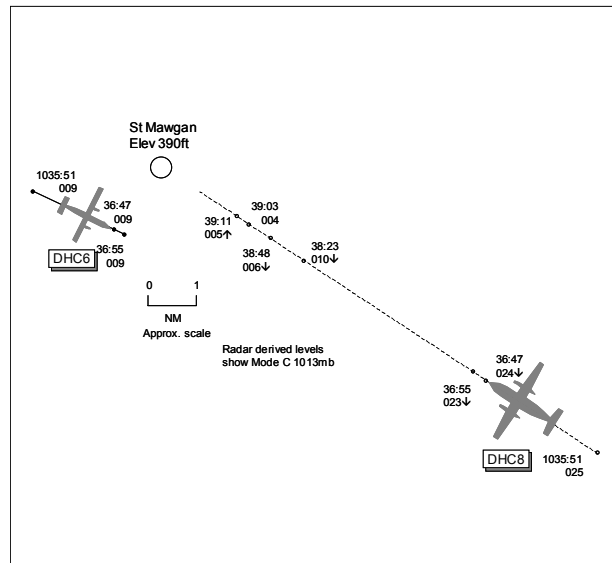
Date/Time: 19 Feb 1039
Position: 5025N 0457W
 (2nm SE St Mawgan - elev 390ft)
Airspace: ATZ (Class: G)
Reporting Ac **Reported Ac**
Type: DHC8 DHC6
Operator: CAT CAT
Alt/FL: 600ft↓ <300ft↓
 (agl) (QFE 1013mb)
Weather VMC CLBC VMC CLBC
Visibility: 17km 17km
Reported Separation:
 200ft V <1nm H 500ft V 2nm H
Recorded Separation:
 NR

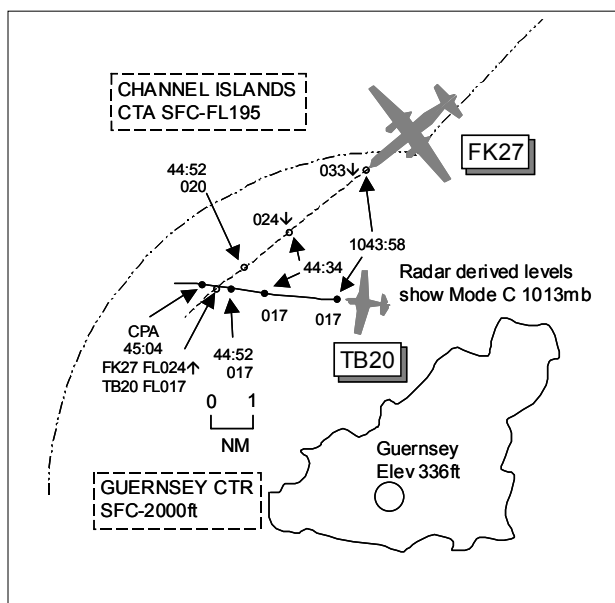
Date/Time: 19 Feb 1045
Position: 4931N 0242W
(6nm NW Guernsey - elev 336ft)
Airspace: CTR (Class: A/D)
Reporter: Guernsey APR
First Ac Second Ac
Type: FK27 TB20
Operator: CAT Civ Trg
Alt/FL: 2400ft↓ 2000ft
(QNH 1024mb) (QNH)
Weather VMC CLOC VMC
Visibility: 10km
Reported Separation:
400ft V >500m H NR
Recorded Separation:
700ft V 0.25nm H

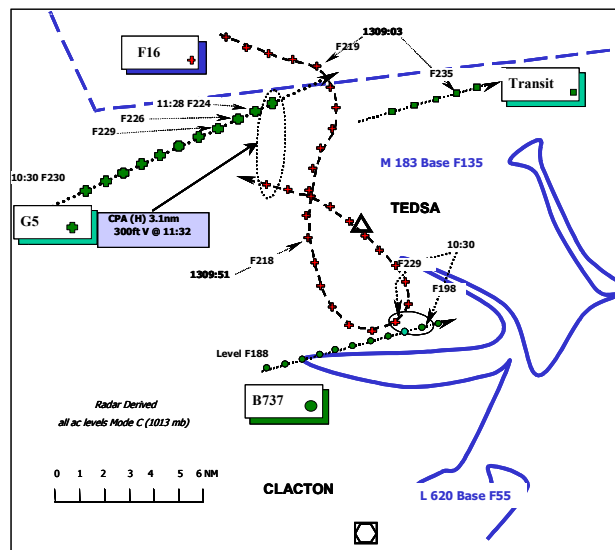
Date/Time: 4 Mar 1309
Position: 5203N 00107E (6nm NW TEDSA)
Airspace: Airway M 183 (Class: A)
Reporting Ac Reported Ac
Type: Gulfstream G5 F16
Operator: Civ Comm Foreign Mil
Alt/FL: FL230 FL200
Weather IMC VMC HAZE
Visibility: NR NR
Reported Separation:
200ft (TCAS) 2000ft H Low V
Recorded Separation:
3.1nm H 300ft

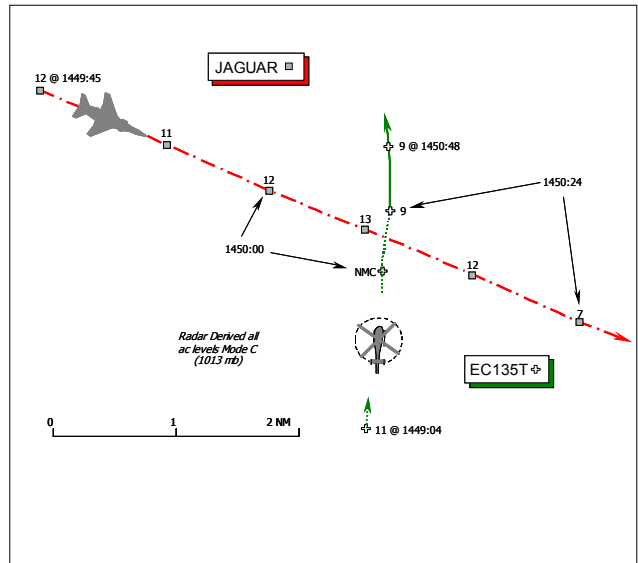
Date/Time: 10 Mar 1450
Position: 5316 N 0344 W
 (3NM ESE of CONWY)
Airspace: London FIR/LFS (Class: G)
Reporting Ac Reported Ac
Type: EC135 T1 Jaguar
Operator: Civ Comm HQ STC
Alt/FL: 1200ft 760-1200ft
 (QNH 1032 mb) (Rad Alt)
Weather VMC HAZE VMC CLBC
Visibility: 4-5km NR
Reported Separation:
 50m H/250-300ft V Not Seen
Recorded Separation:
 Not recorded

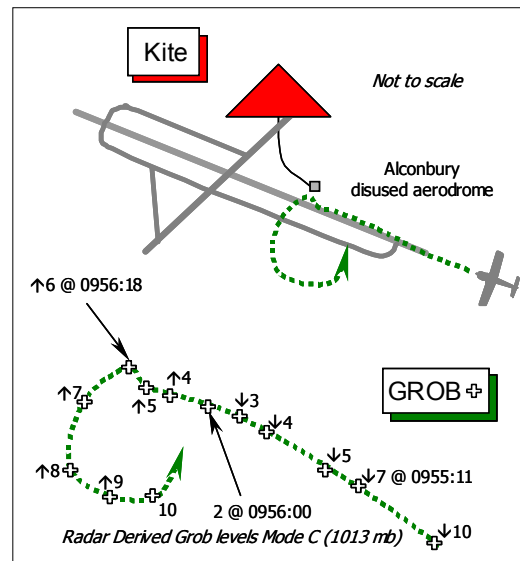
Date/Time: 23 Feb 0956
Position: 5222N 0013W
(Alconbury disused aerodrome)
Airspace: London FIR (Class: G)
Reported Ac Reporting Ac
Type: Grob Tutor Static Kite
Operator: HQ PTC Civ Comm
Alt/FL: 800ft Wyton QFE <750ft
(1018mb) agl
Weather VMC CLOC NR
Visibility: 25km+ NR
Reported Separation:
100m H/150ft V Not observed
Recorded Separation:
NR

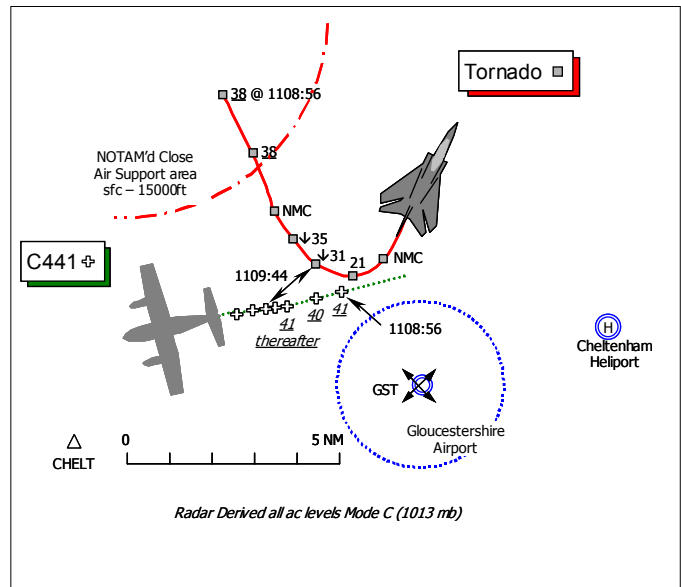
Date/Time: 18 Mar 1109
Position: 5155N 0215W (3½nm NW of Gloucestershire Airport elev: 101ft amsl.)
Airspace: London FIR (Class: G)
Reporter: Gloucestershire ATC
First Ac **Second Ac**
Type: Cessna 441 Tornado GR4
Operator: Civ Pte HQ STC
Alt/FL: FL40 250-3000ft (Rad Alt)
Weather VMC CLBL VMC CLBC
Visibility: 10km+ >10km
Reported Separation:
 200ft V Not Seen
Recorded Separation:
 1000ft V @ 1.5nm H

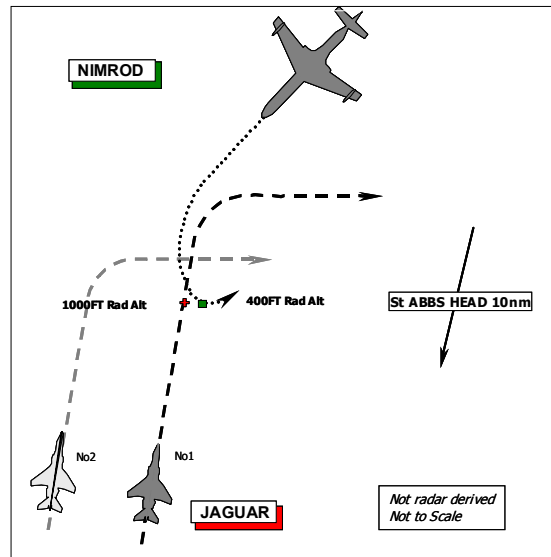
Date/Time: 18 Mar 1148
Position: 5600N 00158W
 (10nm NE St Abbs Hd)
Airspace: LFA 16 (Class: G)
Reporting Ac Reported Ac
Type: Nimrod MR2 Jaguar
Operator: HQ STC HQ STC
Alt/FL: 400ft 1000ft
 (Rad Alt) (Rad Alt)
Weather VMC CAVOK VMC CAVOK
Visibility: 20km 15km
Reported Separation:
 ~200m H 0 V 1500ft H 500ft V
Recorded Separation:
 NR

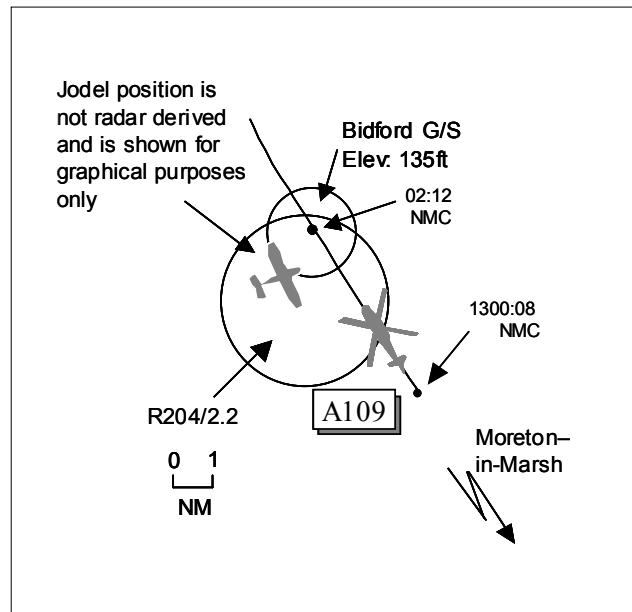
Date/Time: 21 Mar 1302 (Sunday)
Position: 5208N 0151W
(1nm SE Bidford G/S - elev 135ft)
Airspace: FIR (Class: G)
Reporting Ac Reported Ac
Type: Jodel1050 A109
Operator: Civ Pte Civ Pte
Alt/FL: 1500ft↓
(QFE 997mb)
Weather VMC CLBC
Visibility: >10km
Reported Separation:
just below V 200yd H
Recorded Separation:
NR

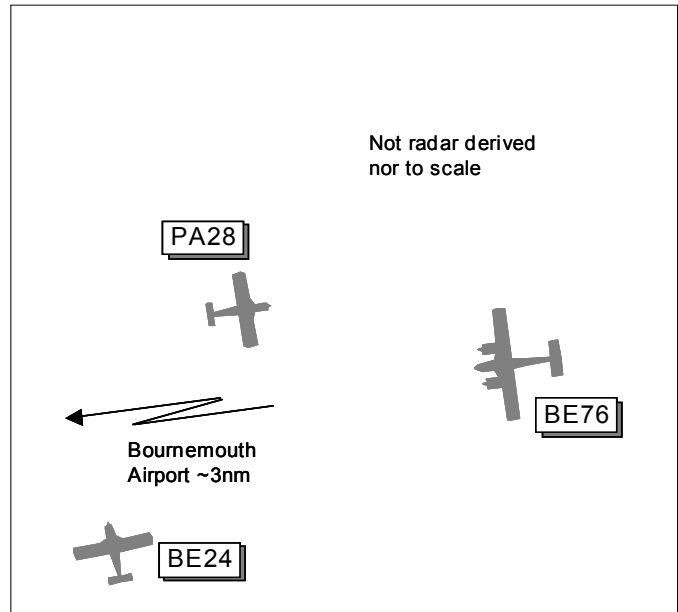
Date/Time: 23 Mar 1238
Position: 5047N 0146W
 (3nm E Bournemouth - elev 38ft)
Airspace: Bournemouth CTR (Class: D)
Reporting Ac *Reported Ac*
Type: BE76 PA28
Operator: Civ Trg Civ Trg
Alt/FL: 1200ft↓ NR
 (QNH 1016mb)
Weather VMC CLBC NR
Visibility: NR
Reported Separation:
 nil V 500m H NR
Recorded Separation:
 not recorded

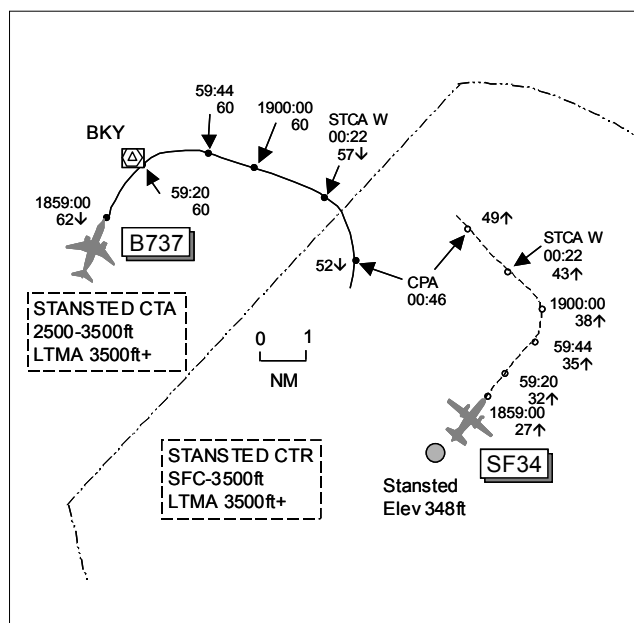
Date/Time: 24 Mar 1901 NIGHT
Position: 5157N 0013E
(4nm N Stansted - elev 348ft)
Airspace: TMA (Class: A)
Reporting Ac Reported Ac
Type: SF34 B737-800
Operator: CAT CAT
Alt/FL: 5000ft ↓3000ft
(QNH 1025mb) (QNH)
Weather IMC KLWD NK NR
Visibility:
Reported Separation:
nil V 1.7nm H NR
Recorded Separation:
300ft V 2.5nm H

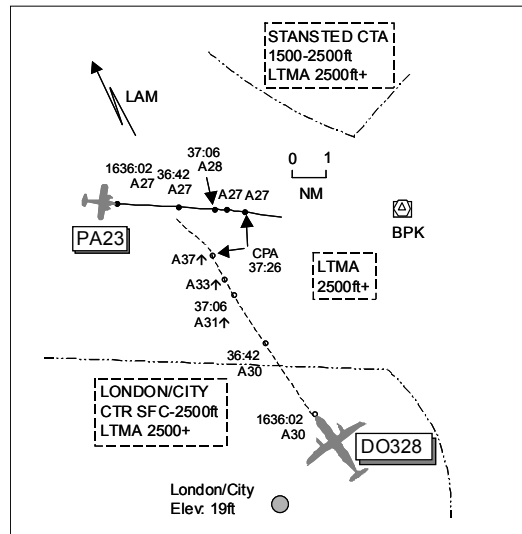
Date/Time: 26 Mar 1637
Position: 5138N 00001E (5nm W LAM)
Airspace: LTMA (Class: A)
Reporting Ac Reported Ac
Type: DO328 PA23
Operator: CAT Civ Pte
Alt/FL: 3000ft 2400ft
 (QNH 1021mb) (QNH 1021mb)
Weather VMC CLOC VMC CLNC
Visibility: >10km >10km
Reported Separation:
 1000-1200ft V 0.5-1nm H not seen
Recorded Separation:
 300ft V 2.5nm H or 1000ft V 1.5nm H

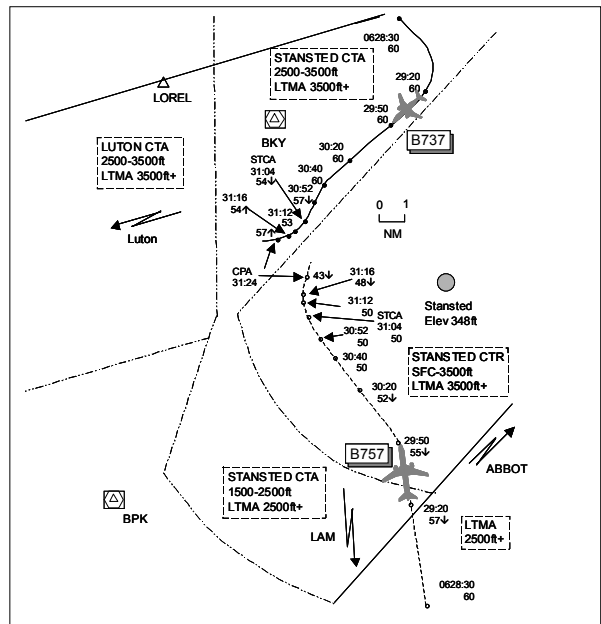
Date/Time: 31 Mar 0631
Position: 5153N 0005E
 (6nm W Stansted - elev 348ft)
Airspace: LTMA (Class: A)
Reporting Ac Reported Ac
Type: B757 B737-300
Operator: CAT CAT
Alt/FL: 5000ft ↓3000ft
 (QNH 1008mb) (QNH)
Weather VMC CLNC VMC CLOC
Visibility: 20nm NR
Reported Separation:
 NR 700ft V 1.5nm H
Recorded Separation:
 600ft V 2.25nm H

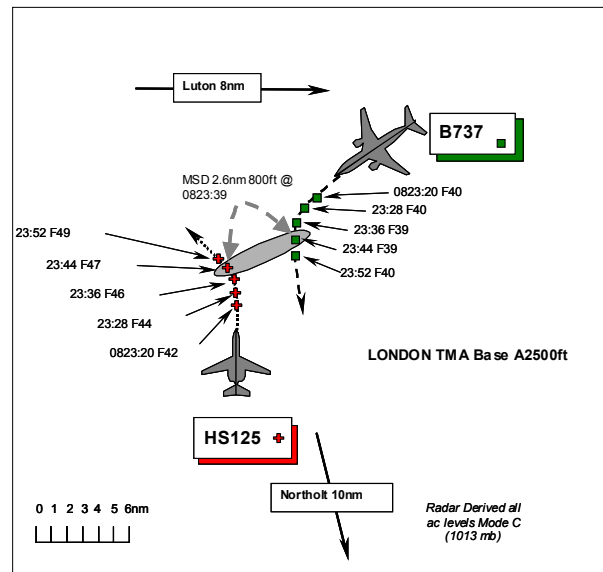
Date/Time: 29 Mar 0824
Position: 5144N 00038W (3nm W of BNN)
Airspace: London TMA (Class:A)
Type: B737 HS125-700
Operator: CAT HQ STC
Alt/FL: 3700ft 4000ft
(QNH 1032) (QNH)
Weather VMC CLBL IMC
Visibility: 5km 5km
Reported Separation:
3nm TCAS H 0 V 1000ft H
- 1000ft V
Recorded Separation:
2.6nm H 800ft V

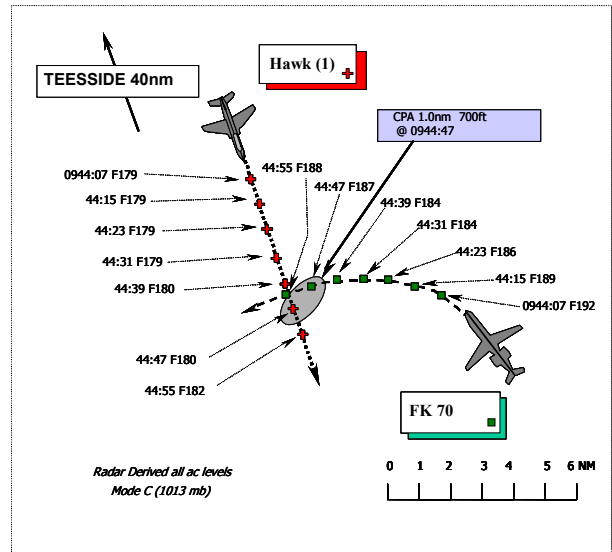
Date/Time: 25 Mar 0945
Position: 5412N 00032E
 (Descent to Teesside)
Airspace: Vale of York AIAA (Class:G)
Reporting Ac Reported Ac
Type: FK70 Hawk
Operator: CAT HQ STC
Alt/FL: FL170 N/R
 (N/K)
Weather VMC CLAC VMC CLAC
Visibility: >10km >10km
Reported Separation:
 1.5nm H 400ft V NR
Recorded Separation:
 1.00nm H 700ft V

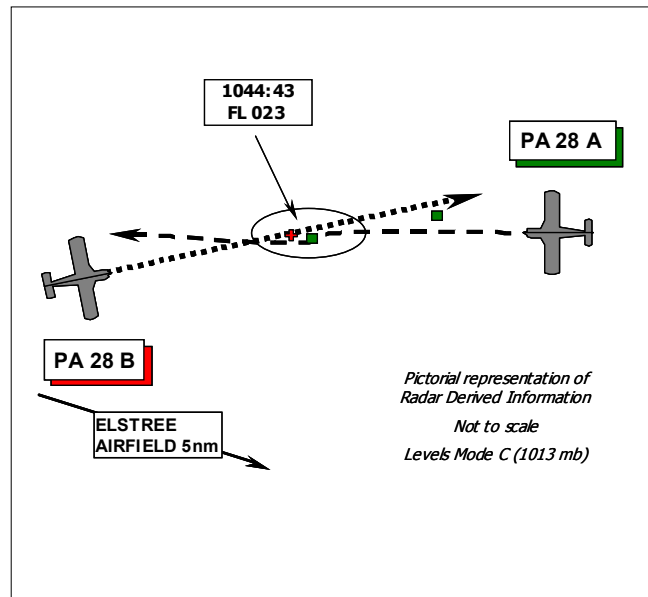
Date/Time: 11 Apr 1045 (Sunday)
Position: 5141N 00030W
(1.5nm West of M1/M25 Junction)
Airspace: London FIR (Class: G)
Reporting Ac Reporting Ac
Type: PA 28 (A) PA28 (B)
Operator: Civ Trg Civ Pte
Alt/FL: 2300ft 2350ft
(QNH 1022 mb) (N/K)
Weather VMC VMC
Visibility: 12km 10kmn
Reported Separation:
20-50ft V <50m H50ft V 100ft H
Reported Separation:
Contacts Merge at 2300ft

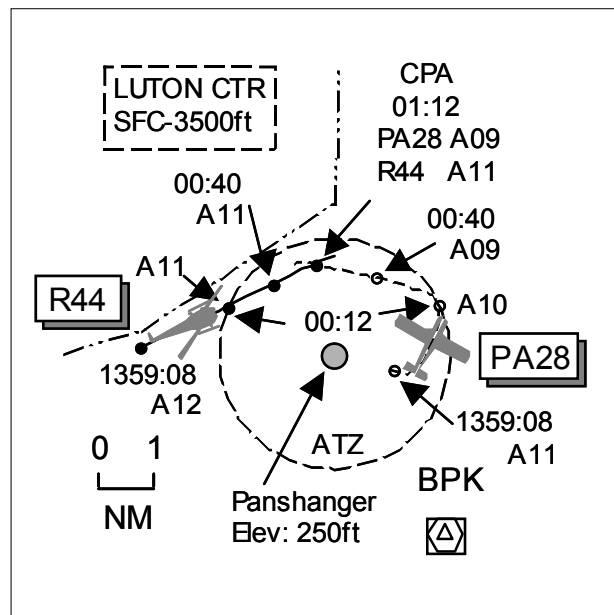
Date/Time: 16 Apr 1401
Position: 5150N 00010W
(1.5nm N Panshanger - elev 250ft)
Airspace: ATZ (Class: G)
Reporting Ac Reported Ac
Type: PA28 R44
Operator: Civ Trg Civ Pte
Alt/FL: 800ft 1300ft
(QFE 1001mb) (QNH)
Weather VMC CLOC VMC CLBC
Visibility: >10km >10km
Reported Separation:
50-100ft V 300ft V&H
Recorded Separation:
Contacts merge 200ft V

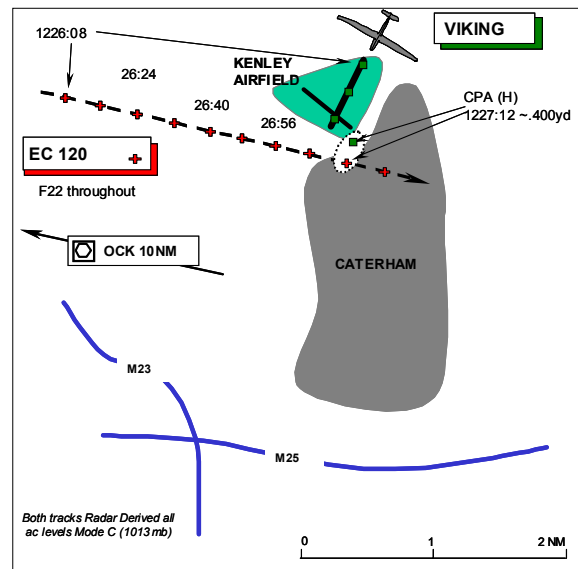
Date/Time: 17 Apr 1227 (Saturday)
Position: 5118N 00005W (S perimeter Kenley Airfield - elev 566ft)
Airspace: London FIR (Class: G)
Reporting Ac Reported Ac
Type: Viking Glider EC120
Operator: HQ PTC Civ Pte
Alt/FL: 1300ft 2000ft amsl
(QFE 984 mb) (N/K)
Weather VMC CLBC VMC N/R
Visibility: >10km N/R
Reported Separation:
200ft H 50/100ft V N/R
Recorded Separation:
Approx 400yd H N/R V

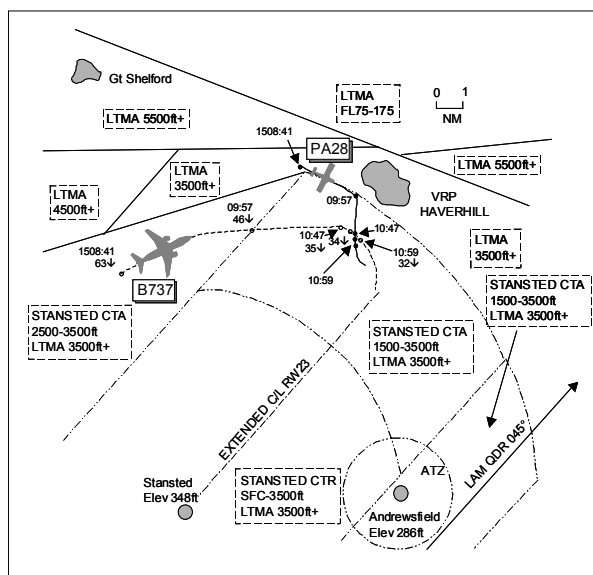
Date/Time: 23 Apr 1511
Position: 5203N 00024 E
(11nm NE Stansted - elev 348 ft)
Airspace: LTMA/CTA (Class: A/D)
Reporting Ac **Reported Ac**
Type: B737-300 PA28
Operator: CAT Civ Pte
Alt/FL: 3500ft↓ 3200ft
(QNH 1025mb) (QNH 1027mb)
Weather VMC CLNC VMC CLOC
Visibility: 10km >10km
Reported Separation:
300ft V 1nm H 1000-1200ft V
Recorded Separation:
0.25nm H

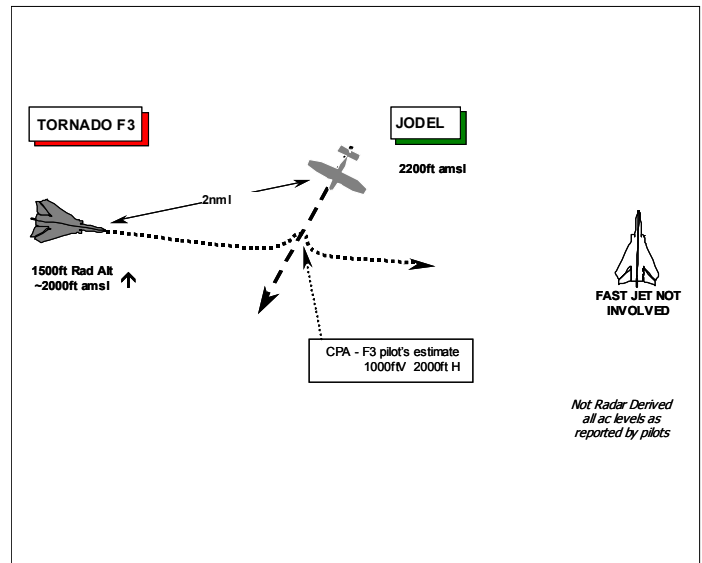
Date/Time: 22 Apr 1625
Position: 5629N 00318W (Perth 030/3.8nm elev 397ft)
Airspace: Scottish FIR/LFA14 (Class: G)
Reporting Ac Reported Ac
Type: Jodel D150 Tornado F3
Operator: Civ Club HQ STC
Alt/FL: 2200ft 1500ft
 (QNH1013mb) (Rad Alt)
Weather VMC CLBC VMC CLBC
Visibility: >10km >10km
Reported Separation:
 NR 2000ft H 1000ft V
Recorded Separation:
 NR

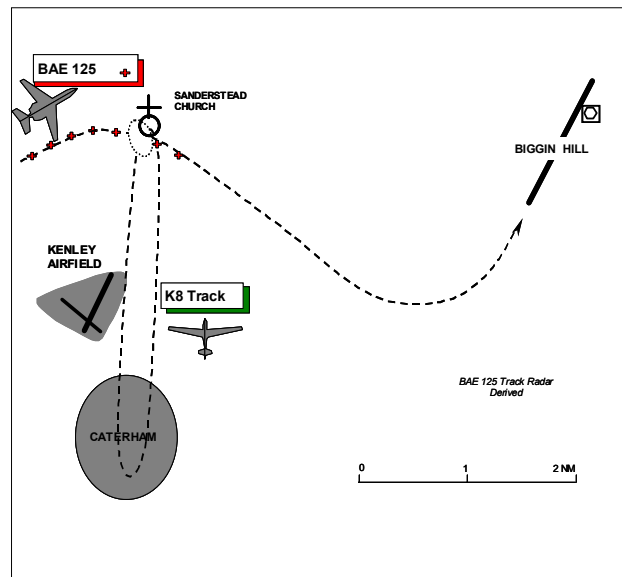
Date/Time: 23 Apr 1650
Position: 5119N 00005W (1½nm N of Kenley Airfield - elev 566ft)
Airspace: London FIR (Class: G)
Reporting Ac *Reported Ac*
Type: K8 Glider BAE125
Operator: Civ Club Civ Comm
Alt/FL: 1900ft 2100ft
(QFE) (QNH)
Weather VMC CLOC VMC CAVOK
Visibility: 50km NR
Reported Separation:
50ft V 0 H NR
Recorded Separation:
NR

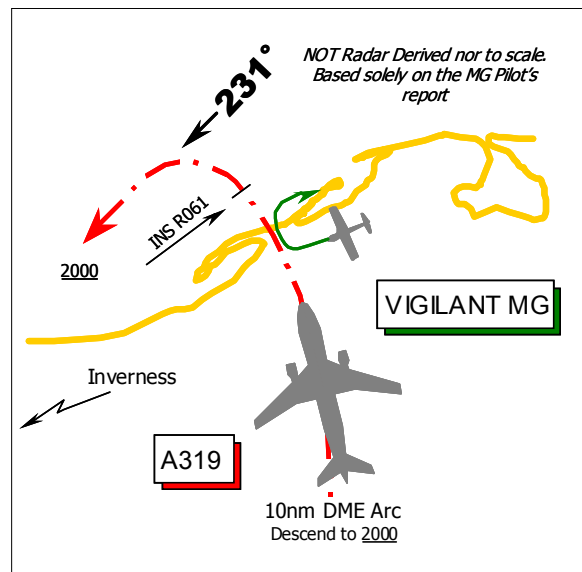
Date/Time: 1 May 1209 (Saturday)
Position: 5737N 00348W
(8nm W of Kinloss - elev 22ft)
Airspace: Kinloss AIAA (Class: G)
Reporting Ac Reported Ac
Type: Vigilant M/Glider Airbus A319
Operator: HQ PTC CAT
Alt/FL: 3900ft ↓ on TAP
(QNH 1010mb) (QNH 1011mb)
Weather VMC HAZE IMC NK
Visibility: 18km NK
Reported Separation:
200m H Not seen
Recorded Separation:
NR

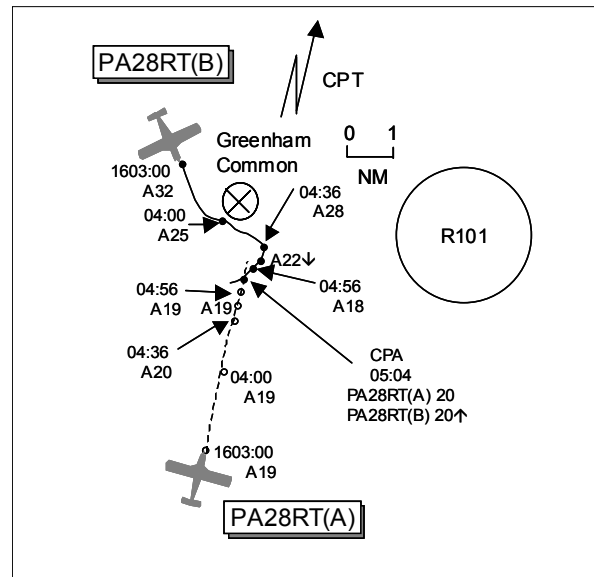
Date/Time: 16 May 1605 (Sunday)
Position: 5121N 00116W
 (2nm S Greenham Common)
Airspace: FIR (Class: G)
Reporting Ac **Reported Ac**
Type: PA28RT(A) PA28RT(B)
Operator: Civ Pte Civ Trg
Alt/FL: 2000ft 4000ft
 (RPS 1028mb) (QNH 1025mb)
Weather VMC CAVOK VMC CLNC
Visibility: >10km
Reported Separation:
 2-3m V not seen
Recorded Separation:
 nil V returns merge

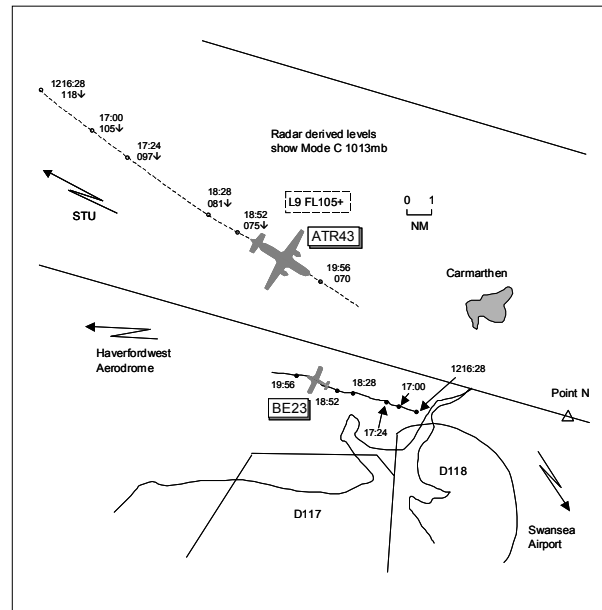
Date/Time: 14 May 1220
Position: 5150N 00430W
 (7nm WSW Carmarthen)
Airspace: LFIR (Class: G)
Reporter: Swansea ADC/APP
First Ac **Second Ac**
Type: ATR43 BE23
Operator: CAT Civ Pte
Alt/FL: ↓FL55 ↑FL65
Weather IMC KLWD VMC CLOC
Visibility: VMC CLAC 17km
Reported Separation:
 Not seen Not seen
Recorded Separation:
 3.75nm H

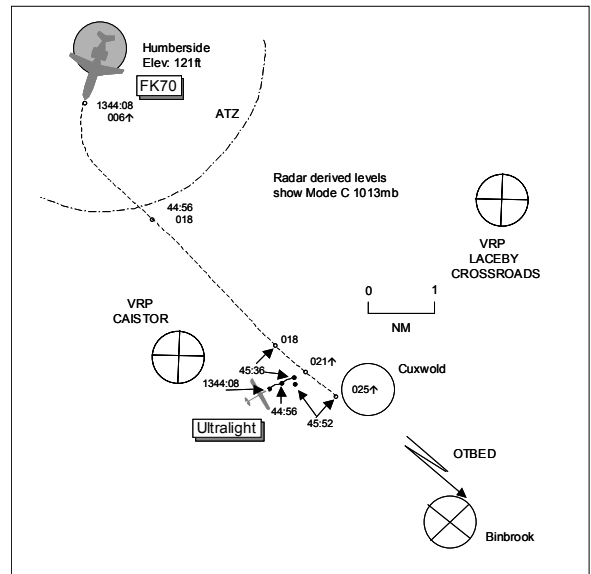
Date/Time: 18 May 1346
Position: 5329N 00016W (6nm SE
 Humberside - elev 121ft)
Airspace: FIR (Class: G)
Reporting Ac Reported Ac
Type: FK70 Untraced Ultralight
Operator: CAT
Alt/FL: 2300ft↑
 (QNH 1024mb)
Weather VMC CAVOK
Visibility: 10km
Reported Separation:
 Nil V 1000m H
Recorded Separation:
 0.2nm H

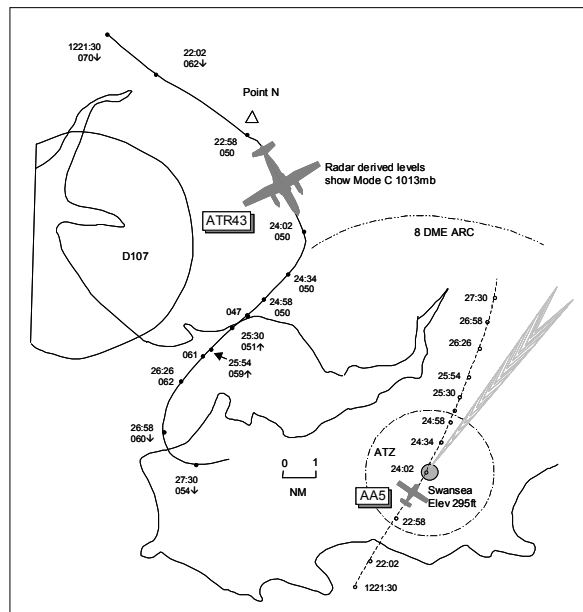
Date/Time: 14 May 1226
Position: 5140N 00408W (4nm NW Swansea Airport - elev 295ft)
Airspace: LFIR (Class: G)
Reporter: Swansea ADC/APP
First Ac Second Ac
Type: AA5 ATR42-300
Operator: Civ Pte CAT
Alt/FL: FL60 FL61↑
Weather IMC CLAC IMC KLWD
Visibility: >10km NR
Reported Separation:
Not seen Not seen
Recorded Separation:
7nm H
