**UK AIRPROX BOARD**

# **Analysis of Airprox in UK Airspace**

**Report Number 15  
July 2005 – December 2005**

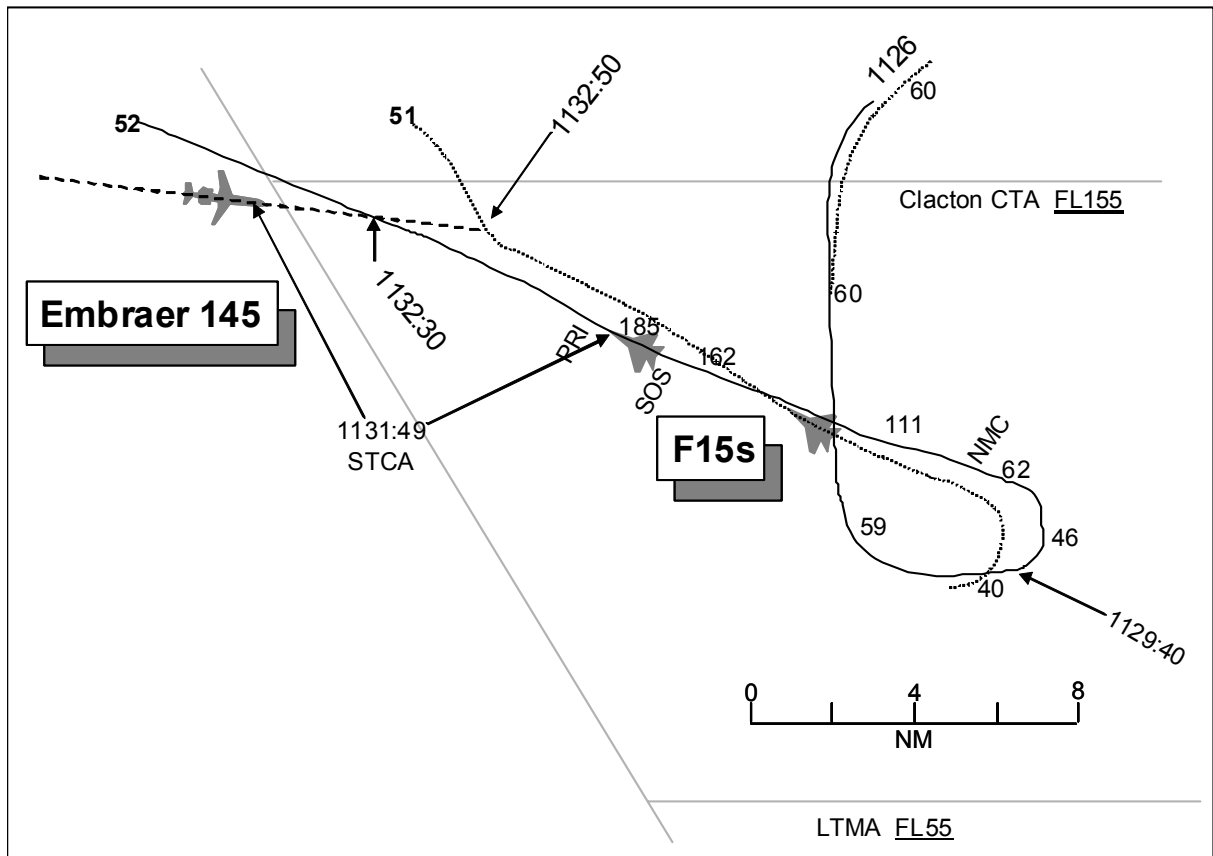
Date/Time: 27 Jan 1132                      Position: 5225N 00031W (15nm SW Peterborough)  
Airspace: Airway P155                      (Class: A)  
Reporting Ac                      Reported Ac  
Type: EMB 145                      F15E  
Operator: CAT                      Foreign Mil  
Alt/FL: FL210                      FL200-240  
Weather VMC                      VMC  
Visibility: 10km  
Reported Separation:  
 200m H/100 ft V                      1000 V/>1nm H  
Recorded Separation:  
 NK

The Board quickly concluded that the primary cause of the Airprox was that the F15 crews did not follow the correct procedures for entering controlled airspace in that they entered before they had been identified and cleared by London Mil; did not adopt either the correct SSR procedures for crossing as a formation or as singletons and did not comply with heading and height instructions passed to them by Lakenheath or London Mil. While they may have been driven by desperation to ignore these instructions, they did not squawk Emergency from the start, or continuously, which would have helped the civil controllers involved; indeed they did not squawk anything continuously, with Mode C, which negated the E145's TCAS and the controllers' STCA. Furthermore, having separated into singletons, they should both have been squawking.

Cause: The F15 crews did not follow correct CAS entry procedures and climbed above their cleared level into conflict with the EMB145.

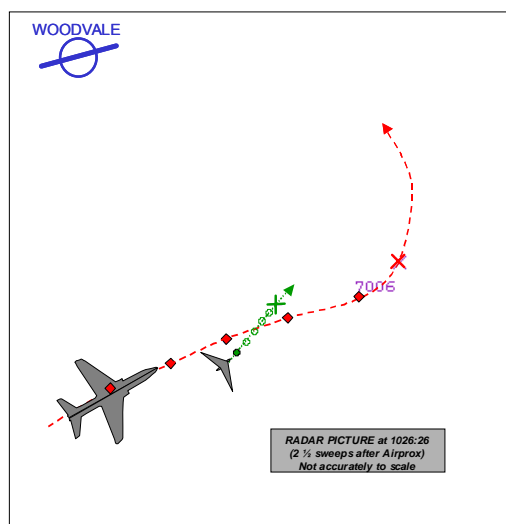
Date/Time: 1 Jul 1020  
Position: 5331 00300W (1nm SE Ince - elev 10ft)  
Airspace: London FIR (Class: G)  
Reporting Ac Reported Ac  
Type: Flexwing Microlight Hawk  
Operator: Civ Trg HQ PTC  
Alt/FL: 1500ft 1000ft  
(QFE 1010 mb)  
Weather VMC CLBC VMC CAVOK  
Visibility: >30km >10km  
Reported Separation:  
50ft V/ OH 350ft V/100yds H  
Recorded Separation:  
NR

The Board was aware of the difficulty of visually acquiring a slow moving microlight against a similarly coloured background. Nonetheless since the Hawk had approached the microlight from the rear, the majority of the responsibility for collision avoidance lay with the Hawk pilot. Although he did see the microlight in sufficient time (just over 10sec) to initiate avoiding action by descending, the Board considered that some lateral as well as vertical separation would have been more appropriate and would have caused the microlight pilot much less concern.

Cause: Having seen the microlight at 1nm, the Hawk pilot flew close enough to cause the microlight pilot concern.

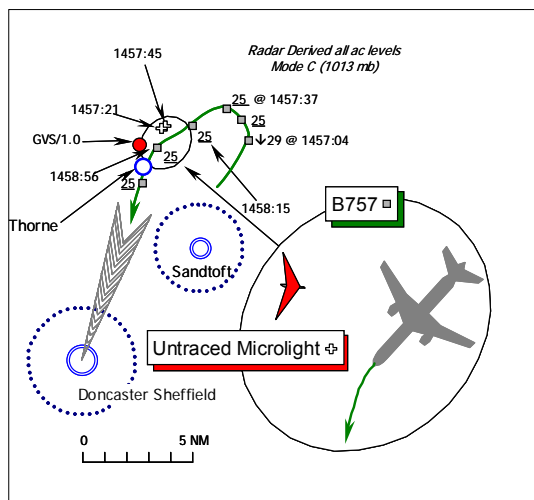
**Date/Time:** 3 Jul 1457 (Sunday)  
**Position:** 5338N 00055W (10nm NE Doncaster  
Sheffield Airport - elev 55ft)  
**Airspace:** London FIR (Class: G)  
**Reporting Ac** **Reported Ac**  
**Type:** B757-200 Untraced M/L  
**Operator:** CAT NK  
**Alt/FL:** 2500ft NR  
(N/K)  
**Weather** VMC CAVOK NR  
**Visibility:** >10km NR  
**Reported Separation:**  
Nil V/¼nm H NR  
**Recorded Separation:**  
Not recorded

Cause: A sighting of an untraced microlight by the B757 pilot.
