UK AIRPROX BOARD

Analysis of Airprox in UK Airspace

**Report Number 8
January 2002 - June 2002**

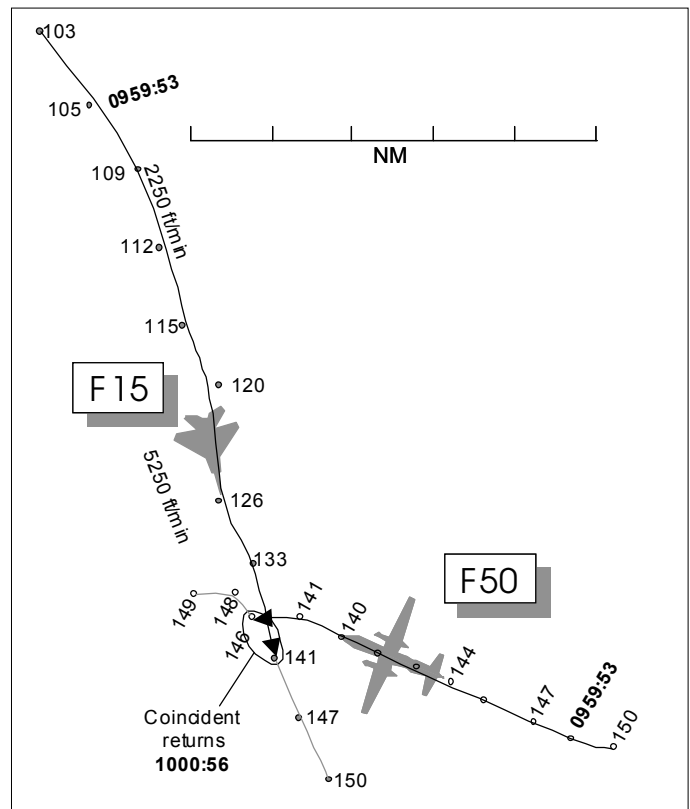
Date/Time: 13 Aug 1001
Position: 5413 N 0025 W (3 NM S of Scarborough)
Airspace: FIR (Class: G)
Reporting Aircraft Reported Aircraft
Type: F50 F15
Operator: CAT Foreign Mil
Alt/FL: FL 140 ↓ 2000 ft Alt/FL 100
Weather VMC CLOC VMC CLOC
Visibility: 10 km+
Reported Separation:
 300 ft V NR
Recorded Separation:
 <0.25 NM H

recordings showed that the only time during the encounter when there was not a risk of collision was after the F50 pilot had started his avoiding action and was pulling up at 2 g to avoid the F15. Members gained the impression that the F15 WSO had seen the F50 virtually as the military jet was passing it, and that this late sighting was the main part of the cause of the Airprox. The Board agreed that this was effectively a non-sighting in terms of the crew's ability to take avoiding action as a result of it. Members considered that the F15 crew could have helped themselves by advising Leeming of their intention to head south before doing so, or by calling London Radar before climbing. As it was, 'see and avoid' was their responsibility.

Opinion was also divided as to whether the Pennine controller's action was timely and accurate. The F15's angle-off from the F50 remained constant at 29° during the period shown in the diagram; almost exactly 1 o'clock rather than the 2 o'clock passed twice by the controller, which may have been partly why the F50 pilots never saw it. The expression 'pop-up' was taken to mean 'I have just noticed it' and it was observed from the radar recording that the F15 had become a threat to the F50 a little while before that. The Pennine Control position was usually very busy and certainly covered a very large area of responsibility. However, at the time, the F50 was the only ac on frequency. Opinions remained divided as to whether the Pennine controller could or should have seen the conflict earlier and issued avoiding action to the F50, but all agreed on part of the cause; by the time the conflict was perceived by Pennine

In discussing the risk level, members noted that the F50 pilot's robust response to his TCAS had produced about 600 ft of vertical separation.

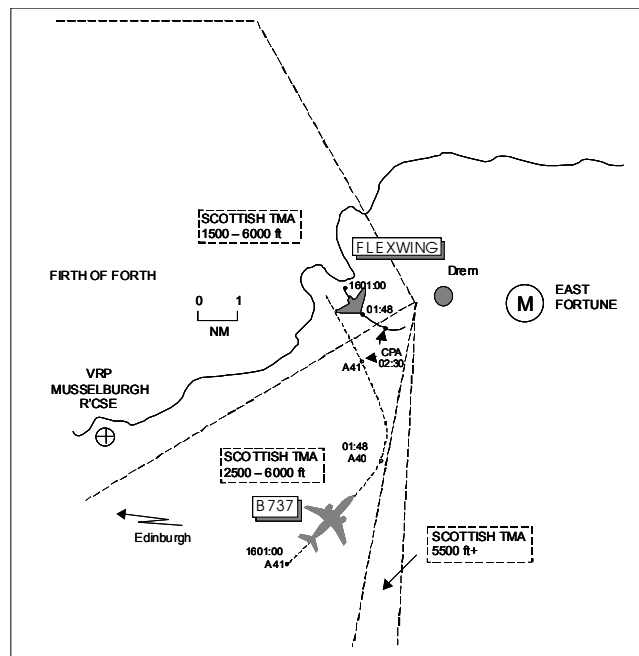
Date/Time: 9 Jan 1602 Twilight
Position: 5559 N 0250 W (17 NM E of Edinburgh)
Airspace: TMA (Class: E)
Reporting Aircraft Reported Aircraft
Type: B737-200 Pegasus Quantum
Flexwing M/L
Operator: CAT Civ Trg
Alt/FL: 4000 ft 4000 ft ↑
(QNH 1030 mb) (QNH 1030 mb)
Weather IMC IICL VMC CLOC
Visibility: >10 km >10 km
Reported Separation:
200 ft V 1 NM H 500 ft V 1 NM H
Recorded Separation:
NK V 1.0 NM H

Discussion reviewed the weather minima applicable to VMC and the ATC service that applied within the Scottish TMA Class E airspace. The Pegasus pilot had knowingly climbed into the TMA, in a hole clear of cloud to maintain VMC, and had then manoeuvred, when on top of the cloud layer, to vacate the Class E airspace to the E. None of this had broken any rules and he had been fully aware of his responsibilities within CAS but had decided not to contact Edinburgh ATC, as recommended in the UK AIP. The B737 had been under a radar control service from the Edinburgh APR who had unwittingly vectored the ac into conflict with the microlight which was not showing on his radar display system; the M/L pilot had not called on his frequency to announce his presence and intentions so there was no way the controller could have known he was there. Normally, an ac only 16 NM from a radar head above 3000 ft would be expected to show on an airfield terminal radar but a M/L is another matter. It is known to be a poor target whose detection would be very much dependent, amongst other factors, on the target aspect presented to the radar head. The Lowther Hill recorded radar had shown the M/L but this primary radar source was not available to the APR. Members agreed the anomaly of the situation that within Class E airspace, a radar control service had vectored the B737 into conflict with undetected traffic (that

had every right to be where it was) and it was this that had caused the Airprox. They felt there was nothing to prevent this situation from being repeated and so it should be looked at to see what could be done.

Cause: In Class E airspace, the B737 was vectored under a Radar Control Service and conflicted with undetected VFR traffic.

Recommendation: The CAA considers a review of the provision of Radar Control Service in Class E airspace.

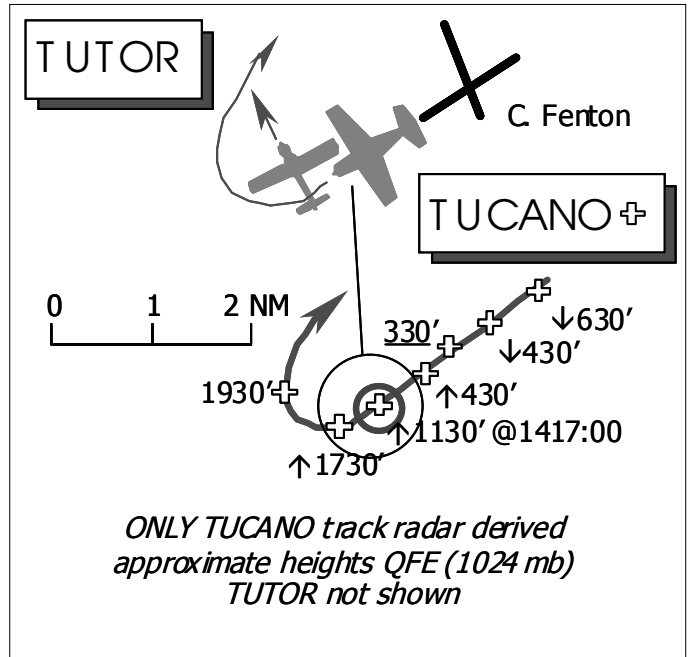
Date/Time: 11 Jan 1417
Position: 5350 N 0111 W (Church Fenton - elev 29 ft)
Airspace: MATZ (Class: G)
Reporting Aircraft Reported Aircraft
Type: Grob Tutor Tucano T1
Operator: HQ PTC HQ PTC
Alt/FL: 1800 ft 1800 ft
 (QFE 1024 mb) (QFE 1024 mb)
Weather VMC VMC HAZE
Visibility: 5000 m 5000 m
Reported Separation:
 100 ft V 100 m H Nil H, <300 ft V
Recorded Separation:
 Not Recorded

HQ PTC comments that this encounter is redolent [suggestive] of so many which have occurred over time in the Cct and perhaps - in the past - have been regarded as a training hazard and gone unreported. A pilot sees another ac in unexpectedly close proximity and avoids it; the other does not because he is "head-in". ATC made all the right standard calls but they didn't work. Are they constrained too much from passing more specific warnings?

Cause: The Grob Tutor pilot flew into conflict with the Tucano. Compounded by a late sighting by the Tucano crew.
