**UK AIRPROX BOARD**

# **Analysis of Airprox in UK Airspace**

**Report Number 7  
July 2001 to December 2001**

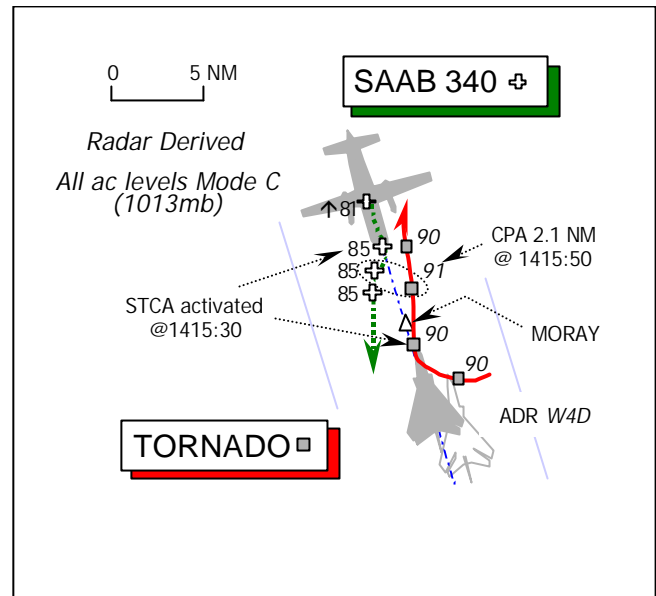
Recorded Separation: 600 ft V @ 2.1 NM H

UKAB Note (2): A review of the ScACC TAY sector RTF transcript reveals that the SC passed traffic information to the SAAB crew relating to another ac at 3000 ft and the Tornado pair (3/A 7001) for the first time at 1412:10, "...traffic in ... your twelve o'clock at a range of 18 miles...appears to be military aircraft or fast jet aircraft...manoeuvring at the moment...last seen climbing through flight level 100 I will keep you updated"; the crew responded "roger that's copied (C/S) looking". Exactly 3 min later at 1415:10, the SC updated the traffic information on the previously observed contacts at 3000 ft and the subject ac - "...previous traffic...the higher one appears to be maintaining

*flight level 90". Followed within the same uninterrupted transmission at 1415:30, with "...avoiding action turn right head..230 traffic in your 12 o'clock at a range of 4 miles unverified at flight level 90". The SAAB crew responded immediately at 1415:40, "taking avoiding action...", whereupon the SC asked for their flight conditions, which were VMC. At 1416:00, the SC instructed the SAAB crew to "...descend flight level eight zero that's avoiding action traffic in your ten o'clock now at a range of 2 miles unverified indicating flight level 90". Whereupon the SAAB crew replied "traffic in sight...". Thirty sec later the Tornado pair was reported by the SC to be "...now behind you in your 7 o'clock at a range of 4 miles you can resume your own navigation again for Aberdeen". The SC later ascertained that the SAAB crew was filing an Airprox and requested the crew's estimation of the minimum separation, to which they replied "...conflicting aircraft was in our 12 o'clock initially...slowly coming round to our nine o'clock...approximately 400 feet above us...and we were actually in process of taking avoiding action before you actually...passed it to us". Adding that the horizontal separation was "...approximately 2..nautical miles".*

Cause: Conflict in Class F airspace resolved by the SAAB pilot.

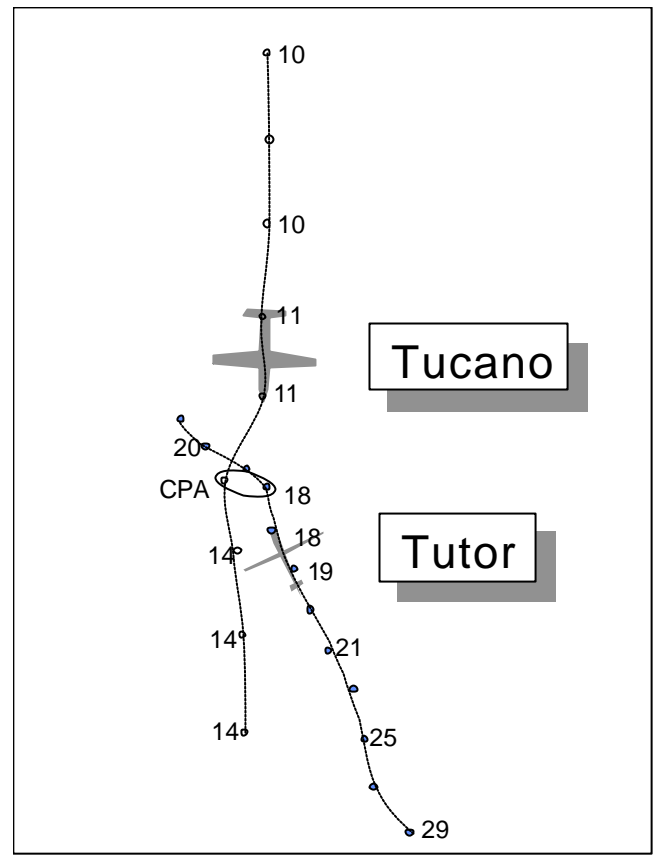
UKAB Note: The LATCC Gt Dun Fell radar recording shows the ac closing as depicted in the diagram. The Tutor is descending gently, following a shallow angle off the Pennines, and the Tucano is level at 1000-1100 ft Mode C in the valley ahead. The latter's Mode C does not show at the closest point but is level at 1400 ft thereafter. The Tutor is at 1800 ft at the CPA, where the lateral separation is

about 0.56 NM, and by interpolation, the Mode C vertical separation would have been 5-600 ft. Both ac alter track somewhat to the right immediately before they pass.

The radar recording indicated that the vertical separation between the 2 ac was somewhat more than both crews' estimates, and the avoiding turns indicated that the sightings were made at a greater distance than reported. Members agreed that both crews had seen the other ac in time to take effective avoiding action and that the encounter was a conflict of flightpaths in the LFS which was resolved by both crews in a manner which removed any possible risk of collision. It was observed that a Tutor, head-on, is not easily seen at distance,

Cause: Conflict of flightpaths in the LFS which was resolved by both crews.

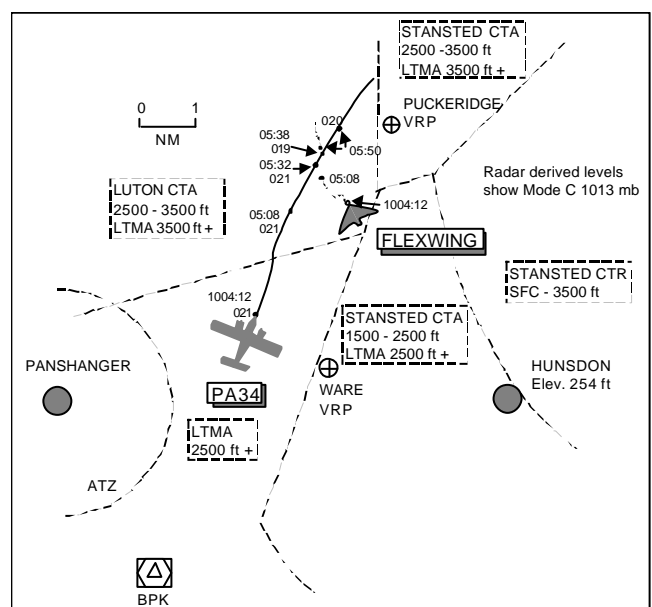
Date/Time: 1 Jul 1006 (Sunday)  
Position: 5152 N 0002 W (1.5 NM WSW Puckeridge VRP)  
Airspace: FIR (Class: G)  
Reporting Aircraft Reported Aircraft  
Type: Mainair Blade PA34  
 Flexwing M/L  
Operator: Civ Trg Civ Trg  
Alt/FL: 2400 ft 2400 ft  
 (QNH NK mb) (QNH 1027 mb)  
Weather VMC CAVOK VMC CLOC  
Visibility: NK >10 km  
Reported <100 ft V/H 200 ft V  
Separation:  
Recorded Separation: not recorded

Cause: Late sighting by the PA34 pilot.
