**UK AIRPROX BOARD**

# **Analysis of Airprox in UK Airspace**

**Report Number 27  
July 2011 – December 2011**

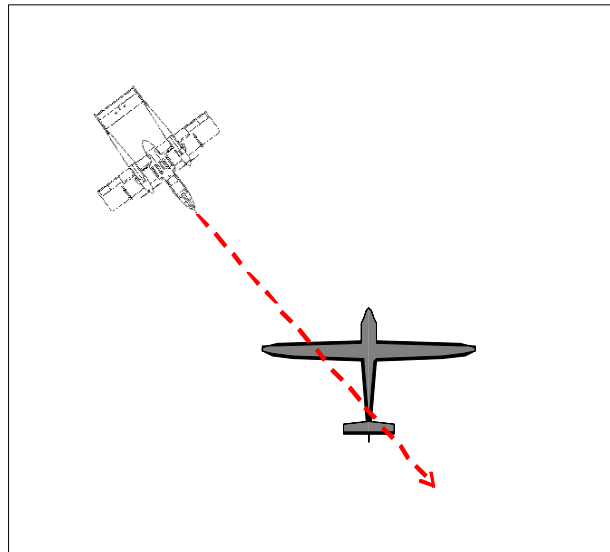
**THE VENTUS GLIDER PILOT** reports soaring at 50kt on the Marham QFE of 1020mb [see UKAB Note (1)] in dark, overcast conditions in a white glider with no SSR fitted but listening out on Marham Ground when he saw a dark camouflage green, twin tail boom Bronco type ac with day glo panels, ½ nm away and approaching him. He rocked the wings of his ac to attract attention of the other pilot and then flew away from the other ac.

Apart from the poor light conditions, Members could not explain why the Bronco pilot did not see the glider.

Cause: A non-sighting by the Bronco pilot.

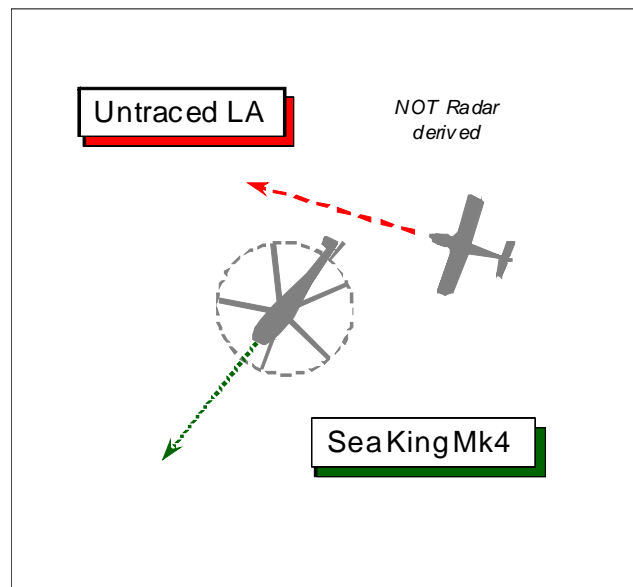
**YEOVILTON ATC** reports that the APP controller and RT voice recordings of the APP frequency support the sequence of events reported. The Sea King was vectored for a Short Pattern Circuit (SPC) PAR to RW22 at Yeovilton and was in receipt of a TS - not a RCS. The Sea King crew was instructed to descend to 1200ft QFE (1026mb), whereupon an intermittent radar contact was observed crossing the approach to RW27 at about 8-9nm E of the A/D before fading. The unknown contact then reappeared to the SE of the Sea King, about 4½ to 5nm away, tracking WNW'ly and was called as being intermittent, possibly spurious, with no secondary radar information. The contact then faded from radar again, before reappearing 2nm SE of the Sea King still tracking WNW'ly; its position was passed again to the Sea King crew. As separation decreased to 1.5nm, TI was called again along with an assessment that it would pass behind the Sea King, whose crew finally became visual with the conflicting LA at a range of 0.5nm as it passed astern.

**SATCO YEOVILTON** commented that the Unit investigation, supported by the RT recordings, indicate that this was a late sighting of an unidentified ac. The APP controller more than fulfilled the conditions of a TS, updating the Sea King crew several times that there was a possible ac tracking towards them, although there was no supporting information to confirm the validity of the primary contact. There are several small aerodromes and LA landing strips in the vicinity of Yeovilton and, whilst most GA operators do call on the LARS frequency, there are still some that do not.

Cause: The untraced LA pilot flew close enough to cause the Sea King crew concern.

**HQ NAVY COMMAND** comments that Yeovilton has for many years had close liaison with the GA community in its vicinity and it is surprising that the LA flew within the DUA and AIAA without calling Yeovilton LARS and is certainly not the norm. The actions of the APP controller were correct, with the LA called to the Sea King crew several times. Once again though it is noted that the correct procedure for initial reporting of an Airprox was not followed; UK AIP (Mil and Civil) ENR 1.14 (3.2.1) states that 'an initial report of an Airprox by a pilot should be made immediately by radio to the ATS unit with which the pilot is in communication'. Aircrew should be reminded of the need to follow this procedure so that the correct actions can be taken by ATC as soon as possible. This issue has been added to the agenda at the next Senior Pilots Meetings of both RNAS Culdrose and RNAS Yeovilton.

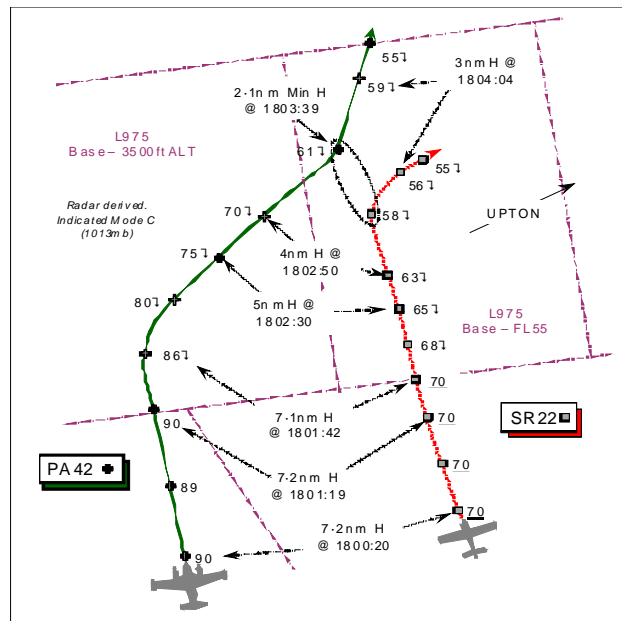
Subsequent phone calls between the Sector PLANNER, Doncaster and Leeds APPROACH established that the infringement was caused because of a late call and subsequent late identification of the SR22 by Doncaster ATC, although actually inbound to Leeds. The Doncaster and Leeds controllers resolved the confliction between the two ac.

Cause: The SR22 pilot entered controlled airspace without clearance.

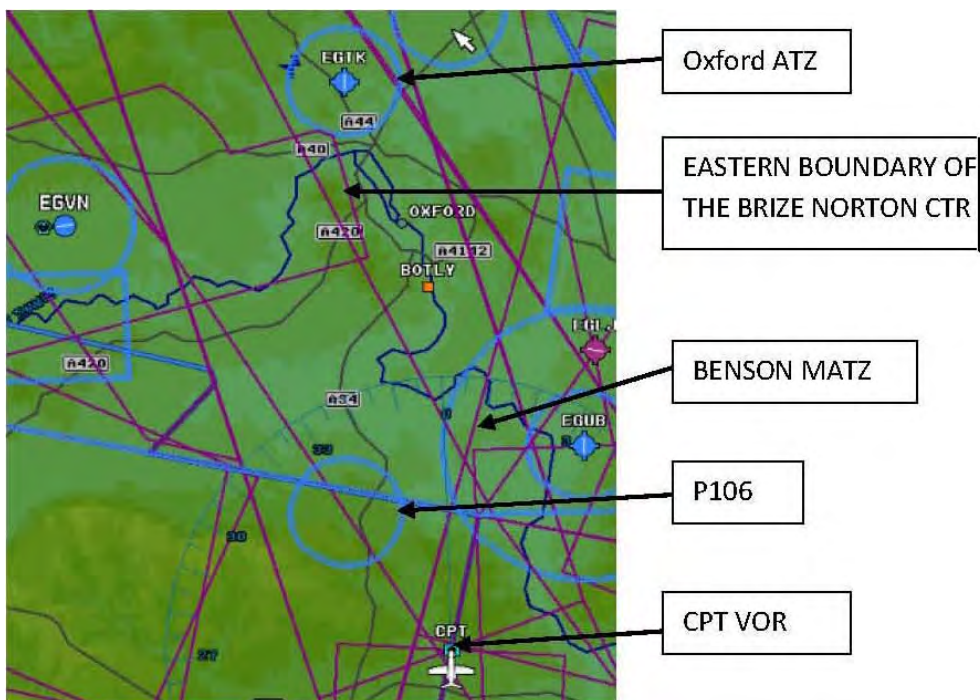
The EMB500 (Phenom) fleet are equipped with integrated electronic navigation systems. The MFD display (example shown below) available to the crew shows very clearly the location of the Brize Norton CTR and this display was in use by the crew at the time of the incident. It supports the position that the crew were completely aware of their position with respect to the zone. It may also explain why the turn to the R to exit the zone was not noted by the Brize controller as the crew would see exactly when they had turned sufficiently to exit the zone prior to resuming their track to the OX NDB.

The above display is in an expanded view. When operating closer to Oxford the depiction is scalable and the proximity of any CAS is very clear.
