UK AIRPROX BOARD

Analysis of Airprox in UK Airspace

Report Number 10
January 2003 - June 2003

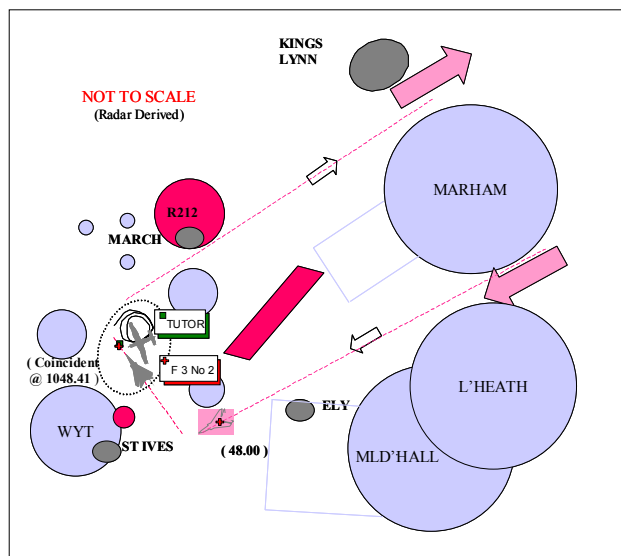
Date/Time: 16 Jan 1048
Position: 5225N 0030W (5.2nm NE Wyton - elev 135 ft)
Airspace: UKLFS (Class: G)
Reporting Aircraft Reported Aircraft
Type: Grob Tutor Tornado F3
Operator: HQ PTC HQ STC
Alt/FL: 500ft↑ 500ft
(RPS 1021mb) (Rad Alt)
Weather: VMC VMC
Visibility: 10km 20km
Reported Separation:
50ft V, 150ft H 30ft V, 100ft H
Recorded Separation:
Contacts Merge

passed in front of the Tutor by approximately 100ft and 30ft above its flightpath. His navigator did not see the Tutor. They were receiving a FIS from Marham at the time (*IAW the requirements of the UK Mil AIP for ac transiting the Marham / Lakenheath gap*). The Tutor's heading was approximately 90° to theirs and they would not have expected to see the Tutor on their radar (*Pulse Doppler*) in that regime. He opined that in these circumstances, and without a Collision Avoidance System, lookout and luck were the only factors preventing a collision. He accepted that his lookout was deficient at that moment.

HQ STC comments that sighting the Tutor, as it climbed into the flight-path of the F3, would have been difficult given its small size and being 'camouflaged in white paint'. It is recommended

Cause: A non-sighting by the Grob pilot and an effective non-sighting by the Tornado crew.

While acknowledging that it may be desirable to improve the conspicuity of all military training ac, HQ PTC stated, that for technical reasons it was not possible to paint the Grob Tutor without weakening its structure, as it was constructed from GRP and paints were not compatible. High visibility adhesive markings have been tried, but were found to be ineffective.

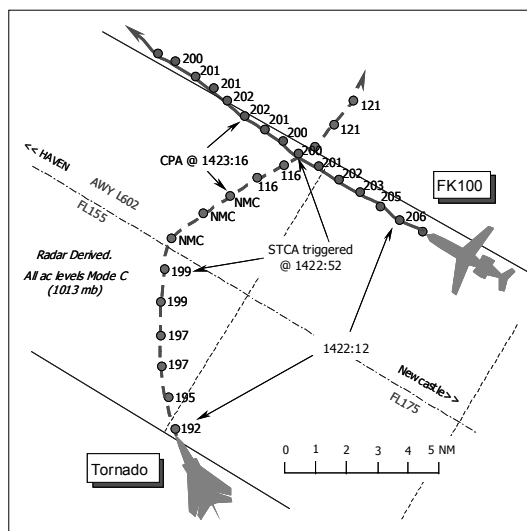
THE ScACC TALLA SECTOR TACTICAL CONTROLLER (TAC) reports that the FK100 was being vectored on the N side of L602 toward HAVEN against two outbound ac on the S side, as co-ordinated with the TAY Sector. Unknown military traffic was observed within the lateral boundary of EGD510 – Spadeadam Range - operating at FL195. The unknown traffic turned onto a northerly heading toward the airway about 15nm SE of HAVEN climbing to FL200. This traffic conflicted with the FK100 at FL200 resulting in a TCAS climb being generated. Traffic information was passed and horizontal separation was eroded to 3nm.

Cause: Unauthorised penetration of Class A CAS by the Tornado GR4 crew.

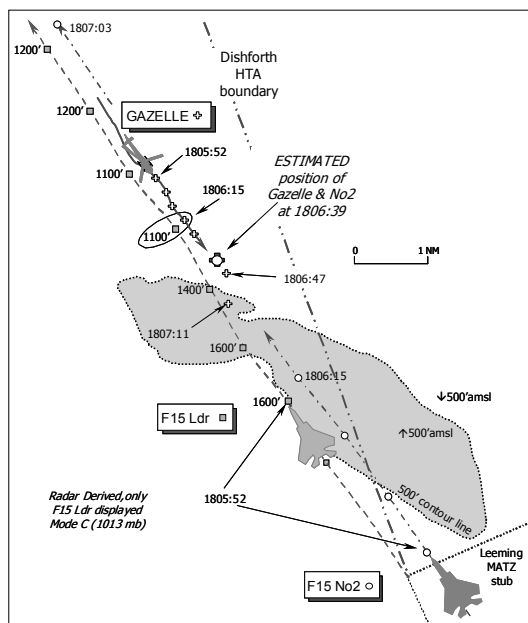
Recorded Separation:
v F15 Ldr - 330m
v F15 No2 - NR

THE GAZELLE PILOT reports that the navigation lights were burning on steady bright and the upper anti-collision beacon was on, whilst conducting a dual NVG sortie at night, within the Dishforth Helicopter Training Area (HTA). A squawk of A7000 was selected, but Mode C is not fitted. They were 'listening out' on the LFS UHF frequency of 300.8MHz and also the Teesside VHF frequency of 118.85MHz, but were not in receipt of an ATS.

Cause: A mistaken impression of the vertical separation by the Gazelle crew, whilst using NVG.

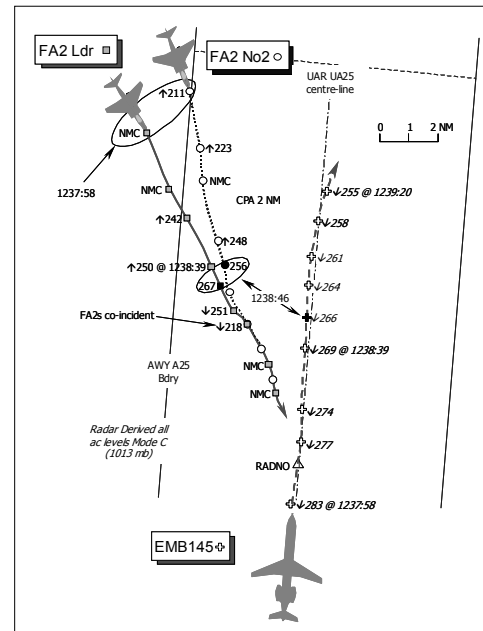
Date/Time: 15 Jan 1238
Position: 5220N 0314W (6nm N of RADNO)
Airspace: UAR-UA25 (Class: B)
Reporting Aircraft Reported Aircraft
Type: EMB 145 SHAR FA2 x2
Operator: CAT HQ STC
Alt/FL: FL280↓ 25000ft
Weather VMC VMC
Visibility: NR >10km
Reported Separation:
 2nm Not seen
Recorded Separation:
 2.84nm H/100ft V

FA2s in fighting wing/loose echelon port, returning to Yeovilton on completion of a low-level fighter affiliation sortie. Neither HISLs nor TCAS are fitted. Heading 160° at 400kt, his No2 advised that he had fuel indication problems so they expedited the climb and he elected to chop from the exercise AWACS frequency to the LATCC (Mil) ICF as he believed that it would facilitate a faster climb and recovery. Once they had checked in on the frequency he followed all the instructions issued by London MILITARY and he advised the controller that he required a fuel priority climb to FL300 and direct track to base. The recovery was carried out without further incident and neither he nor his No2 saw another ac – either visually or on AI radar - at any time. He did not assess the risk.

THE SEA HARRIER FA2 PILOT'S UNIT comments that the FA2 pair had just completed a "bounce" and were commencing a re-join and climb out from low level, when the No2 FA2 reported his fuel was indicating below the pre-briefed minima for their return to base. This immediately concerned the leader who believed his No2 should have significantly more fuel than indicated, leading him to believe that the No2 ac might have a possible fuel leak. His priority was to climb expeditiously to their ac's optimum cruise level - FL300 - and head for Yeovilton. As the leader was working two frequencies - the GR4s/No2 on one box and the AWACS on the other, his workload and frequency loading were high, in particular with his No2 (a junior pilot who had just joined from the training squadron) who gave a running commentary on his fluctuating fuel indications. With the busy RT scenario and realising from his navigational equipment that they were approaching A25, the FA2 leader elected to free-call London MILITARY, whereupon the FA2 pilots immediately received avoiding action. They complied instantly, rolling and descending at the maximum rate attainable, but neither pilot saw the other ac.

Cause: The FA2 formation leader led the formation into controlled airspace without clearance and into conflict with the EMB145, which he did not see.

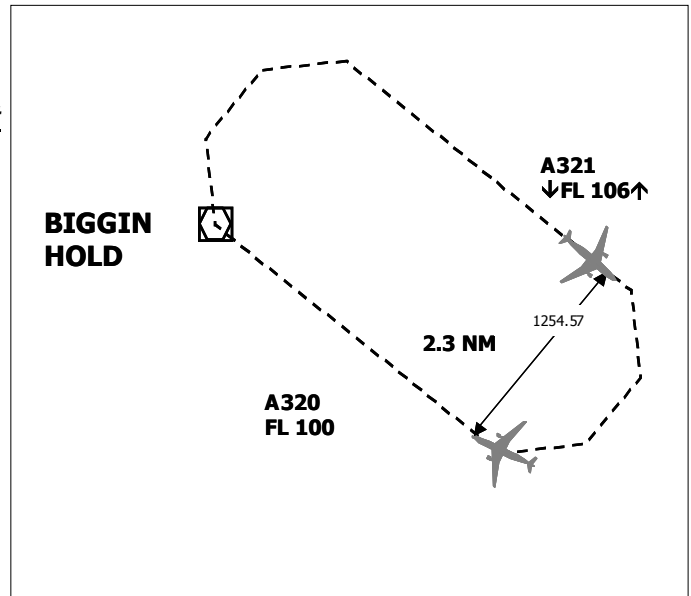
Date/Time: 19 Jan 1256 (Sunday)
Position: 5135N 0010E (Biggin Hold)
Airspace: Lon TCA (Class: A)
Reporting Aircraft Reporting Aircraft
Type: A320 A321
Operator: CAT CAT
Alt/FL: FL100 ↓FL106
Weather VMC VMC
Visibility: >20k 20k
Reported Separation:
 500ft V, 1.5nm H 800ft V, 2nm H
Recorded Separation:
 600ft V 2.3nm H

Cause: The INT DIR S (Mentor) did not obtain a complete and correct readback from the A321 pilot.
