UK AIRPROX BOARD

Analysis of Airprox in UK Airspace

Report Number 11
July 2003 to December 2003

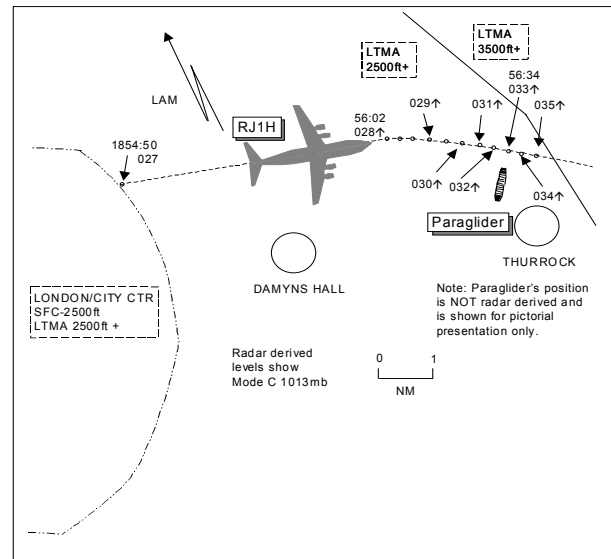
Date/Time: 7 Jul 1856
Position: 5134N 0022E (9nm SE LAM)
Airspace: LTMA (Class: A)
Reporting Ac Reported Ac
Type: RJ1H Untraced
 Paraglider
Operator: CAT NK
Alt/FL: 3500ft ↑
 (QNH 1022mb)
Weather VMC CLBC
Visibility: >10km
Reported Separation:
 100ft V 0.8nm H
Recorded Separation:
 NR

It was clear that this Airprox had been caused by the unauthorised penetration of the LTMA by an untraced Parafoil pilot. Any infringement of Class A airspace is a serious matter and invariably leads to conflict with the established flow of traffic. During a busy phase of the flight, fortunately the good weather conditions permitted the RJ1H crew to see the Parafoil after rolling out onto an assigned heading. Although no avoiding action was necessary because of the lateral separation that pertained, this was by chance and not design. There had been potential for a closer conflict but fortunately in this instance the outcome was benign, the Board concluding that during this encounter there had been no risk of collision.

Cause: Unauthorised penetration of the LTMA by an untraced Parafoil pilot.

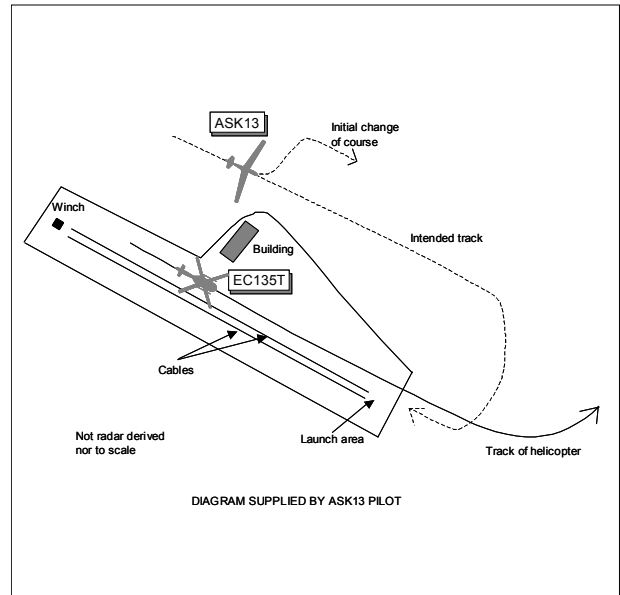
Date/Time: 6 Jul 1017 (Sunday)
Position: 5353N 0237W (O/H Chipping G/S - elev 600ft)
Airspace: FIR (Class: G)
Reporting Ac Reported Ac
Type: ASK13 EC135T
Operator: Civ Club Civ Comm
Alt/FL: 700ft↓ 1500ft
(QFE) (QNH 1020mb)
Weather VMC CLBC VMC CLBC
Visibility: Unltd >10km
Reported Separation:
nil V 100m H nil V 400m H
Recorded Separation:
NR

Members were dismayed that the EC135T pilot had used a GPS track without adequately monitoring his progress subsequently by use of a map. This course of action had led him to overfly an active promulgated glider site below cable launch height, which could have resulted in a potentially serious incident, but had ultimately caused the Airprox. The ASK13 pilot was concerned to see the helicopter without warning just 100m on her R, in conflict and apparently without seeing her ac.

Cause: The EC135T pilot flew overhead an active promulgated glider site below cable launch height and close enough to cause concern to the ASK13 pilot.

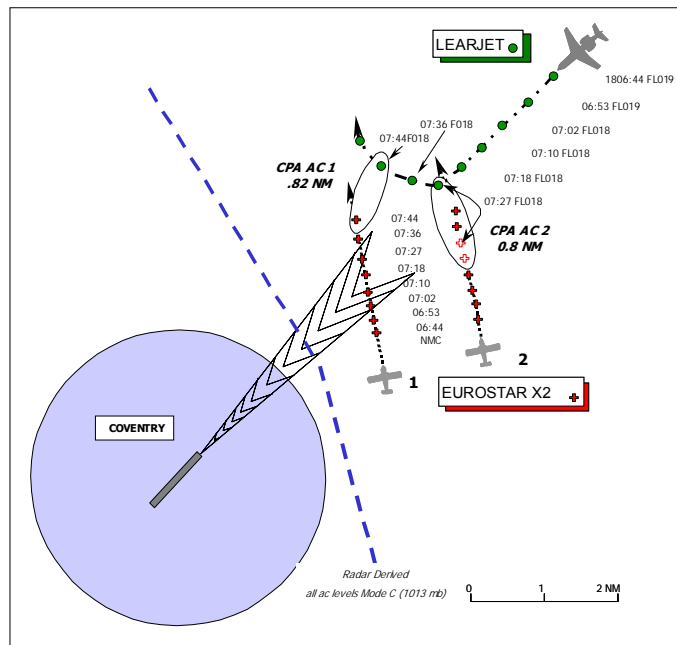
Learjet v Eurostar 1	.85nm
Learjet v Eurostar 2	.8 nm

UKAB Note (1): Both Eurostar ultralight ac had departed from Long Marston and were transiting VFR to Sittles Farm. It is probable, from the pilots' reports available, that they were not in company but flying independently of one another; however both had each other in sight. The pilot of Eurostar (2) probably misidentified the other Eurostar as a Jodel which is similar in appearance.

UKAB Note (2): From the timings of the 2 consecutive right turn instructions given by Coventry APR, recorded on the RT transcript, and the Learjet's corresponding right turn(s) seen on the Clee Hill radar recording commencing a few seconds later, it is probable that the avoiding action was given as against Eurostar (1), (the westerly ac). The ac observed and reported in the Airprox by the Learjet pilot was, however, the easterly ac (Eurostar (2)), which was not initially seen by Coventry APR, although it shows on the recording of the Clee Hill radar and was reported to the Learjet pilot in a subsequent transmission. Both radar primary returns were reported as weak, which would be consistent with the small size of Eurostar ac.
