UK AIRPROX BOARD

**Analysis of  
Airprox in UK Airspace**  
Report Number 4  
January 2000 to June 2000

Report by the UK Airprox Board,  
'Analysis of Airprox in UK Airspace'

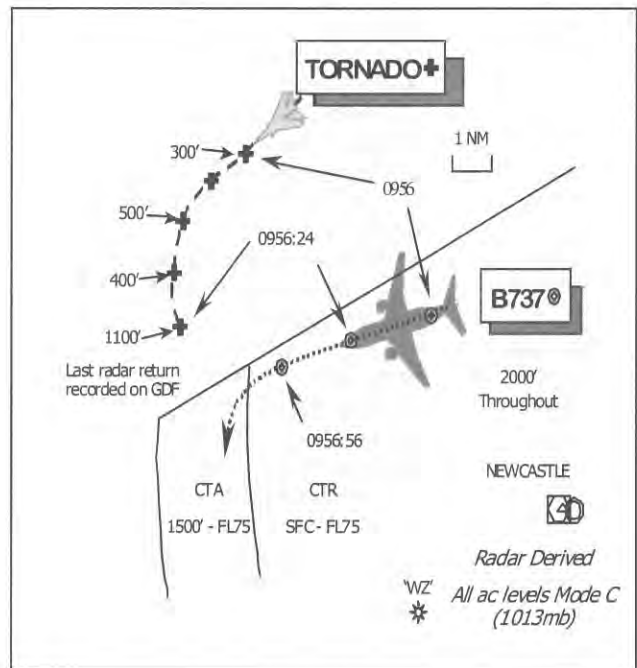
**THE NEWCASTLE RADAR DIRECTOR (DIR)** reports that the B737 was vectored downwind LHD for an ILS approach to RW 07 at 2500 ft QNH. The B737 crew was number three in the pattern and in receipt of a RCS. At about 0956, traffic information was passed to the B737 crew on military traffic observed operating just west of the CTR boundary, which the crew acknowledged and advised that they were flying in IMC. As the B737 passed N abeam the 'WZ' NDB, one of the contacts was seen to climb into CAS he thought, level off at 2500 ft Mode C and fly directly toward the B737 at the same level. Avoiding action was issued to the B737 crew "...avoiding action turn left heading 160, 160, avoiding action, similar level traffic 12 o'clock range of 3 miles coming towards". Whereupon the B737 crew queried the heading. This was reaffirmed by DIR and preceded by updated traffic information just before 0957, "...now 1 o'clock range of 2 miles turning northbound similar level". By the time the turn onto 160° was seen to take effect he perceived the horizontal separation had reduced to 1 NM, whereupon the observed ac turned L northbound and descended below radar coverage.

Cause: The Tornado flew sufficiently close to Newcastle CAS to cause the Newcastle RADAR DIRECTOR extreme concern for the safety of the B737.

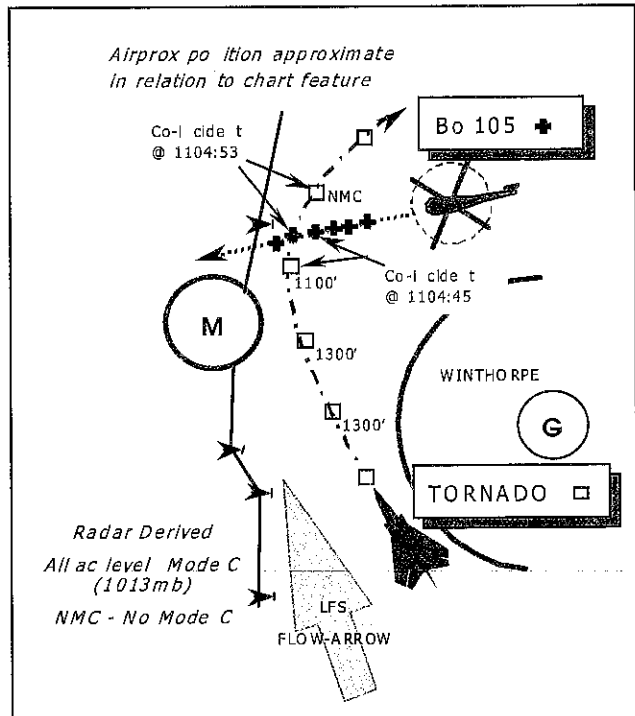
**HQ MATO** reports with RT transcript that the Bo105 pilot departed Waddington and called Waddington ZONE that was bandboxed with APPROACH. At 1057:40, the pilot reported "...two miles W of the field, Flight Information please, en-

Turning to risk, it was evident from the radar recording that horizontal separation was recorded at less than 0.5 NM and although the Mode C of the helicopter was not evident, reported transit altitudes reinforced the Bo105 pilot's perception of the vertical separation being about 200–250 ft. He also reported having no time to take avoiding action, which one member found surprising in view of the helicopter's speed and manoeuvrability. Nevertheless, there were no other safety nets available in the shape of traffic information under a radar service or TCAS. This, coupled with the non-sighting of the Bo105 by the Tornado crew, led members to agree with the Bo105 pilot that the safety of both ac had been compromised.

Cause: Late sighting by the Bo105 pilot and a non-sighting by the Tornado crew.

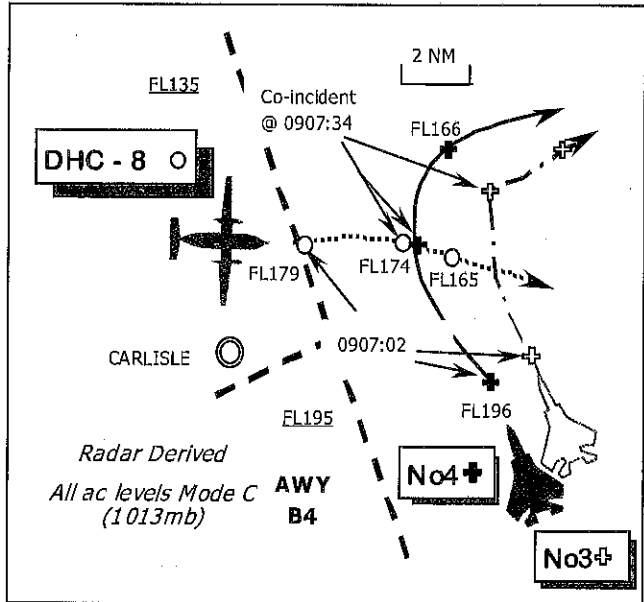
Spadeadam EWTR with a formation of 4 F15E ac, whilst being targeted by simulated surface to air threats and air defence ac in the vicinity. All formation ac were camouflaged dark grey but HISLs are not fitted. The leader and No2 had completed their simulated attack and were some 8 NM away as the No3 & 4 were running in. Whilst executing a simulated weapons delivery in a straight descent through FL 187, heading 340° at 500 kt, the No3 acquired a radar contact on the DHC-8 at a range of 12 NM but did not assimilate the geometry of the conflict correctly. The DHC-8 was seen after they had completed their simulated attack as they were turning R 'off-target'. At the CPA they passed about a mile apart, as the No3 & 4 were in the 30° nose down descent.

It was clear that the inadvertent incursion by the F15 formation into BRAVO4 before the Airprox, whilst probably avoidable, did not contribute to the cause of the Airprox. However, it did focus the attention of the TALLA SC on the ac and traffic information resulted, which enabled the DHC-8 crew to sight the formation as they departed CAS into the open FIR. Members agreed that the actions of the DHC-8 crew were sound but emphasised that flying CAT in Class G airspace was vastly

Cause: Conflict in the FIR.

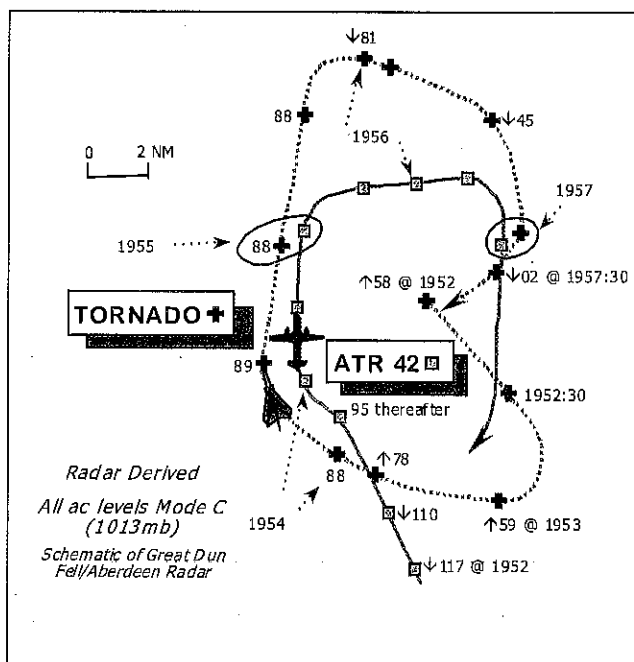
was turned R onto 300°. He then handed over the sector and observed that the unknown lead ac was now squawking 3/A 2476, tracking W with another also squawking 2476 further to the W. After a few miles the unknown ac descended below radar cover about 15 NM E of Leuchars. He adds that the ATR42 crew was given traffic information updates several times, but they reported IMC all the time and did not see the reported ac.

Cause: Conflict in Class G airspace, at night, between IFR and VFR traffic.
