**UK AIRPROX BOARD**

# **Analysis of Airprox in UK Airspace**

**Report Number 1**

**January 1998 to December 1998**

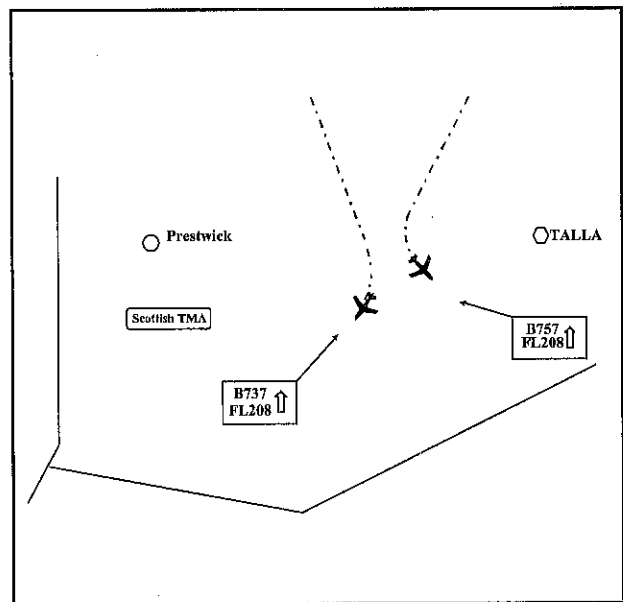
### Occ No. 98/00306

The AIRPROX was caused by the Scottish 'TMA Out' controller who did not provide the required horizontal separation between the B757 and the B737 whilst clearing them to climb to the same level.

The controller adopted a potentially flawed control technique which required close monitoring and a positive intervention in order to prevent an unsafe situation developing. Subsequent to this AIRPROX, a Scottish Airways Operational Notice has been issued drawing controllers attention to this flawed technique and stating that horizontal separation must be applied before vertical separation is eroded.

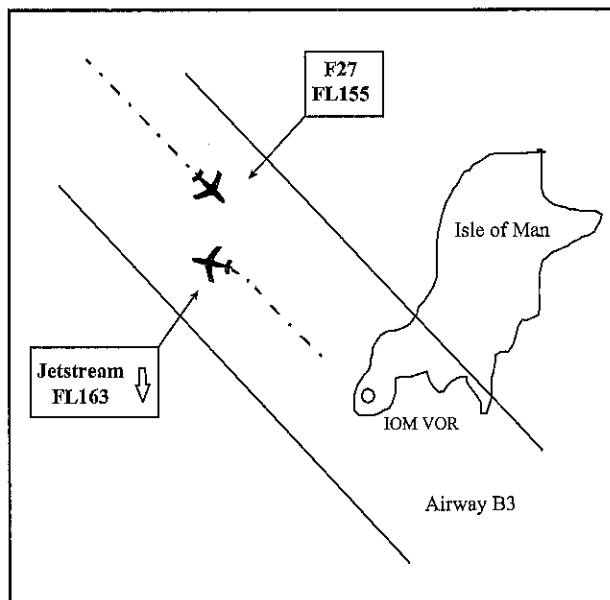
At 0807.20, the Jetstream pilot established contact with the Antrim Sector, reporting at FL200 and requesting descent. This request was acknowledged and the pilot was told to standby for descent. At 0808.30 the trainee controller instructed the Jetstream pilot, "(callsign) descend flight level one seven zero (FL170)". The Jetstream pilot read back, "Descend flight level one six zero (FL160) (callsign)". This error in the read back was not noticed either by the trainee or mentor controller.

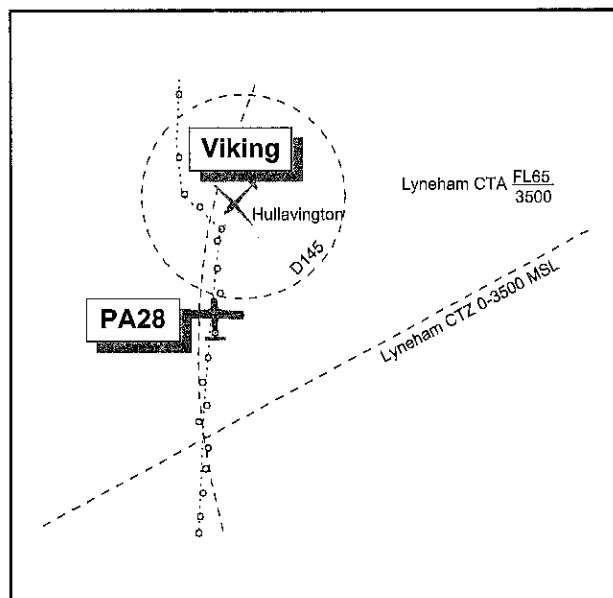
local agreement, Lyneham ATC had been advised earlier that morning that the winch-launch glider site at Hullavington would be active. Several intermittent primary radar contacts had been observed by Zone in the vicinity of Hullavington prior to the occurrence. Consequently, when the PA28 left the Class D Lyneham CTZ, northbound for Gloucestershire Airport at 0918:15, Zone advised the pilot that a RIS was being applied and that "Hullavington may be active", which was acknowledged. Zone then passed traffic information to the PA28 pilot on an unknown ac squawking 7000, "12 o'clock 5 NM right to left no height", which was acknowledged. No other contacts were observed by Zone in the immediate vicinity of the PA28 before the pilot reported at 0920:00, "re-climbing to 1300 on 1015 (Cotswold RPS) I just had to drop down to avoid a glider". Zone perceived that the PA28 was just outside EGD145, marked on the radar video map. No Airprox report was filed over RT before the PA28 pilot switched to Gloucestershire. Subsequently, the gliding supervisor at Hullavington contacted Lyneham and advised that the Viking glider pilot would be filing an Airprox (P).

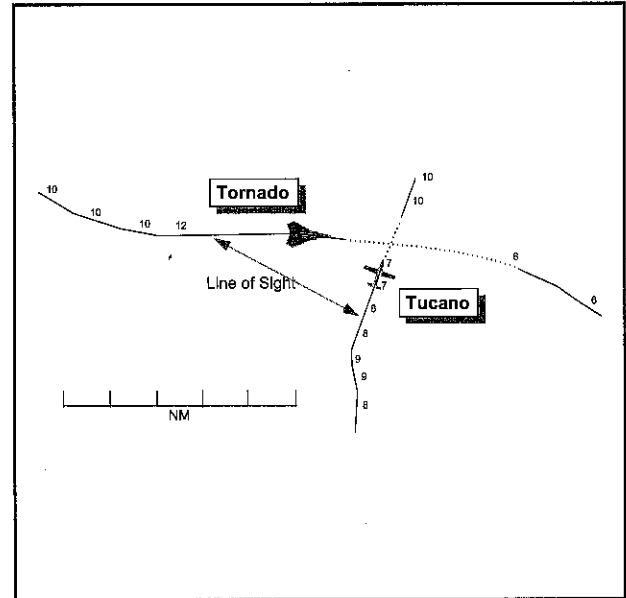
**HQ STC** comments that this Airprox occurred at low level in excellent visibility. In assessing the late sighting of the Tucano by the Tornado crew, 2 distinct causal factors are apparent. Firstly, the Tornado crew readily acknowledge that due to in-cockpit distractions their lookout scan was degraded at the time of the Airprox. Cockpit distraction is a recurring theme in many Airprox scenarios. Therefore, one of the core functions of STC FS publicity in recent publications has been to raise awareness of the importance of an effective lookout scan during all phases of flight at low level. Secondly, the relative altitudes of the 2 ac would have placed the Tucano below the skyline to the Tornado, exacerbating the difficulties of visual acquisition at low level. In the event, a late sighting of the Tornado by the Tucano crew negated the actual risk of collision.

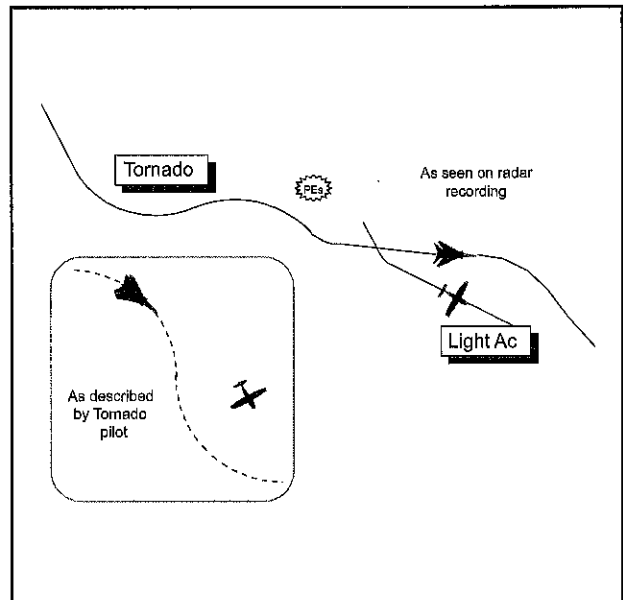
**HQ STC** comments that the Tornado pilot, under high workload, made a late sighting but with sufficient time to take avoiding action to nullify the collision risk in a controlled manner.
