AIRPROX REPORT No 2019257

Date: 01 Sep 2019 Time: 1311Z Position: 5154N 00153W Location: NIRMO, E Gloucestershire

PART A: SUMMARY OF INFORMATION REPORTED TO UKAB

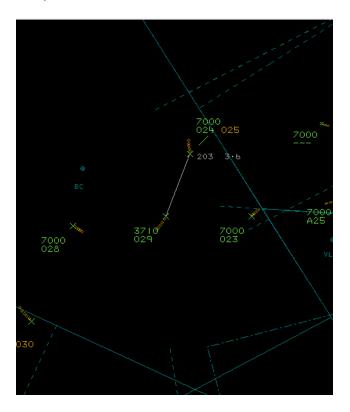
Figure 1 – 1309:43

The C414 was on a navigation exercise routing via NAXAT and was in receipt of a Traffic Service from Brize LARS. 10nm east of Gloucester, the DA42 reported coming within 150ft of an aircraft on a reciprocal heading. The C414 pilot reported no close proximity events in their report. In the minutes leading up to this incident, the Brize LARS controller had called numerous conflictors to the C414 pilot. At the time of the last piece of Traffic Information the DA42 was approximately 10nm away and not a factor. However, the geometry of the aircraft was such that at 1309:26 the separation between the aircraft decreased to less than 5nm. Traffic Information was passed 17sec later by which point separation had decreased to 3.6nm and 500ft.

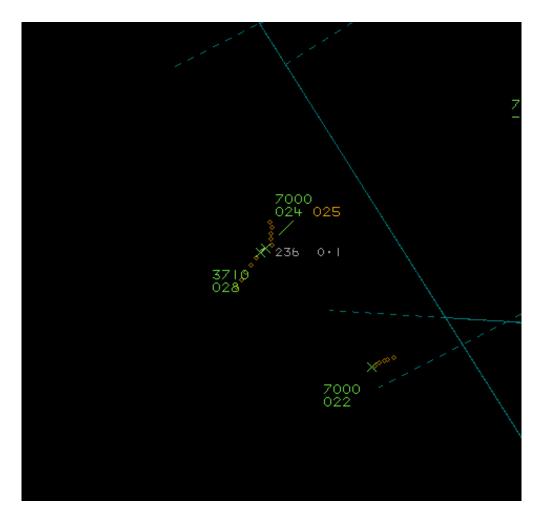
Figure 2 - 1310:33 CPA

CPA occurred 50sec later and was measured at 0.1nm and 400ft. 20sec after CPA the C414 requested a frequency change and no mention was made of a close proximity event.

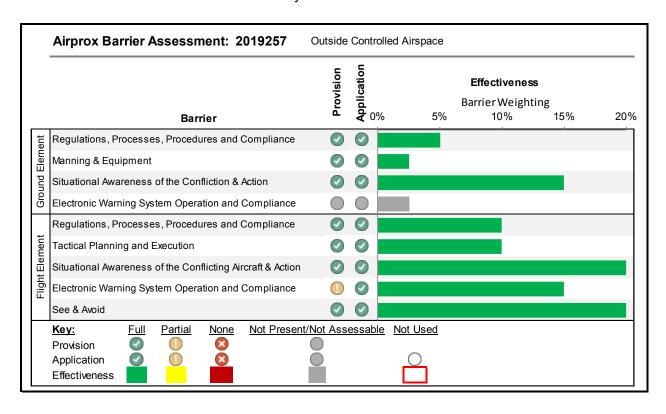
<u>Safety Barrier Assessment</u>³: In assessing the effectiveness of the safety barriers associated with this incident, the Board concluded that, other than the fact that the DA42 did not have a CWS fitted, all of the available barriers had worked effectively.

Recommendation: Gloucester to consider applying for an SSR transponder conspicuity code.
