### **AIRPROX REPORT No 2020156**

Date: 25 Oct 2020 Time: 1426Z Position: 5119N 00048W Location: Blackbushe circuit

# PART A: SUMMARY OF INFORMATION REPORTED TO UKAB

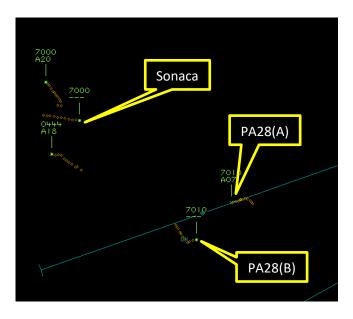
Figure 1 – 1420:42

At **1420:42** the Sonaca pilot reported 3NM north for join and was advised by the Blackbushe AFISO that the circuit was left-hand RW25, and they were passed the QFE, all of which was readback correctly (Figure 1). The AFISO then advised the Sonaca pilot that there were four other aircraft in the circuit and requested the pilot to report "dead-side" which was acknowledged by the pilot.

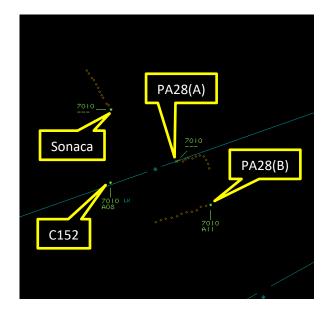
Figure 3 - 1422:36

The AFISO then passed Traffic Information to the Sonaca pilot; "circuit traffic, one on climb-out, one on final and one on base", to which the Sonaca pilot replied; "keep a good lookout and fit in where we can" (Figure 3). At **1423:19** the AFISO updated the traffic information "er traffic downwind – appears ahead of you in your two o'clock". The Sonaca pilot replied; "visual with the two o'clock traffic, and the one just departed now. I'll fit in with the one on downwind" (Figure 4).

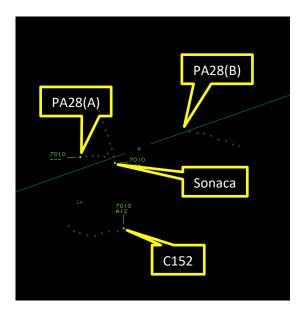
Figure 5 – 1423:52

The PA28(B) pilot reported on final for a touch-and-go at **1423:34**. The C152 pilot reported downwind for a touch-and-go at **1423:52** and was requested to report final (Figure 5). At **1424:34** the PA28(A) pilot reported downwind to land and was asked by the AFISO to report final. Immediately following this the Sonaca pilot reported downwind to land also, and was told "one ahead – report final", which was acknowledged by the pilot (Figure 6).

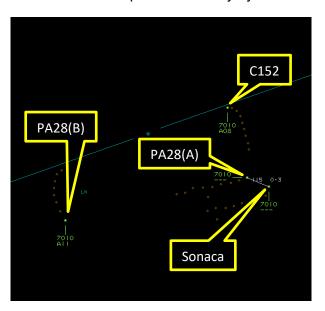
Figure 7 - 1425:40

At **1425:40** the C152 pilot reported on final for a touch and go (Figure 7). CPA occurred at **1425:52** with the aircraft separated laterally by less than 0.1NM (Figure 8).

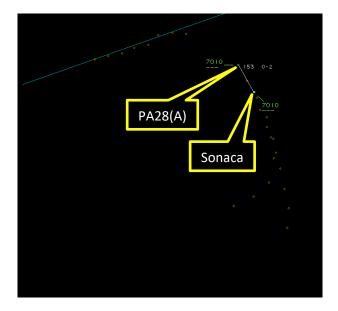
Figure 9 - 1426:13

At **1426:13** the pilot of the Sonaca reported "(Sonaca c/s) is now behind (PA28(A) c/s). I think he's just come underneath me" (Figure 9). The AFISO acknowledged this, followed by one of the pilots (not identifiable) advising "not visual". Then the PA28(A) pilot reported on final and was advised that the runway was occupied with an aircraft conducting a touch-and-go. At **1426:40** the AFISO advised the Sonaca pilot that "traffic appears underneath you – ahead of you" to which the Sonaca pilot replied "yeah, visual now" (Figure 10).
