AIRPROX REPORT No 2020159

Date: 04 Nov 2020 Time: 1424Z Position: 5226N 00100W Location: 4NM SW Market Harborough

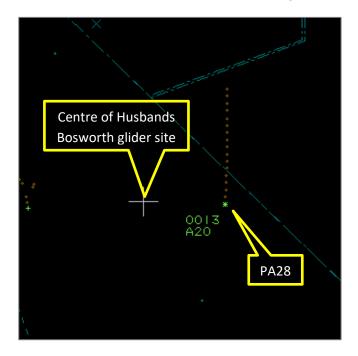
The SZD-51 Junior glider pilot was contacted and requested to provide a GPS log of the aircraft's flight if possible. Unfortunately, the trace only recorded the initial portion of the flight – up until approximately 1405Z – and so did not show the glider in the lead-up to and during the Airprox. Analysis of the NATS radar replay was undertaken but no indication of the presence of any aircraft, other than the PA28, could be seen in the vicinity of Husbands Bosworth glider site at the time of the reported Airprox. Figure 1 below is a screenshot of the NATS radar at the estimated time of CPA (1424:08); the PA28 passed 1.5NM to the east of the centre of the glider site at an altitude of 2000ft.
