AIRPROX REPORT No 2021003

Date: 13 Jan 2021 Time: 1117Z Position: 5240N 00030W Location: IVO Stamford

PART A: SUMMARY OF INFORMATION REPORTED TO UKAB

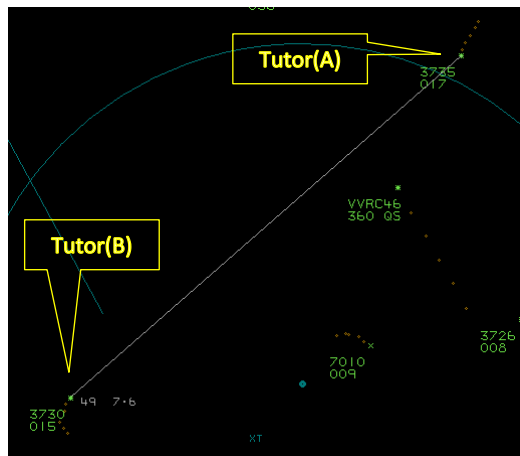
Figure 1: Tutor(A) instructed to climb to 2000ft.

Tutor(A) was holding to the NE of the airfield following notification that the visual circuit was full. Tutor(A) was instructed to climb and report level at 2000ft, the pilot advised that a climb to 2000ft would put them in IMC. The controller advised them that the climb would coordinate them against traffic (Tutor(B)) in the RTC. Separation was 7.6NM and 200ft (Figure 1).

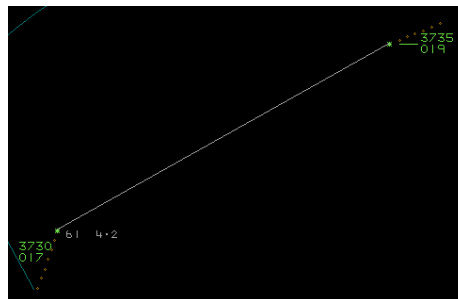
Figure 2: DS provided and the climb instruction to 2000ft reiterated.

Tutor(A) pilot requested, and was given a Deconfliction Service, and the controller reiterated the climb to 2000ft instruction. Separation decreased to 4.2NM and 200ft (Figure 2).

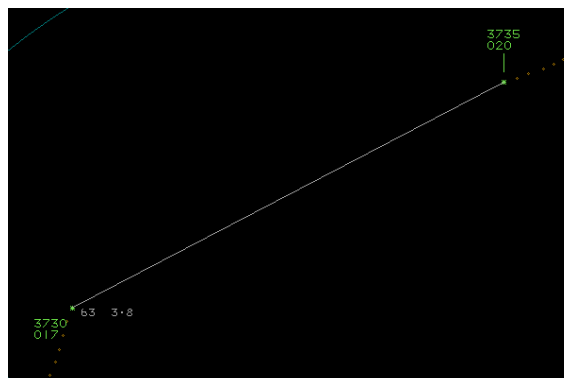
Figure 3: Traffic Information passed to Tutor(B).

Eleven seconds later Traffic Information was passed to Tutor(B) on Tutor(A) however, it was not acknowledged by the pilot. Separation was measured at 3.8NM and 300ft (Figure 3).

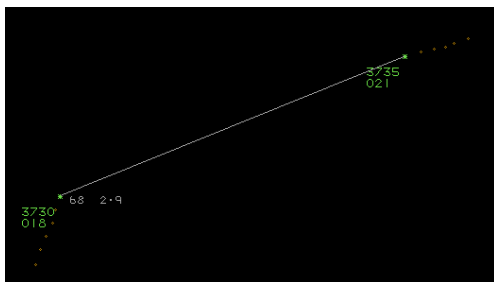
Figure 4:
Tutor(B) turned onto 070°.

Twenty-one seconds later Tutor(B) was instructed to turn right onto 070° (Figure 4) which was passed again by the controller fifteen seconds later (Figure 5) as there was no visual confirmation of the turn. Tutor(A) had reached their assigned level although Tutor(B) Mode C now indicated they climbed 100ft. Separation was measured at 2.2NM and 400ft (Figure 5).

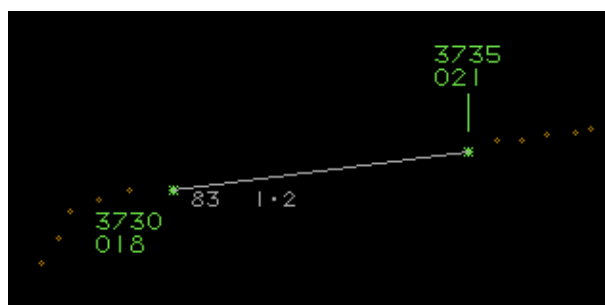
Figure 6:
Both Tutor pilots report descending for traffic.

Twenty-one seconds later both Tutors reported descending for traffic. Separation decreased to 1.2NM and 300ft. CPA was measured at 0.4NM and 100ft.

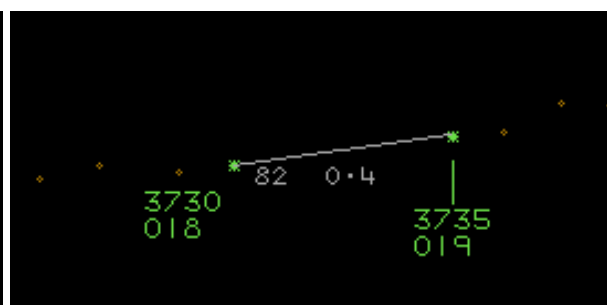
Figure 7 :CPA

At approximately 1117:42 on the Swanwick 'all systems' radar selection the two Tutors were separated laterally by 0.4NM and 100ft, giving a slant range of around 2400ft (Figure 7 above). At 1117:44 on the Claxby single source radar selection, Tutor(A) had turned and descended to 1400ft (Figure 8) and by 1117:52 the separation had reduced to 0.2NM and 400ft, an approximate slant range of 1265ft, making this actual CPA, although by this stage Tutor(A) had descended below and was heading away from Tutor(B) (Figure 9).
