## AIRPROX REPORT No 2021068

Date: 03 Jun 2021 Time: 1332Z Position: 5254N 00104W Location: Nottingham ATZ

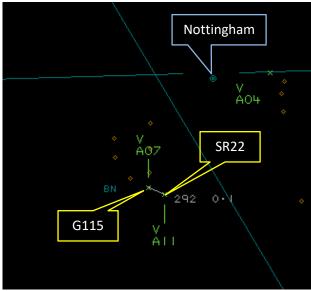
Figure 1: CPA 1332:28

The G115 pilot was climbing out from a touch-and-go to re-join downwind as the SR22 pilot was descending crosswind into downwind. CPA occurred when the aircraft were separated by 400ft vertically and 0.1NM horizontally (Figure 1). This is the closest point observed on the radar replay, it is after CPA that the SR22 pilot climbed slightly and the G115 pilot maintained their height prior to descending slightly.
