AIRPROX REPORT No 2021093

Date: 24 Jun 2021 Time: 1442Z Position: 5142N 00146W Location: Brize Norton

PART A: SUMMARY OF INFORMATION REPORTED TO UKAB

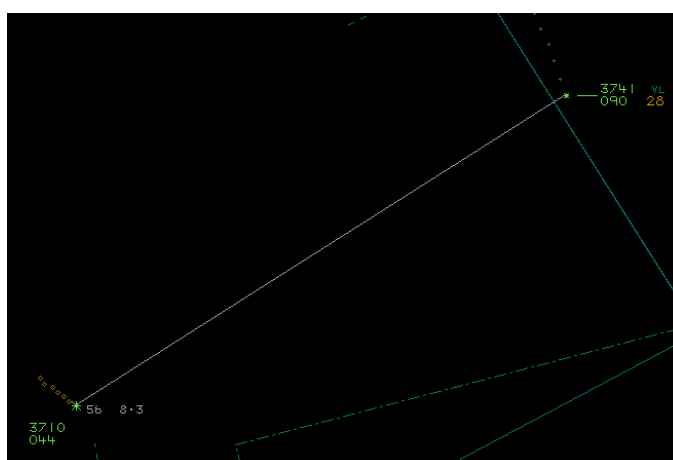
Figure 1:

Figures 1-6 show the positions of the Atlas and the PA28 at relevant times during the Airprox. The screen shots are taken from a replay using the NATS Radars, which are not utilised by Brize Norton, therefore, may not be entirely representative of the picture available to the Brize Norton controllers. The Approach controller had given the Atlas descent to 2800ft 20sec prior to the PA28 having their Traffic Information reduced due to surveillance cover by the LARS controller. The PA28 had already been approved to climb to 5000ft to avoid the CTR. Separation was 8.3NM and 4600ft (Figure 1).

The Atlas in the descent to 2800ft and the PA28 in the climb to 5000ft.

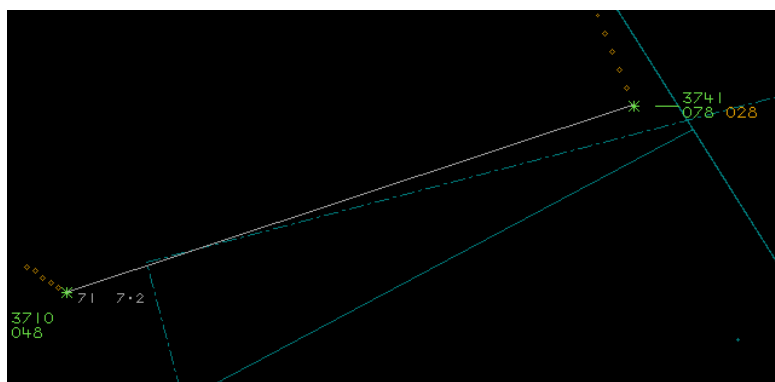
Figure 2:

Fifty-nine seconds after the further descent was given the Atlas was advised that they would be required to fly one hold due to traffic at Oxford. The Approach controller had also had another aircraft freecall on the Zone frequency for transit of the CTR. During this period the LARS controller was engaged in a call with an external agency. Separation decreased to 7.2NM and 3000ft (Figure 2).

Atlas advised they will be required to enter the Hold due to Oxford Traffic.

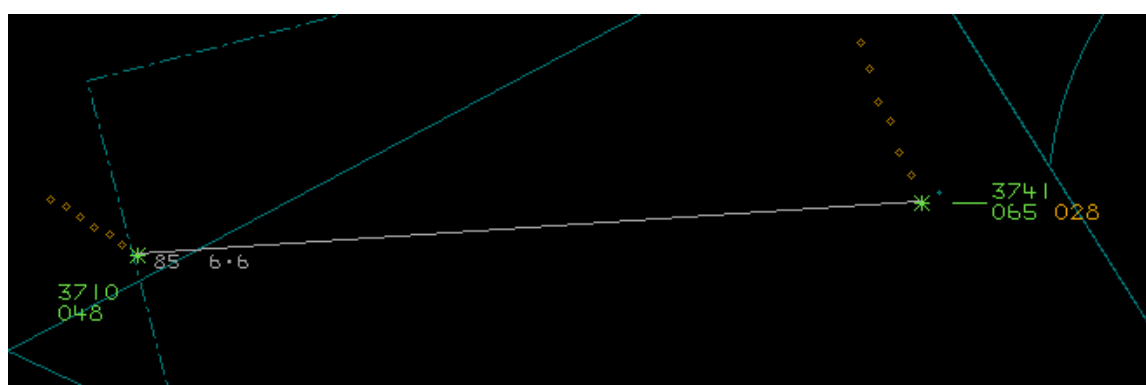
Figure 3:

Forty-nine seconds later the LARS position had been handed over to a new controller. Separation decreased to 6.6NM and 1700ft (Figure 3).

LARS position handover complete.

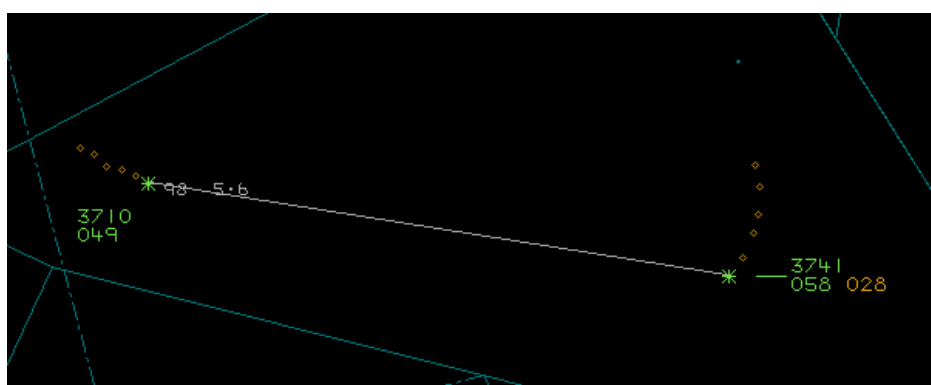
Figure 4:

The Approach controller, realizing that the Atlas had turned right when they incorrectly expected it to turn left, issued a stop descent instruction and passed Traffic Information on the PA28 to the Atlas pilot. Twenty-six seconds later the Approach controller rang the Zone controller to hand over the Zone tasking. Separation decreased to 5.6NM and 900ft.

Atlas given a stop descent instruction and passed Traffic Information.

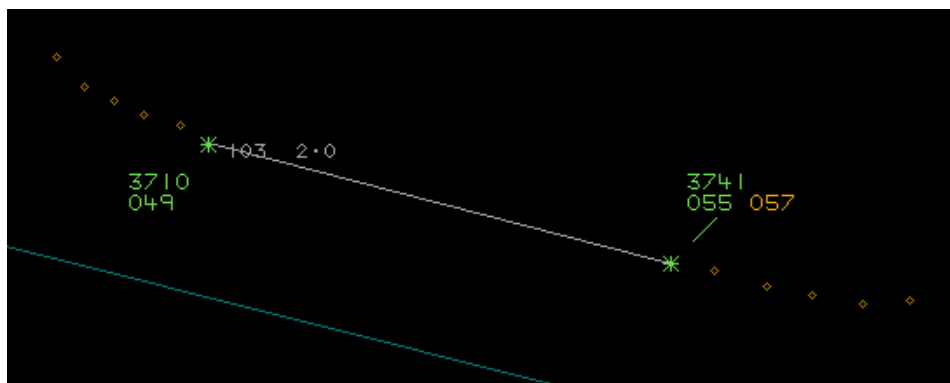
Forty-five seconds after the stop descent instruction and Traffic Information had been passed, the Atlas crew received a TCAS RA and reported visual with the PA28. The Approach controller acknowledged the TCAS RA and advised the Atlas pilot to report when ready for vectors. Separation decreased to 2NM and 600ft (Figure 5).

Figure 5:
The Atlas reported a TCAS RA.

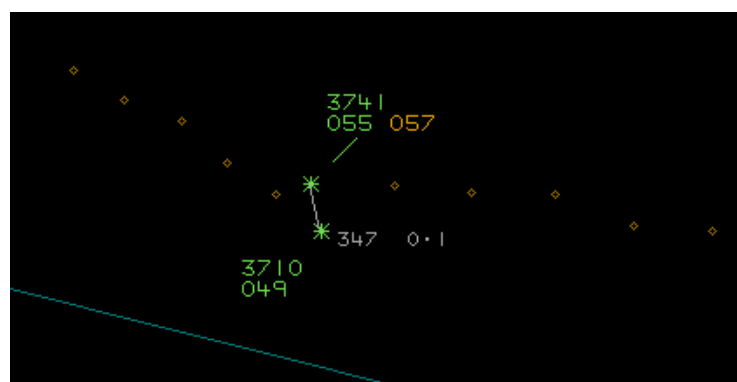
Twelve seconds after the Atlas pilot reported a TCAS RA the Approach controller answered the land line to the LARS controller who passed Traffic Information on another aircraft. CPA occurred during the final stages of the phone call and separation was measured at 0.1NM and 600ft.

Figure 6: CPA.
