## AIRPROX REPORT No 2021181

Date: 16 Sep 2021 Time: 1455Z Position: 5111N 00107W Location: 3NM W of Lasham

### PART A: SUMMARY OF INFORMATION REPORTED TO UKAB

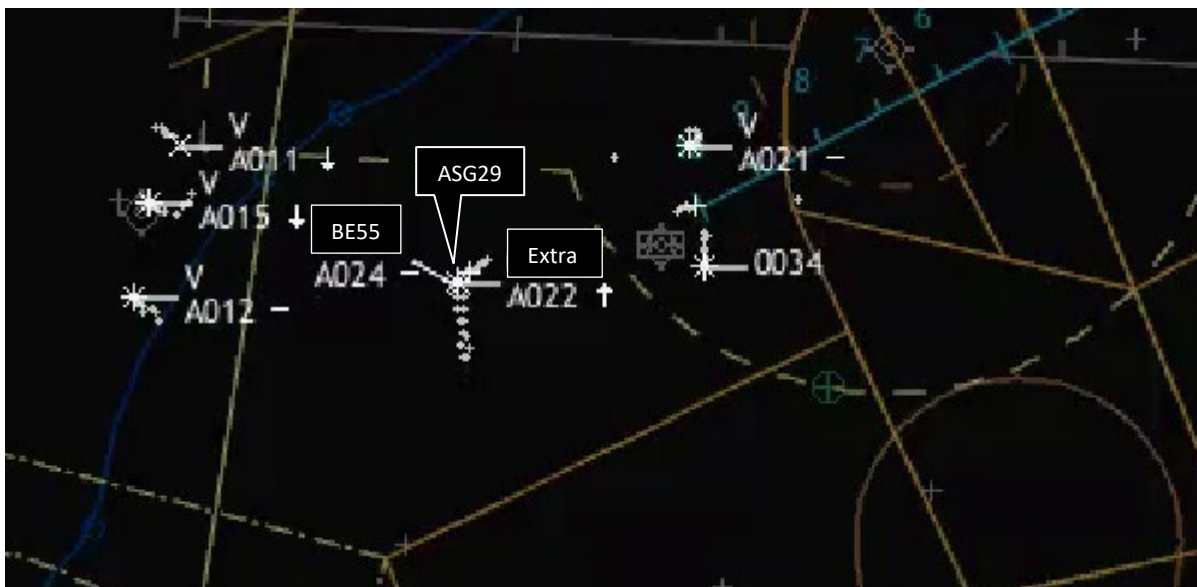
Figure 4 – 1454:54

At **1454:54** the returns of [the BE55] (squawk 0432) and [the Extra] (squawk 0433) merged with a primary only return that was tracking westbound from Lasham. This occurred approximately 3 miles west of Lasham. After the merge, the primary only contact can be seen to take a left turn and track south. [The BE55] and [the Extra] continued northbound on the same track. There was no RT call made about their proximity.
