AIRPROX REPORT No 2021206

Date: 04 Oct 2021 Time: 1237Z Position: 5211N 00030W Location: 2.5NM NW of Bedford

PART A: SUMMARY OF INFORMATION REPORTED TO UKAB

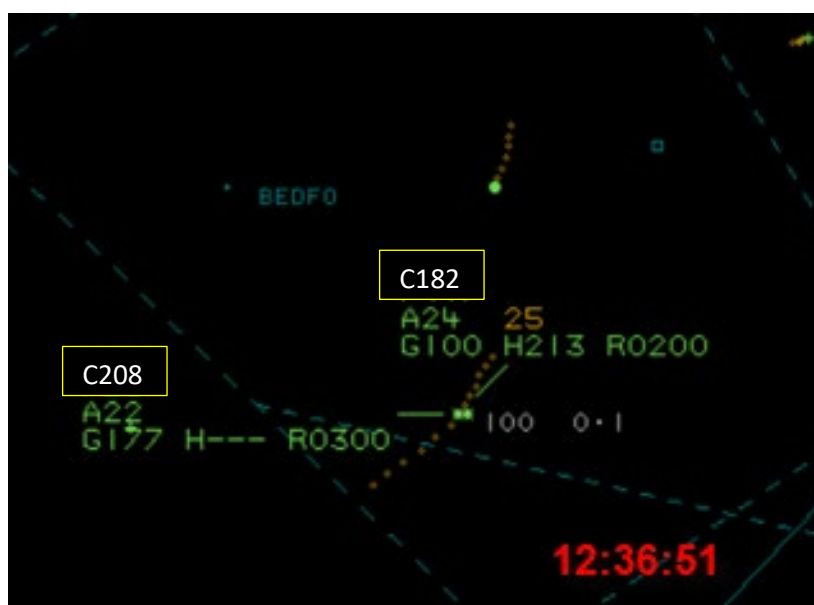
Figure 1 – CPA

NODE Radar displayed the closest point of approach (CPA) between [the C208] and [the C182] occurred at **1236:51**, with 0.1NM lateral and 200ft vertical distance (see Figure 1). [The C182] displayed a radar-derived rate of descent (ROD) of 170fpm; [the C208] displayed a ROD of 305fpm.

The Airprox occurred when [the C208 pilot] had initiated their descent into [destination airfield], on an opposite direction track to [the C182]. The pilot of [the C208] had requested to leave the LFIS frequency almost coincident with the closest point of approach between the two aircraft. Closest Point of Approach occurred at **1236:51** and was recorded on Multi-Track Radar as 0.1NM and 200ft. The incident was resolved by, according to the Airprox report from the pilot of [the C208], [the C182] passing above and to the left of their aircraft. No avoidance manoeuvre was enacted.
