AIRPROX REPORT No 2021213

Date: 13 Oct 2021 Time: 1243Z Position: 5102N 00221W Location: 2.5NM N Henstridge

PART A: SUMMARY OF INFORMATION REPORTED TO UKAB

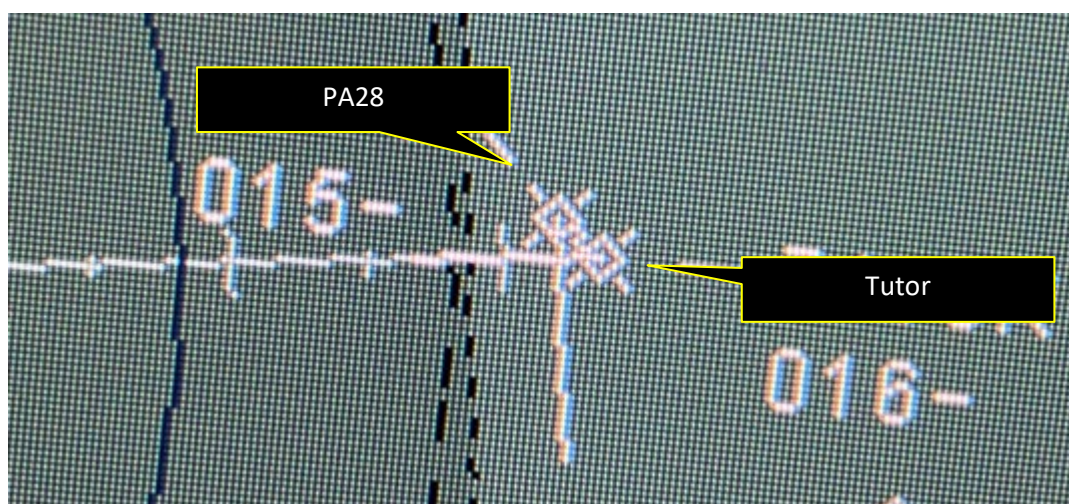
Figure 1 - Yeovilton radar screenshot

A review of the NATS radar replay was undertaken on which both aircraft can be identified, however shortly before CPA the altitude information had been lost, however, Yeovilton Approach were able to provide a screenshot from their radar replay at CPA (Figure 1) which had recorded the Mode C flight level readout information for both aircraft. This has been combined with the NATS radar replay to determine the vertical separation at CPA.
