## AIRPROX REPORT No 2021237

Date: 25 Nov 2021 Time: 1558Z Position: 5306N 00009W Location: Coningsby ATZ

### PART A: SUMMARY OF INFORMATION REPORTED TO UKAB

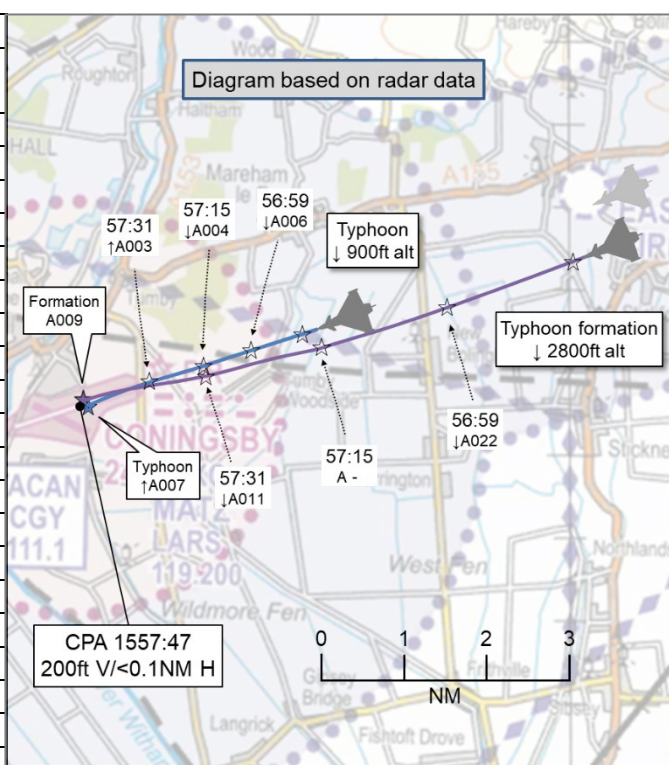
Recorded	Aircraft 1	Aircraft 2
Aircraft	Typhoon	Typhoon (Formation)
Operator	HQ Air (Ops)	HQ Air (Ops)
Airspace	Coningsby ATZ	Coningsby ATZ
Class	G	G
Rules	VFR	VFR
Service	ACS	ACS
Provider	Coningsby TWR	Coningsby TWR
Altitude/FL	700ft	900ft
Transponder	A, C, S	A, C
Reported		
Colours	Grey	Grey
Lighting	Anti-col, Nav	NR
Conditions	VMC	NR
Visibility	>10km	>10km
Altitude/FL	750FT	800ft
Altimeter	QFE (1015hPa)	QFE (1015hPa)
Heading	252°	259°
Speed	220kt	350kt
ACAS/TAS	Not fitted	Not fitted
Separation at CPA		
Reported	50ft V/20ft H	150ft V/100ft H
Recorded	50ft V/<0.1NM H <sup>1</sup>

<sup>1</sup> CPA from HUD data. Diagram information based on NATS Ltd radar data.

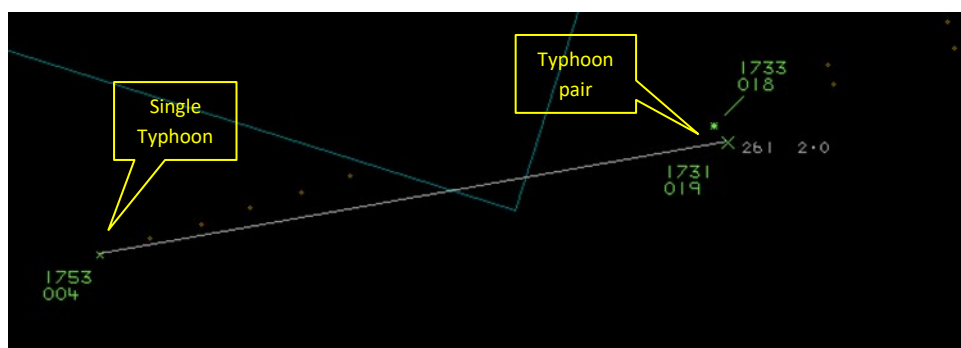
Figure 1 - Lead pilot of Typhoon pair reported initials.

Prior to reporting initials, the lead pilot of the Typhoon pair was given permission to join the visual circuit with one on a radar approach at 2NM to fly through, gear-up, and join. Thirty-one seconds later the lead pilot of the Typhoon pair reported initials. The Tower controller updated them on the

location of the single Typhoon which was on short finals to fly through gear up. Separation was 2NM and 1400ft.

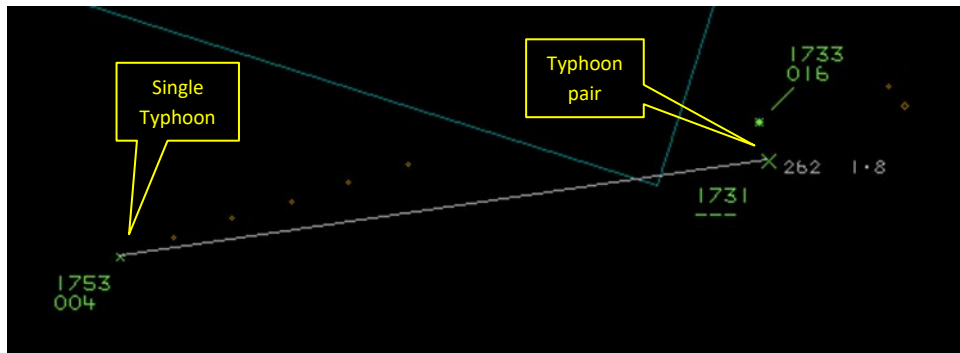
Figure 2 - Lead pilot of Typhoon pair reported visual.

Five seconds later the lead pilot of the Typhoon pair reported visual with the single Typhoon. Separation decreased to 1.8NM and 1200ft.

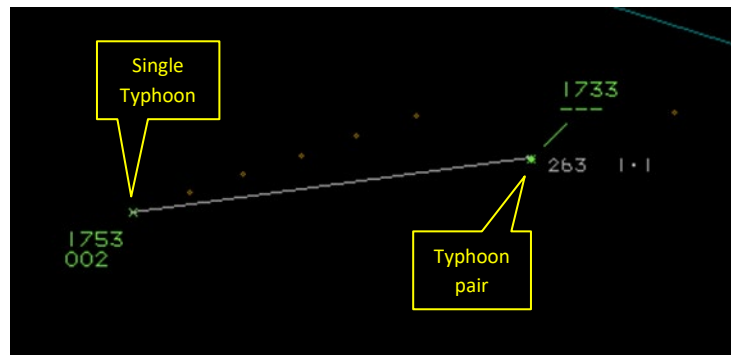
Figure 3 - Single Typhoon received Traffic Information and pair reminded to remain deadside.

The Talkdown controller, observing traffic on their radar screen, advised the Typhoon pilot of traffic which appeared to be joining the visual circuit on the live side. This was overheard by the ATC Supervisor who prompted the Tower controller to remind the lead pilot of the Typhoon pair to remain on the deadside. Separation decreased to 1.1NM and unknown height.

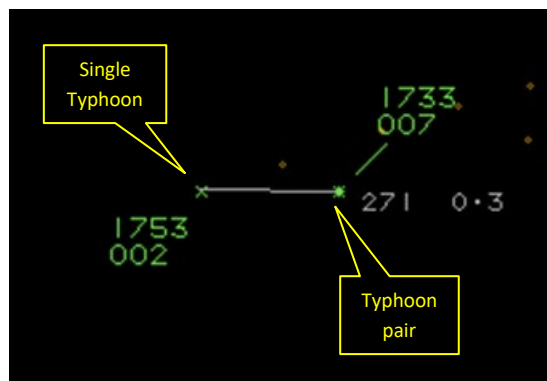
Figure 4 - Typhoon requests to join from radar.

Sixteen seconds later the single Typhoon pilot requested to join the visual circuit from their radar approach, which is approved by the Tower controller, who advised them that there were two joining from behind. Separation decreased to 0.3NM and 500ft.

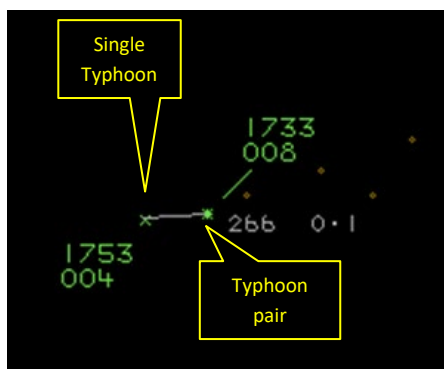
Figure 5 – Prior to CPA.

CPA appeared to occur between radar sweeps with the Typhoon pair overtaking the single Typhoon. Previously measured radar separation was 0.1NM and 400ft <sup>4</sup>.
