## AIRPROX REPORT No 2022134

Date: 11 Jul 2022 Time: 1420Z Position: 5221N 00028W Location: 3NM SE Thrapston

### PART A: SUMMARY OF INFORMATION REPORTED TO UKAB

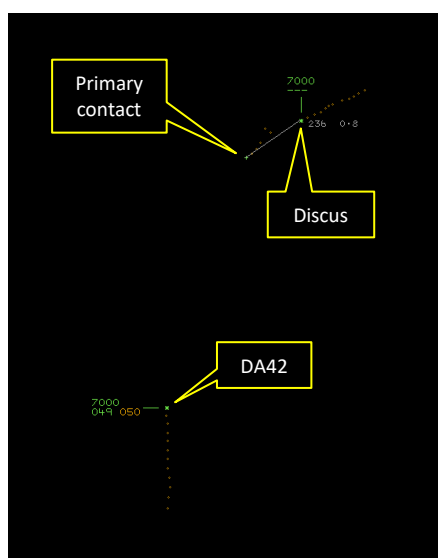
Figure 1 – Discus range to primary contact

The Discus pilot reported receiving an alert on their (commonly used by glider pilots) EC equipment and stated that 'they're not sure that the urgency of the alarm corresponded to the closeness of the other aircraft'. At 1418:07, the NATS radar detected a primary-only contact in the vicinity of the Discus which was visible for 22sec before it disappeared, during this time the separation between the primary-only contact and the Discus was measured at 0.8NM, see Figure 1. Although it cannot be confirmed, it is possible that the primary-only aircraft had been equipped with compatible EC equipment which may have triggered the alarm to which the Discus pilot referred. The primary contact disappeared from radar 1min 39sec before the recorded CPA, at which time the horizontal separation between the Discus and the DA42 was 3.9NM, Figure 2.
