AIRPROX REPORT No 2022211

Date: 15 Sep 2022 Time: ~0933Z Position: 5100N 00219W Location: 1.5NM ENE Henstridge

PART A: SUMMARY OF INFORMATION REPORTED TO UKAB

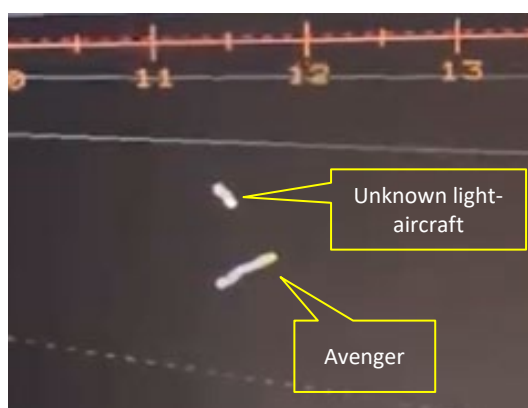
An analysis of the NATS radar replay was undertaken and only the Avenger and the Henstridge circuit traffic were detected, the Airprox unknown light-aircraft was not. However, Yeovilton ATSU kindly supplied the UKAB Secretariat with a recording from their Precision Approach Radar (PAR) which did detect the unknown light aircraft as a primary-only contact and showed its position both horizontally and vertically. Although the PAR replay does not have a tool to accurately measure aircraft separation, it has been possible to use the range scales incorporated in the picture to measure an approximate altitude for the unknown light-aircraft and the separation between the aircraft, Figure 1.

Figure 1 – PAR extract showing CPA.
