AIRPROX REPORT No 2022214

Date: 18 Sep 2022 Time: 1423Z Position: 5203N 00114W Location: 4NM E Banbury

PART A: SUMMARY OF INFORMATION REPORTED TO UKAB

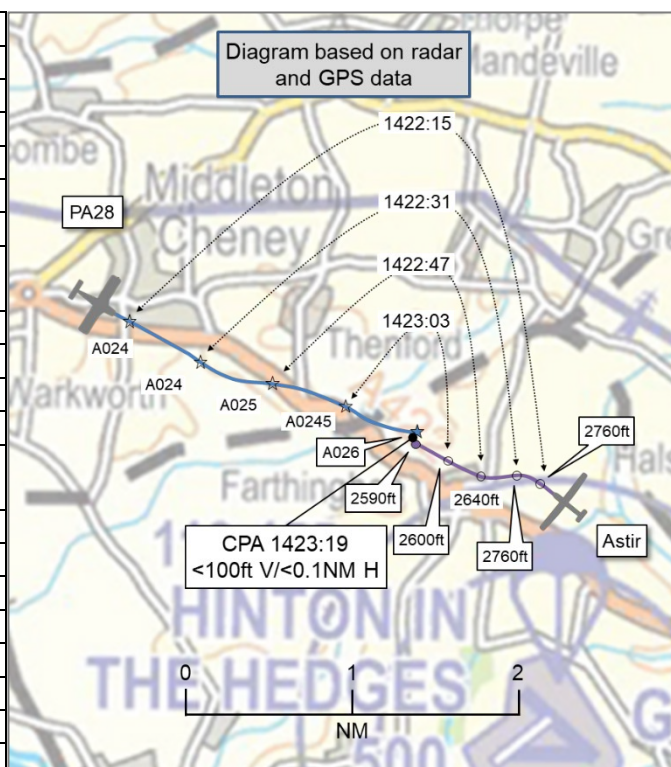
The NATS radar replay showed that the PA28 pilot had been tracking in a southeasterly direction and slowly climbing in the lead-up to the Airprox, commencing a slight turn to the left 8sec, (2 radar sweeps), before CPA. The Astir pilot reported that, at the time of the Airprox, they were turning by 20° to the south, the GPS data relating to the Astir flight recorded this turn as commencing at, or very shortly after, CPA.

The diagram has been produced by combining different data sources, radar and GPS, and as a result the separation at CPA has been recorded as an approximation.
