**AIRPROX REPORT No 2022234**

Date: 23 Sep 2022 Time: 1417Z Position: 5322N 00010W Location: 6NM W Louth

**PART A: SUMMARY OF INFORMATION REPORTED TO UKAB**

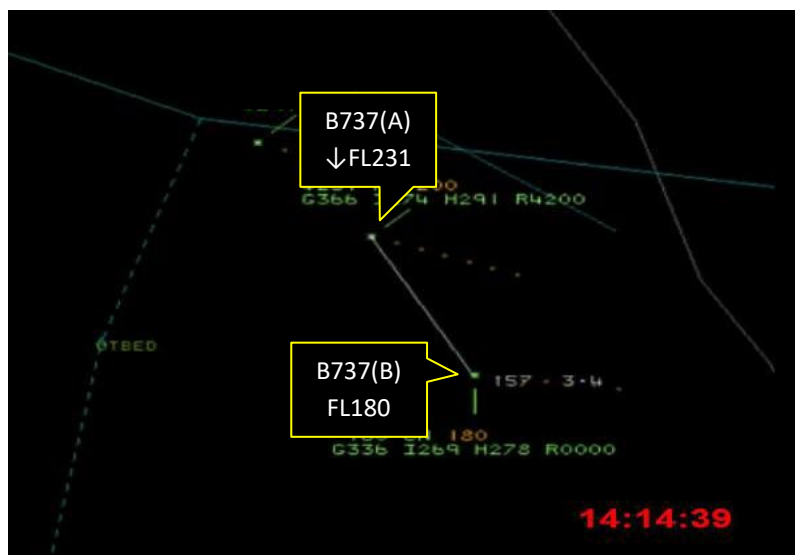
This transmission ended at 1414:39 and the relative locations of each aircraft at this time are shown in Figure 1.

Figure 1. Relative positions of event aircraft when [B737(B)] was transferred to Doncaster ATC.

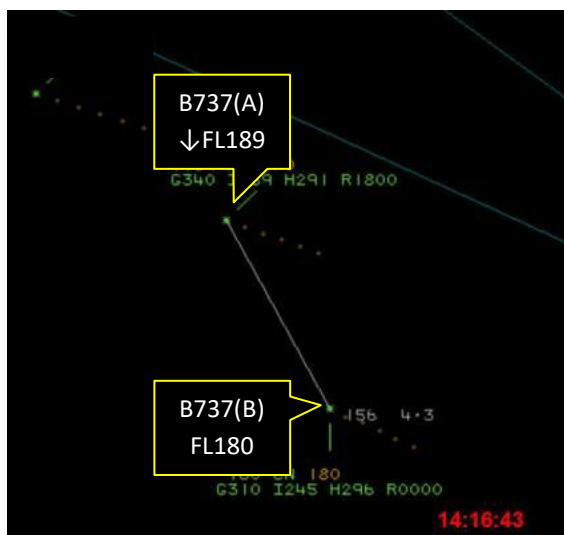
Figure 2

Separation between [B737(A)] and [B737(B)] was eroded at 1416:43 to 4.3NM and 900ft, where 5.0NM or 1000ft were required, as shown in Figure 2.

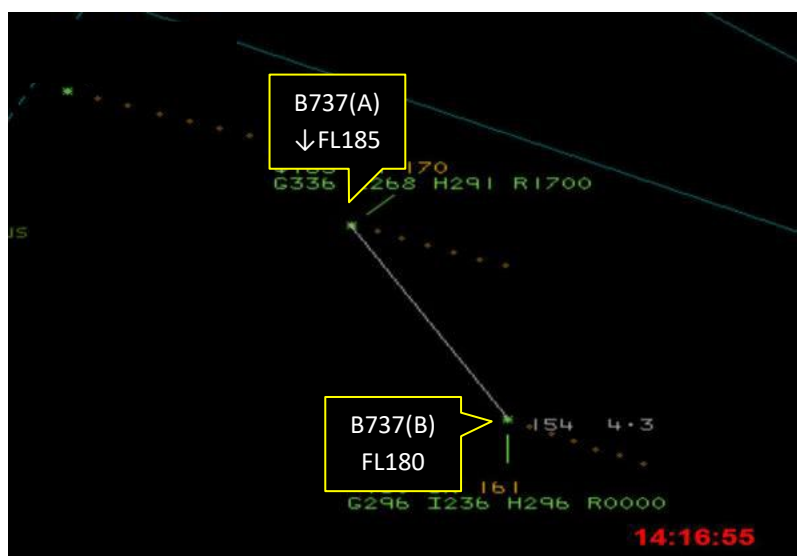
Vertical separation between [B737(A)] and [B737(B)] continued to erode to a minimum of 4.3NM and 500ft at 1416:55 as shown in Figure 3.

Figure 3. Point of minimum separation.

Separation was eroded at 1416:43. Minimum separation occurred at 1416:55 and was recorded on the Multi-Track Radar as 4.3NM and 500ft.
