AIRPROX REPORT No 2022266

Date: 18 Nov 2022 Time: 1248Z Position: 5047N 00112W Location: Lee-on-Solent ATZ

PART A: SUMMARY OF INFORMATION REPORTED TO UKAB

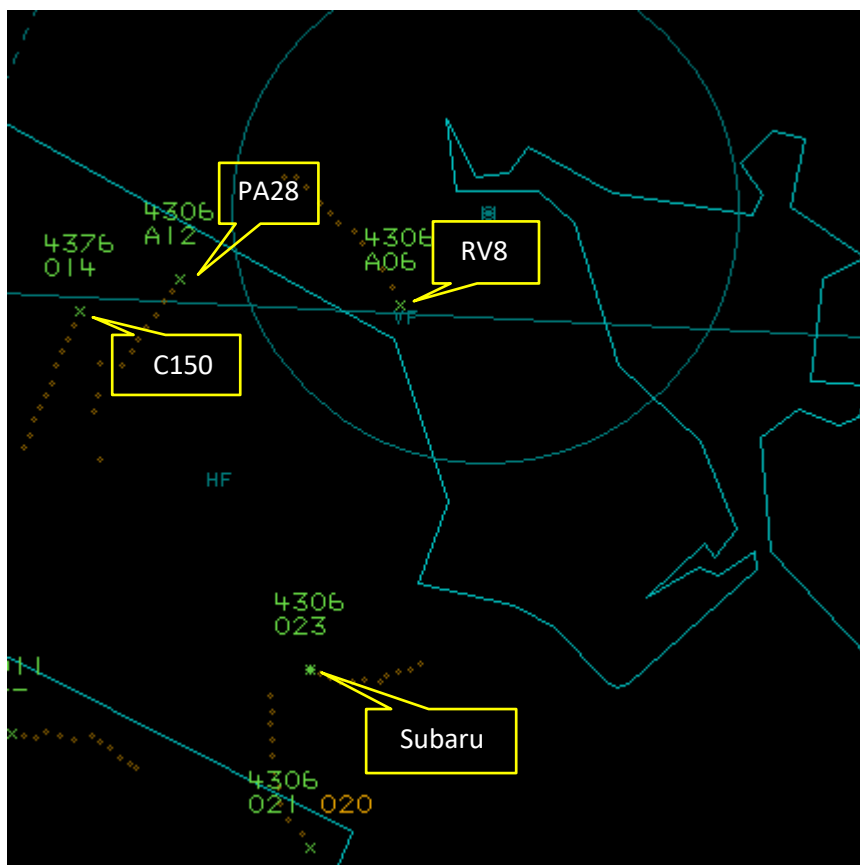
Figure 1 - 1240:00

At 1240:00 the FISO asked the PA28 pilot to confirm that they were behind the C150. The pilot responded, *“negative we're ahead.”*

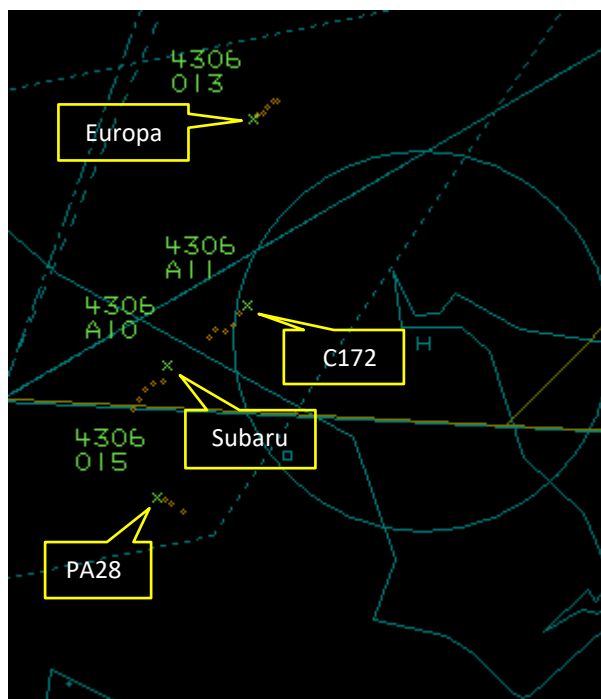
Figure 2 - 1243:30

At 1243:30 the FISO requested a position report from the Europa pilot and advised them that there were 3 aircraft in the circuit. The pilot responded, *"just outside the ATZ to the north, about 3 miles, copied the traffic."* The FISO advised, *"three in the circuit, with the last one downwind er crosswind, to remain."* The Europa pilot responded, *"not far from joining base if I may?"* There was no response from the FISO. The Europa had passed Wickham VRP with no position report received.

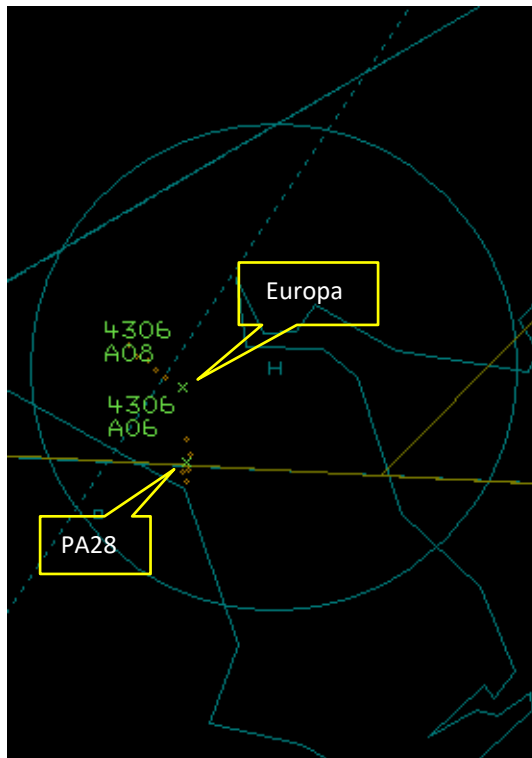
Figure 3 - 1246:00

At 1246:00 the PA28 pilot reported, *“going around.”* The FISO replied, *“roger.”*

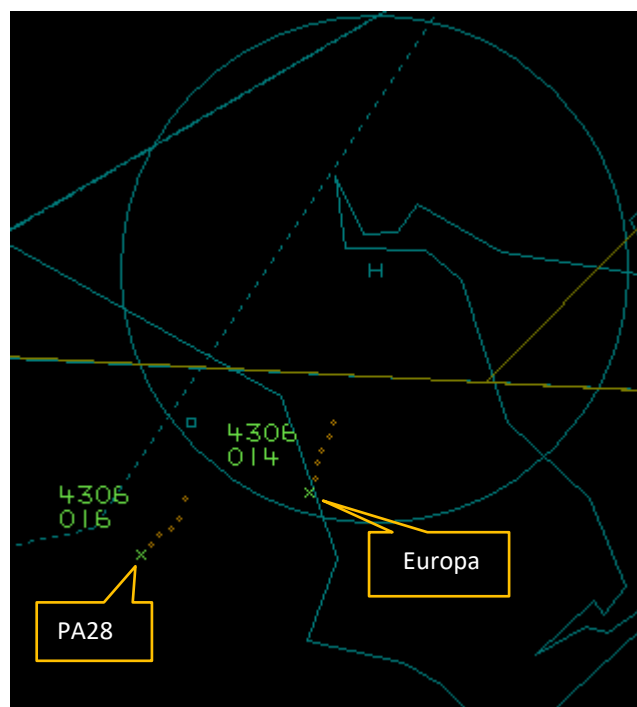
Figure 4 - 1246:50

At 1246:50 the Europa pilot reported, *“right-hand downwind and I’ll join downwind, er left-hand downwind for 23, I’ll join right-hand downwind 23.”* The FISO responded, *“roger there should be 2 ahead.”* The pilot replied, *“I’ll keep my eyes open.”*

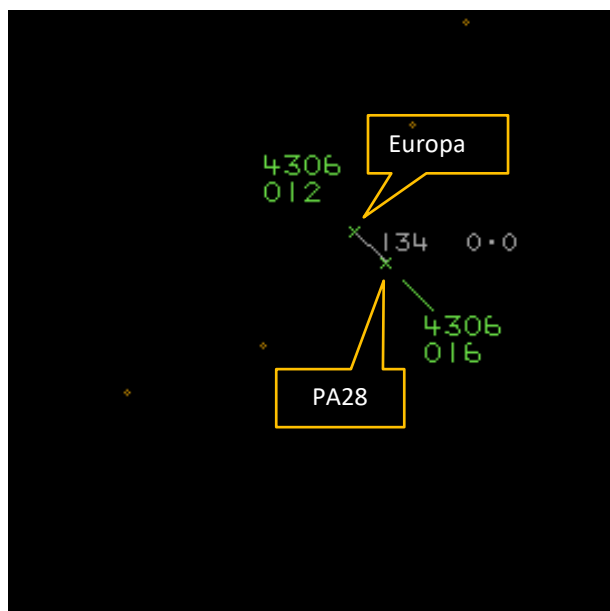
Figure 5 - 1247:47 CPA

At 1247:47 CPA occurred with the two aircraft separated by less than 0.1NM laterally and 400ft vertically.
