AIRPROX REPORT No 2022268

Date: 28 Nov 2022 Time: 1355Z Position: 5616N 00312W Location: 4NM N Glenrothes

PART A: SUMMARY OF INFORMATION REPORTED TO UKAB

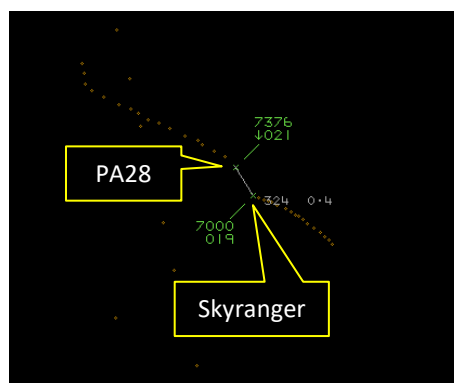
Prior to the Airprox, both aircraft had been maintaining a steady altitude, the PA28 at 2500ft and the Skyranger at 1800ft. The PA28 pilot was maintaining a steady heading whilst the Skyranger pilot's track displayed a small and steady drift to the pilot's left. However, at 1354:08, whilst the Skyranger pilot continued at 1800ft, the PA28 pilot initiated a slow descent. At this time the aircraft tracks were starting to diverge until, at 1354:28, the PA28 pilot, still in the descent, made a turn to their right. At this time the aircraft were separated by 0.4NM laterally and by 200ft vertically with the PA28 above the Skyranger and descending, Figure 1.

Figure 1 - PA28 pilot initiated right turn.

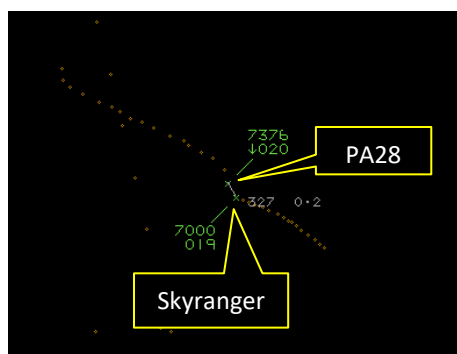
Figure 2 – 1354:33.

At 1354:33, the separation had reduced to 0.2NM horizontally and 100ft vertically, Figure 2. On the next radar sweep, 4sec later at 1354:37, the horizontal separation had reduced to less than 0.1NM and, during that 4sec period, the radar recorded that the PA28 had descended through the

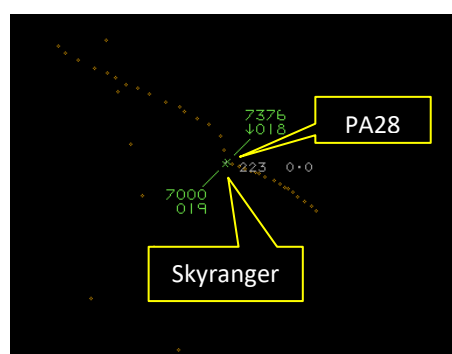
altitude of the Skyranger and was now 100ft below it, Figure 3, and so the vertical separation has been recorded as less than 100ft.

Figure 3 – 1354:37. CPA.
