## **AIRPROX REPORT No 2022273**

Date: 08 Dec 2022 Time: ~1208Z Position: 5059N 00207W Location: Compton Abbas

### **PART A: SUMMARY OF INFORMATION REPORTED TO UKAB**

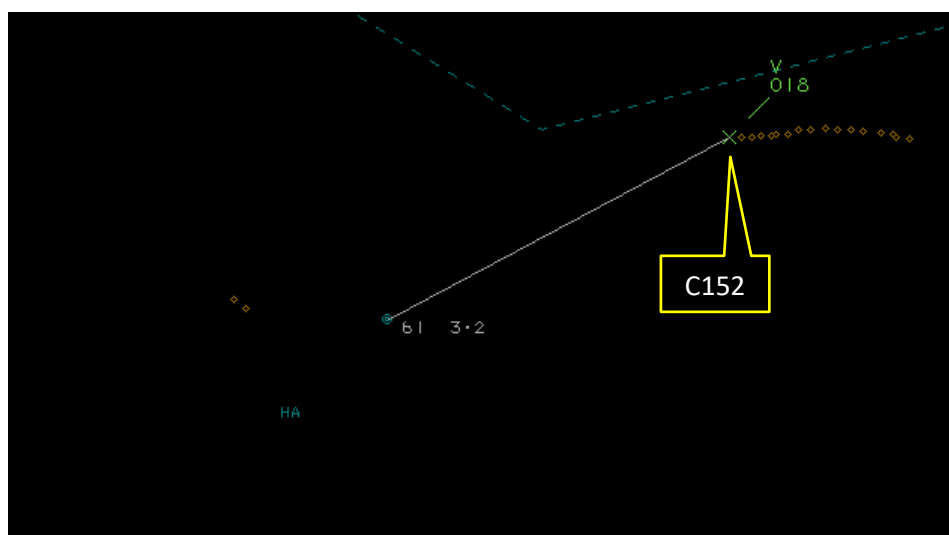
Figure 1 - 1205:59

An analysis on the NATS radar replay was undertaken. The C152 could be seen on the radar and identified using Mode S data. At 1205 the C152 could be seen approaching Compton Abbas from the east, indicating FL018. The PA28 could not be seen on the radar replay.

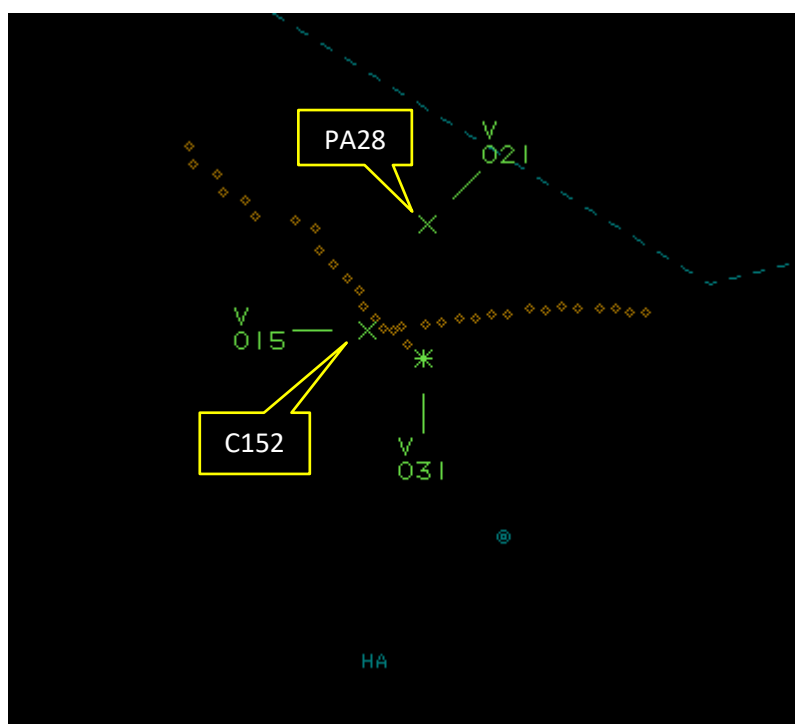
Figure 2 - 1208:23

At 1208:23, the PA28 (identifiable via Mode S) appeared on the radar replay for the first time, to the northeast of the C152. CPA was therefore not visible on the radar.
