**AIRPROX REPORT No 2023008**

Date: 24 Jan 2023 Time: 0952Z Position: 5139N 00028W Location: 5NM SSE Elstree

**PART A: SUMMARY OF INFORMATION REPORTED TO UKAB**

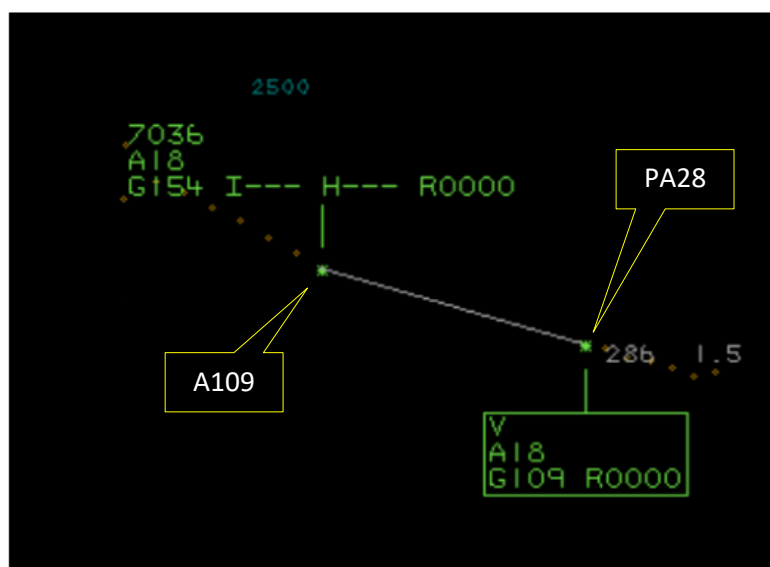
Figure 1 – 0951:42, just after TI had been passed on the PA28 to the pilot of the A109

The relative locations of each aircraft, a single radar update after the controller began to issue Traffic Information, are shown in Figure 1. The SVFR Controller then immediately gave further information, "Eleven o'clock, half a mile, same level". The pilot's short response was blocked by a call from another aircraft on frequency.

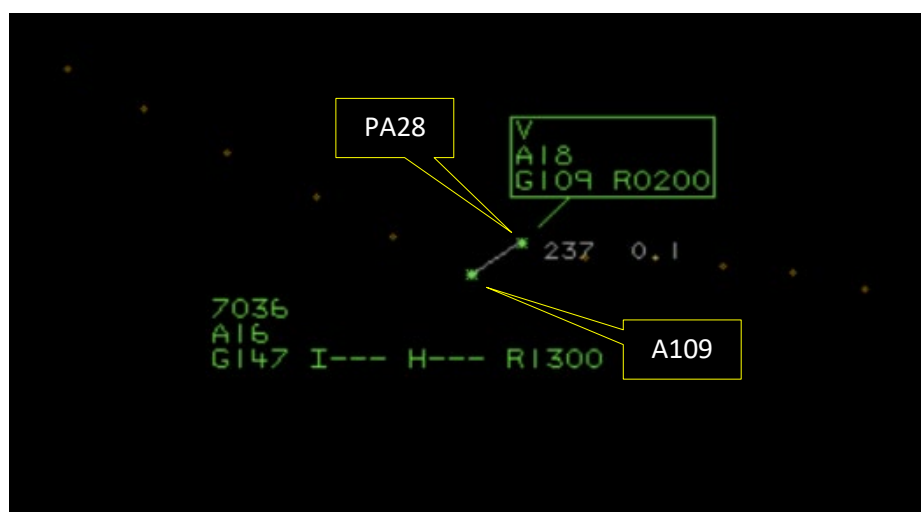
Figure 2 – CPA at 0952:01

The closest point of approach between [the A109] and [the PA28] was at 0952:01, 4.8NM west of Elstree, and the distance between the two was assessed using radar data as 0.1NM and 200ft, as per Figure 2. The pilot of [the A109] had descended to 1600ft.
