**AIRPROX REPORT No 2023077**

Date: 17 May 2023 Time: 1209Z Position: 5053N 00203W Location: 2.5NM NNE Tarrant Rushton

**PART A: SUMMARY OF INFORMATION REPORTED TO UKAB**

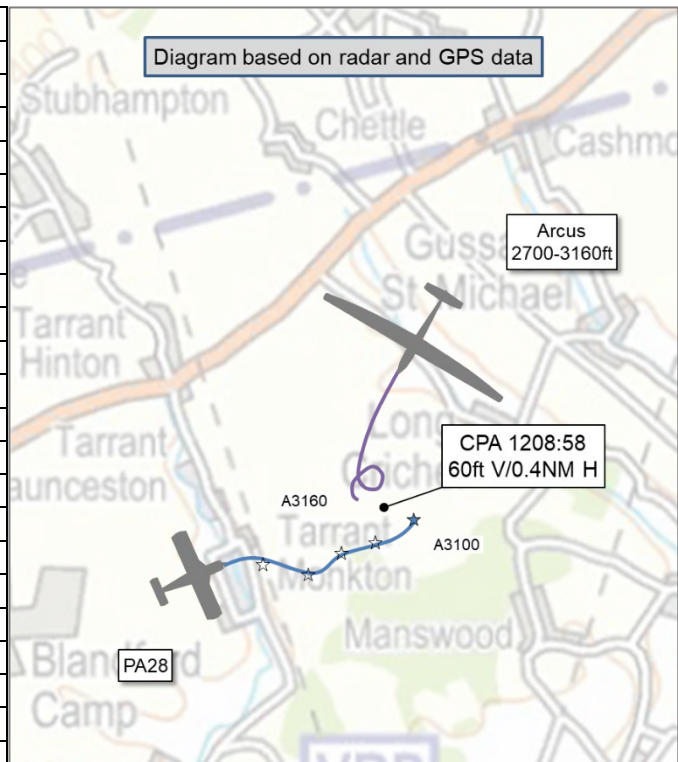
Board members noted that the correlation of the PA28 radar track and Arcus GPS track indicated that lateral separation at CPA was of the order of 0.4NM and that the PA28 pilot may have perhaps underestimated separation due to a degree of ‘startle factor’. A GA member felt that requesting a Traffic Service in a block may have assisted the PA28 pilot. Turning to EC, members noted that an optional licence could have enabled the PA28 TAS to detect the Arcus TAS and that the Arcus transponder was ADS-B out capable but it was not known whether these capabilities had been enabled (and the Arcus transponder was turned off in any case). Some members felt that the EC barrier could not be assessed but the majority felt that the situation was such that an alert could have been expected but did not occur. Overall, the Board felt that although the PA28 pilot had been startled by the proximity of the Arcus glider, normal procedures, safety standards and parameters had pertained, with the following contributory factors:

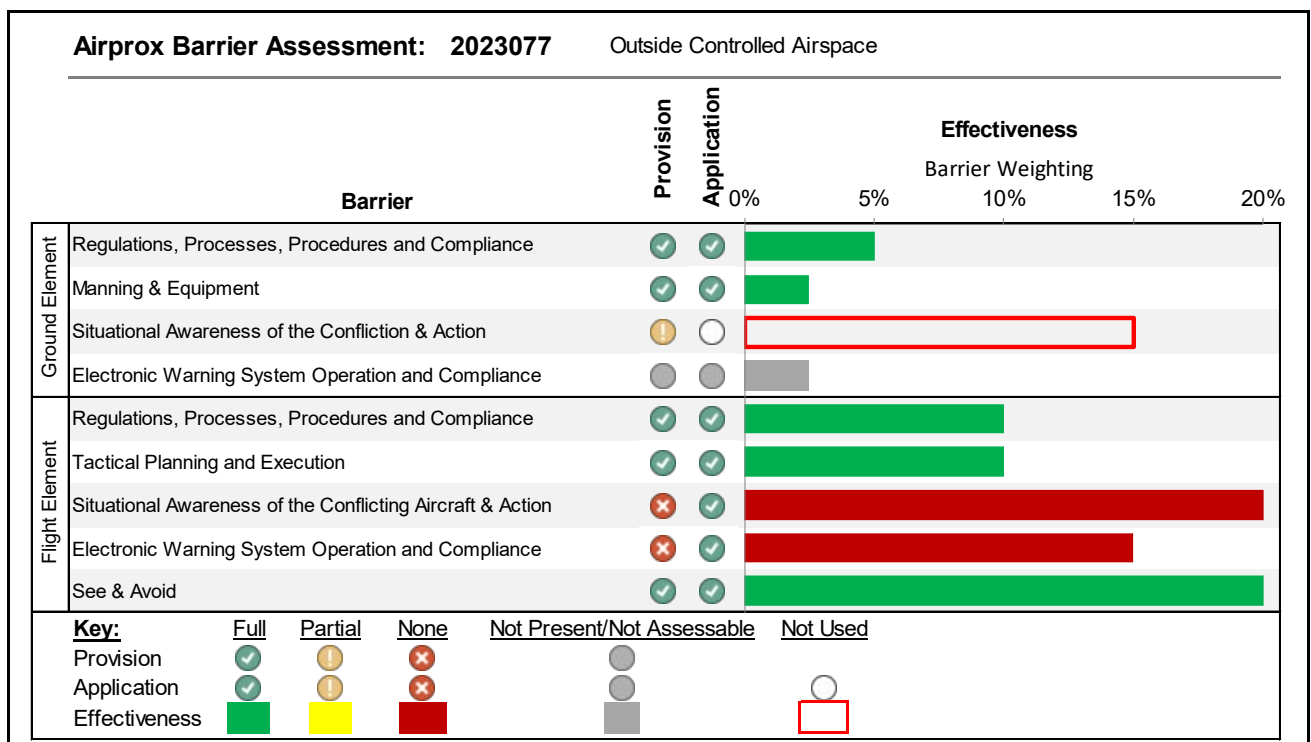
**Situational Awareness of the Confliction and Action** were assessed as **not used** because the Bournemouth controller was not required to monitor the PA28, under a Basic Service.

**Situational Awareness of the Conflicting Aircraft and Action** were assessed as **ineffective** because neither pilot was aware of the other aircraft until sighted.

**Electronic Warning System Operation and Compliance** were assessed as **ineffective** because neither TAS alerted when an alert could have been expected.
