AIRPROX REPORT No 2023087

Date: 22 May 2023 Time: 1009Z Position: 5214N 00126W Location: 7NM ENE of Wellesbourne

PART A: SUMMARY OF INFORMATION REPORTED TO UKAB

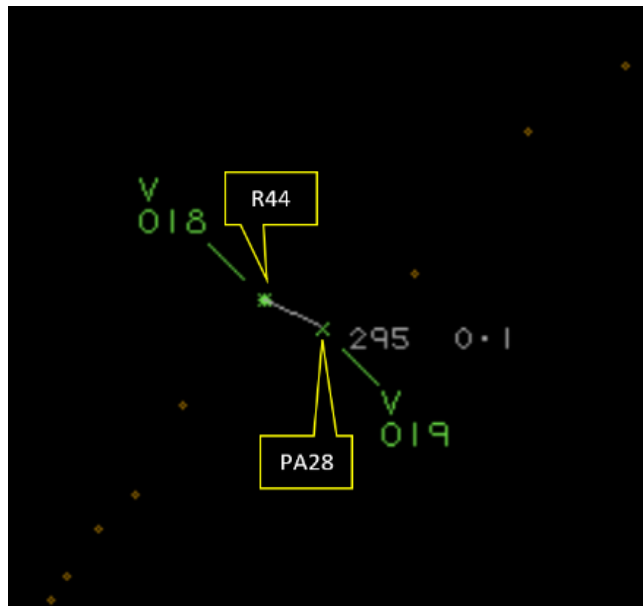
An analysis of the NATS radar replay was undertaken and both aircraft could be positively identified from Mode S data. The closest point of approach was determined as 1008:50 and the diagram constructed from the radar data. The R44 was on a north-easterly heading and the PA28 was opposite direction traffic on a south-westerly heading (Figure 1).

Figure 1 – CPA 1008:50 separation was 100ft and 0.1NM
