**AIRPROX REPORT No 2023107**

Date: 10 Jun 2023 Time: 1332Z Position: 5203N 00005E Location: 2NM SW Duxford

**PART A: SUMMARY OF INFORMATION REPORTED TO UKAB**

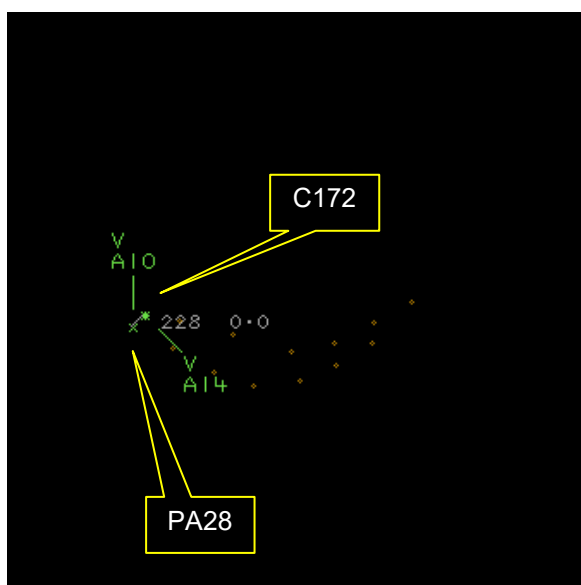
Having reviewed the radar and RT files for this event ATSI noted that, with both aircraft still downwind, the PA28 pilot who had been following the C172 by 0.2NM, reported clearing the ATZ at 1331:38 and "*picking up a track for Royston*". The C172 pilot continued downwind with the PA28 initially continuing to follow. The turn onto base by the C172 had not been obvious on the radar until 1331:49 whilst the PA28 appeared to take up a more westerly track ultimately passing 400ft underneath the C172.

Figure 3: CPA+2secs 400ft V/<0.1NM H 1331:58
