**AIRPROX REPORT No 2023141**

Date: 25 Jun 2023 Time: 1806Z Position: 5143N 00033W Location: Bovingdon Hold

**PART A: SUMMARY OF INFORMATION REPORTED TO UKAB**

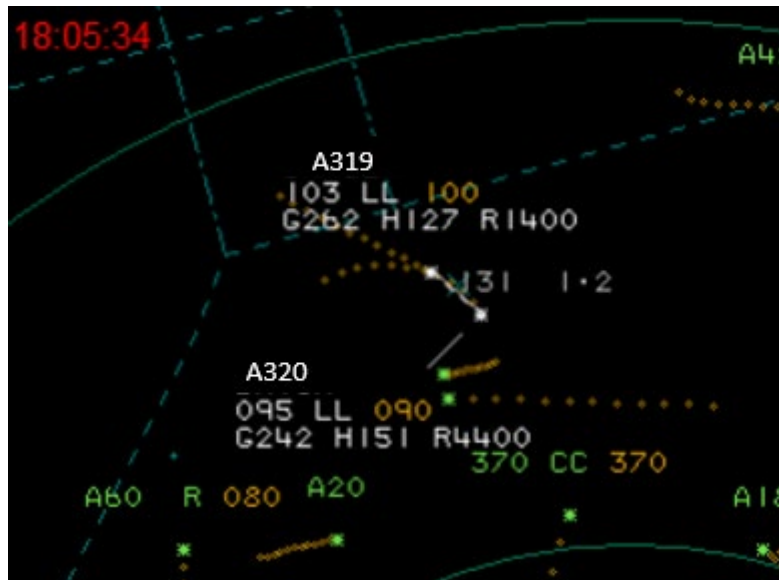
[A320 C/S] reached BNN at 1805:26 with Mode C indicating FL90, [A319 C/S] was 1.3NM behind passing FL104 for FL100. The next radar update showed [A320 C/S] had initiated a climb and was now indicating FL91 with an indicated rate of climb of 700fpm. A Low-Level Short Term Conflict Alert (STCA) was generated at 1805:31. The Mode C of the A320 had now increased to FL95 with an associated 4400fpm rate of climb at 1805:34, at which time [A319 C/S] was passing FL103 in the descent for FL100, and separation minima was eroded (Figure 1).

Figure 1 - Separation minima were eroded at 1805:34

The INT N controller issued the pilot of [A320 C/S] an avoiding action turn onto a heading of 090° at 1805:41, followed by an avoiding action right turn onto a heading of 230° and Traffic Information to the pilot of the A319. As the INT N controller was passing the avoiding action instructions the A320 was climbing and turned past the assigned heading of 165°.

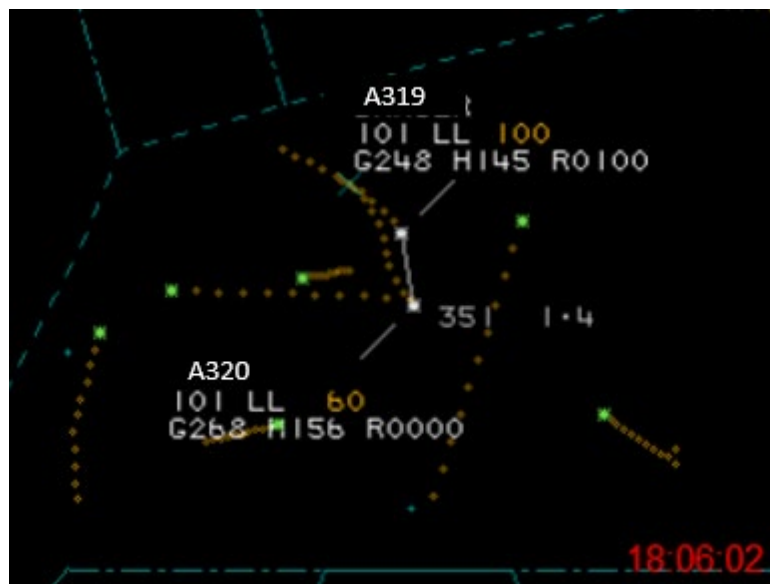
Figure 2

Following the avoiding action instructions, the INT N controller transmitted to the pilot of A320 “*you should be descending now, descend now flight level eight zero*”, which was read back by the pilot. During this RT exchange the A320 reached the maximum indicated flight level of FL102 at 1805:58. This was read back correctly by the pilot of the A320, the Mode S Selected Flight Level (SFL) briefly changed (one radar update) to indicate 60, prior to the correct level being displayed.

Minimum separation occurred at 1806:02 and was recorded on the Multi Track radar as 0 feet. Note: lateral separation of 1.4NM was not applicable as both aircraft were assessed to be still within the same holding area.

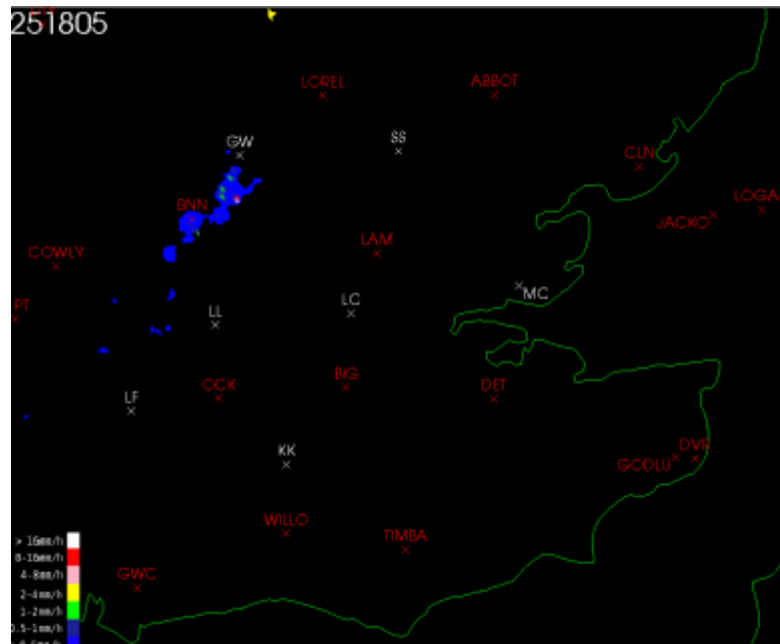
Figure 3

A snapshot of the Coremet system showed that there was a small area of precipitation bearing clouds over BNN timed at 1805 (Figure 3).
