**AIRPROX REPORT No 2023147**

Date: 13 Jul 2023 Time: 1148Z Position: 5231N 00213W Location: Wolverhampton Airport ATZ

**PART A: SUMMARY OF INFORMATION REPORTED TO UKAB**

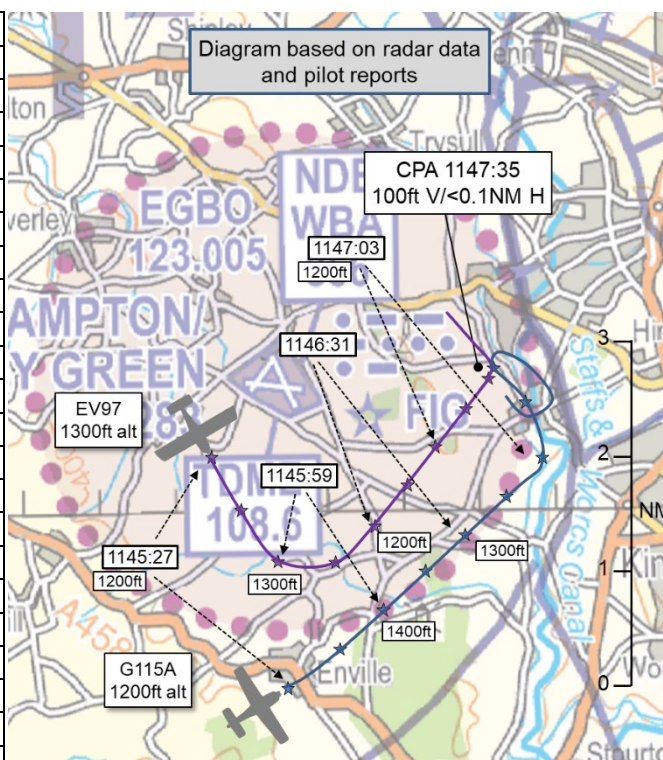
Recorded	Aircraft 1	Aircraft 2
Aircraft	Grob G115A	EV97 Eurostar
Operator	Civ FW	Civ FW
Airspace	H'penny Green ATZ	H'penny Green ATZ
Class	G	G
Rules	VFR	VFR
Service	AFIS	AFIS
Provider	Halfpenny Green	Halfpenny Green
Altitude/FL	1400ft	1300ft
Transponder	A, C, S	A, C, S
<b>Reported</b>		
Colours	White / Orange	Silver
Lighting	Nav, Landing	None
Conditions	VMC	VMC
Visibility	>10km	>10km
Altitude/FL	1000ft	1000ft
Altimeter	QFE (1004hPa)	QFE
Heading	040°	040°
Speed	95kt	80kts
ACAS/TAS	Not fitted	Not fitted
Alert	N/A	N/A
<b>Separation at CPA</b>		
Reported	0ft V/250ft H	0ft V/500ft H
Recorded	100ft V/<0.1NM H

From the radar replay it is apparent that neither pilot had been aware of the other as they tracked downwind with the Grob turning on to base leg directly ahead of the EV97.
