AIRPROX REPORT No 2023170

Date: 07 Aug 2023 Time: ~1238Z Position: 5207N 00311W Location: Lane Farm Airpark

PART A: SUMMARY OF INFORMATION REPORTED TO UKAB

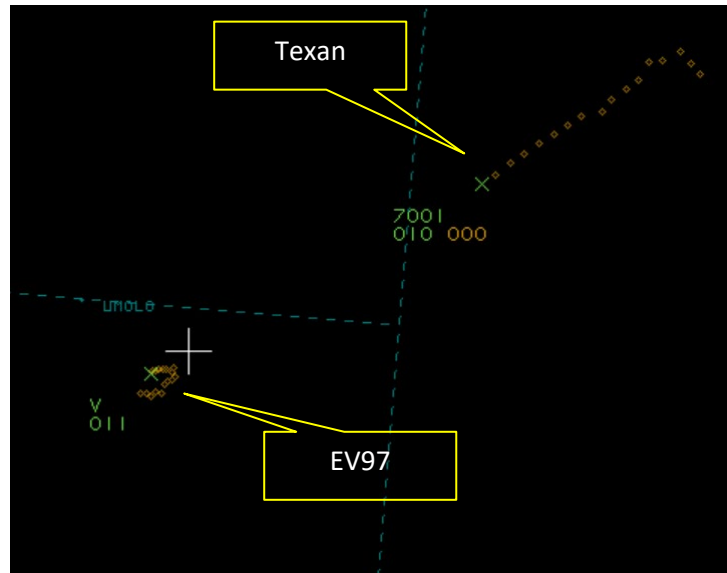
Figure 3

An analysis of the NATS radar replay was undertaken. Both aircraft were visible on the radar and identifiable from Mode S data (see Figure 3). The white cross represents the position of Lane Farm Airpark.

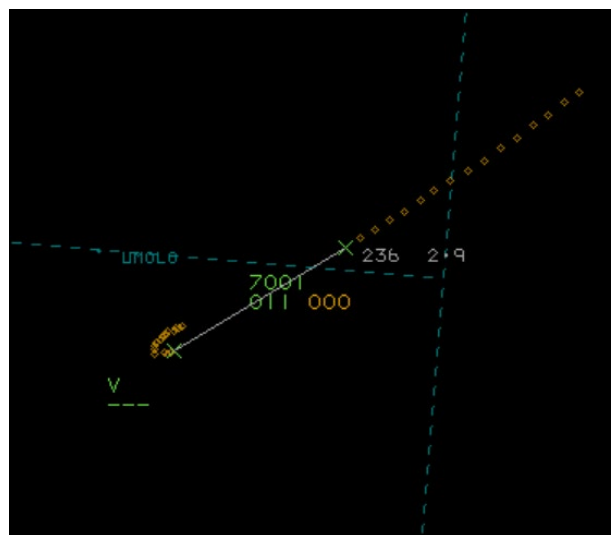
Figure 4 - 1237:18

By 1237:18 the Mode C on the EV97 was not available, probably due to the height of the aircraft; the Texan could be seen continuing on track, indicating FL010 (Figure 4).

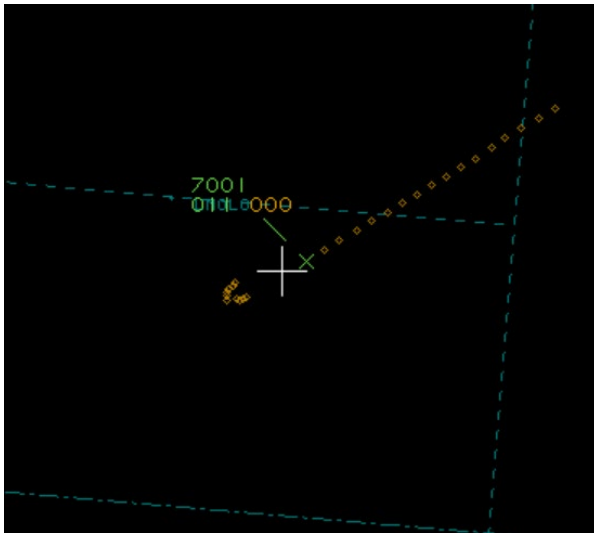
Figure 5 – Probable CPA, 1237:43

Shortly afterwards the EV97 faded from the radar, the Texan continued on track and CPA probably occurred at approximately 1237:43 when the Texan appeared to be overhead the airfield (Figure 5). The exact separation could not be measured. At 1237:59, after CPA, the EV97 again appeared on radar, as it climbed out. By this time the Texan was well to the southwest of the airfield (Figure 6).
