AIRPROX REPORT No 2023198

Date: 28 Aug 2023 Time: ~1649Z Position: 5227N 00108E Location: Priory Farm

PART A: SUMMARY OF INFORMATION REPORTED TO UKAB

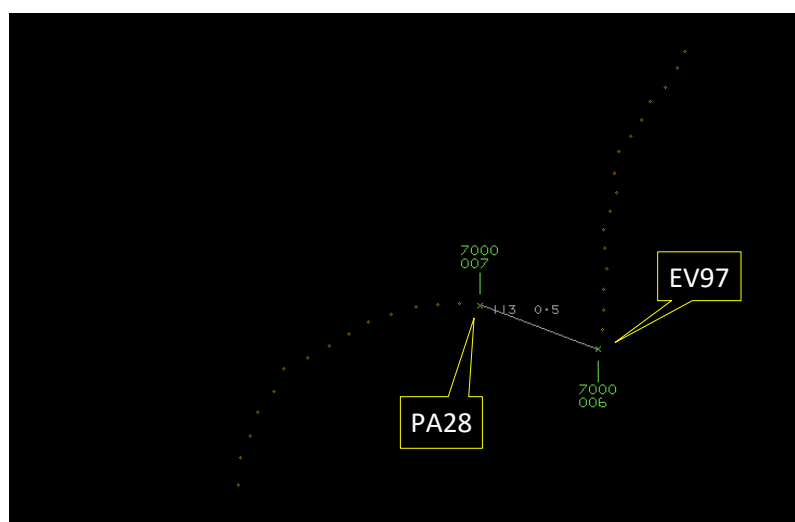
Figure 1 – Aircraft positions at 1647:38

The radar returns from the PA28 faded at 1647:38 and the radar returns from the EV97 faded at 1648:26. The tracks of the aircraft after those times are shown in the diagram as approximations. The exact moment of CPA, and the separation between the aircraft, could not be determined.
