AIRPROX REPORT No 2020070

Date: 11 Jul 2020 Time: 1039Z Position: 5107N 00216W Location: 2km WSW The Park gliding site

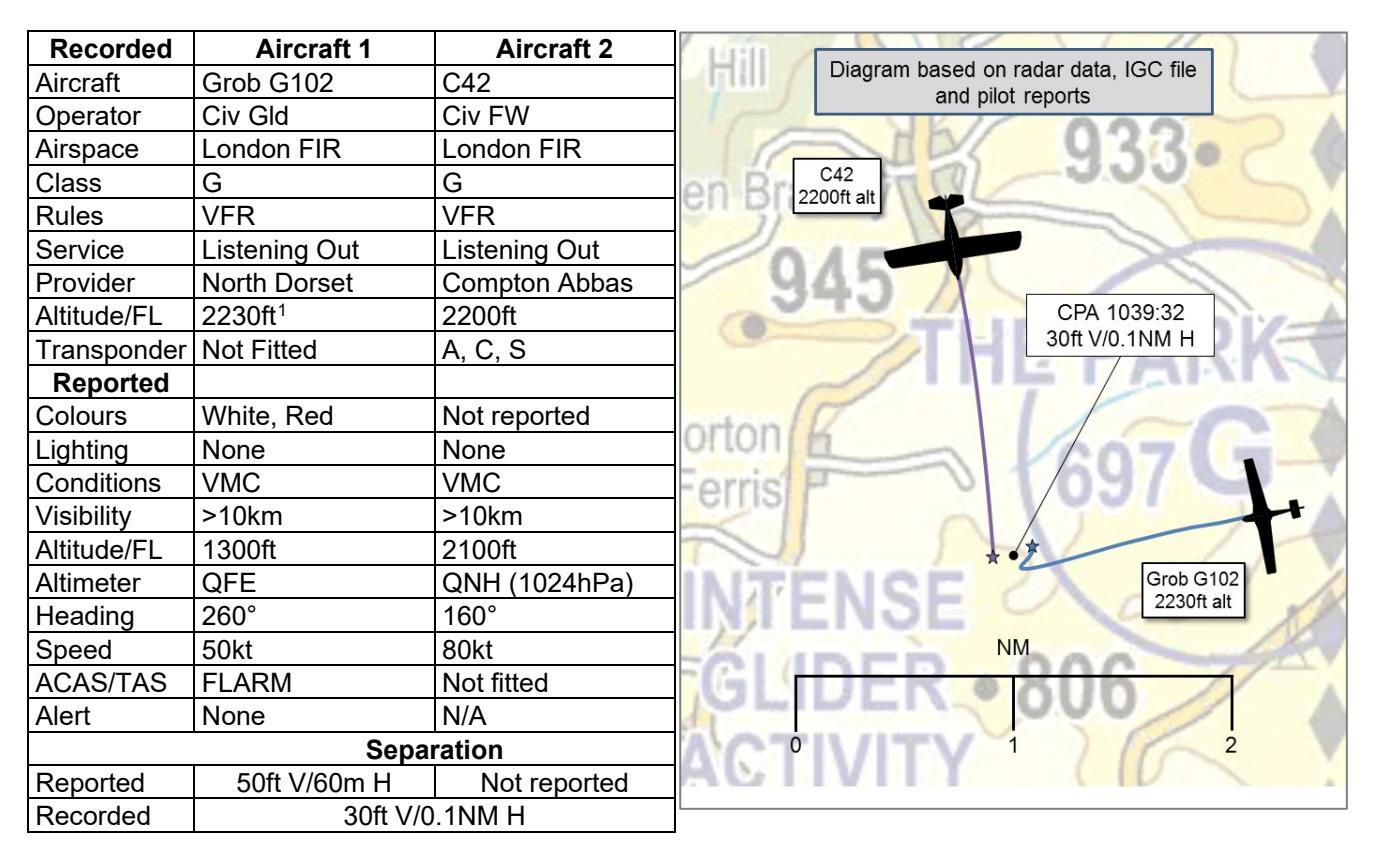
An Airprox was reported when a Grob G102 and a C42 flew into proximity 2km WSW The Park gliding site at 1039Z on Saturday 11th July 2020. Both pilots were operating under VFR in VMC, the Grob G102 listening out on the North Dorset frequency and the C42 pilot listening out on the Compton Abbas frequency.
