AIRPROX REPORT No 2020129

Date: 19 Sep 2020 Time: 1744Z Position: 5208N 00057E Location: Wattisham elevation 283ft

An Airprox was reported when an ASK21 and a BE36 flew into proximity at Wattisham at 1744Z on Saturday 19th September 2020. Both pilots were operating under VFR in VMC, the ASK21 pilot was not in receipt of an ATS and the BE36 pilot was in receipt of a Basic Service from London Information.

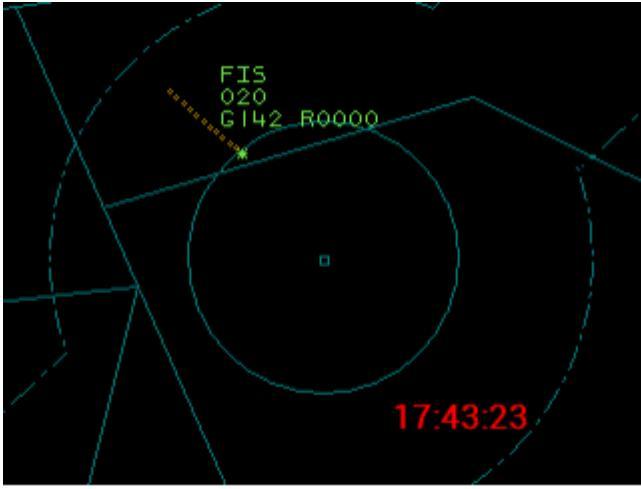
Figure 2

[BE36 C/S] maintained an indicated FL020 (local QNH 1016hPa, therefore pressure adjusted altitude of 2090ft) entered the Wattisham MATZ at 1742:19. The BE36 (displayed as FIS on radar) entered the Wattisham ATZ at 1743:23 (Figure 2).

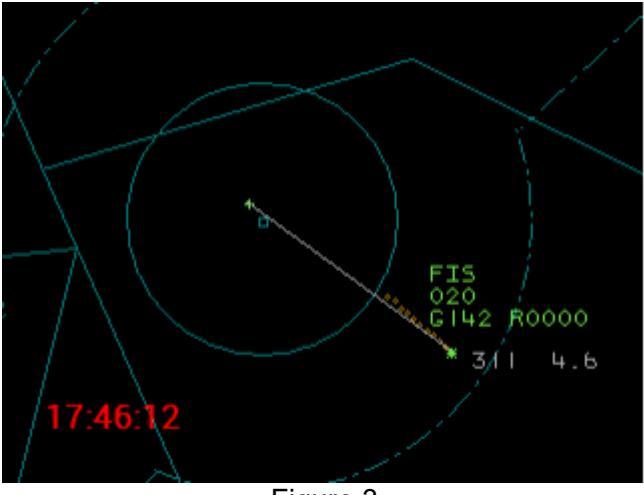
Figure 3

As the BE36 transited the MATZ, there were no radar contacts associated with the gliding activity until 1746:12, see Figure 3, at which point the BE36 was vacating the MATZ.
