AIRPROX

THE PUBLICATION OF THE UK'S AIRPROX BOARD

2013

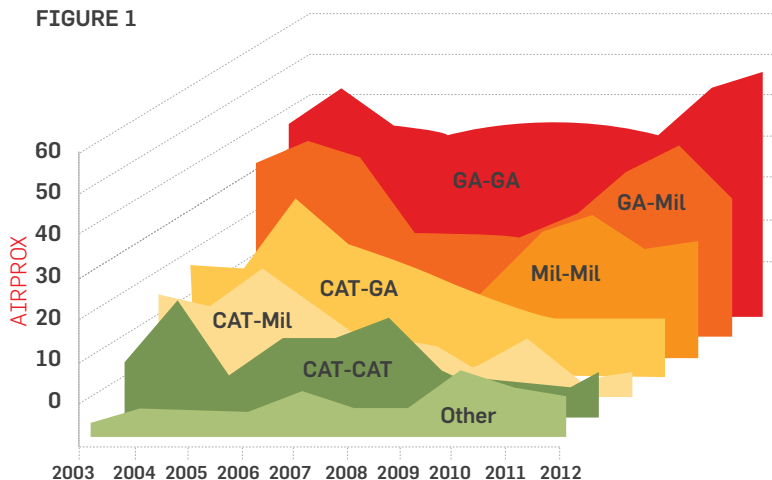
FIGURE 1 shows the breakdown by flight category; 'Other' refers to airprox in which one of the aircraft has not been traced.

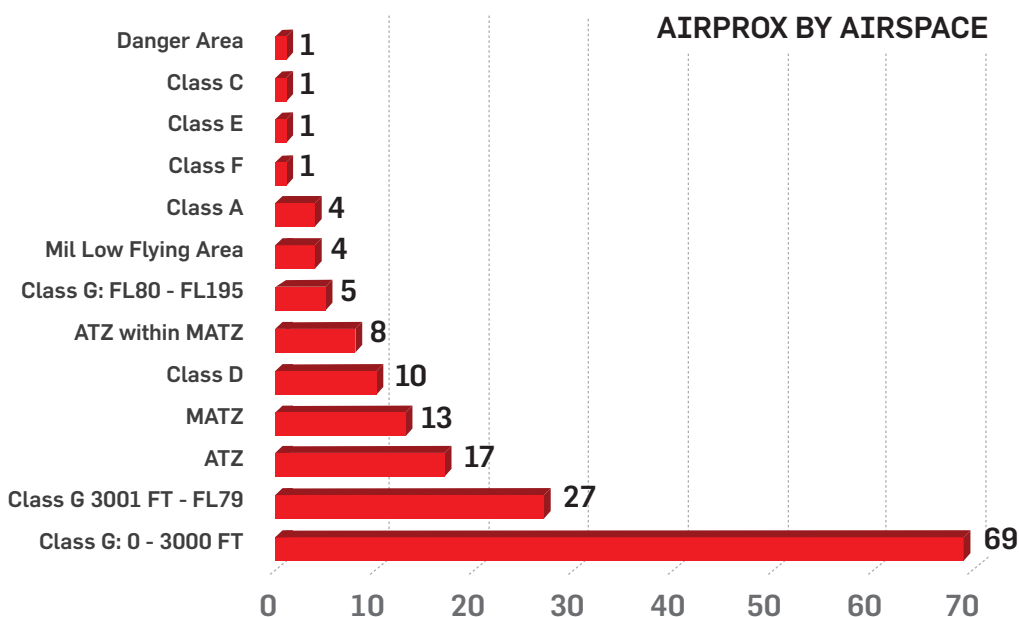
THE BREAKDOWN of airprox by airspace is shown in **FIGURE 2**. The figures are for those for 2012, which show a typical distribution. In 2013, of the first 35 airprox, 17 occurred in Class G airspace below 3,000ft. So on the next CAVOK day, if you are free to choose your cruising altitude, what will it be?

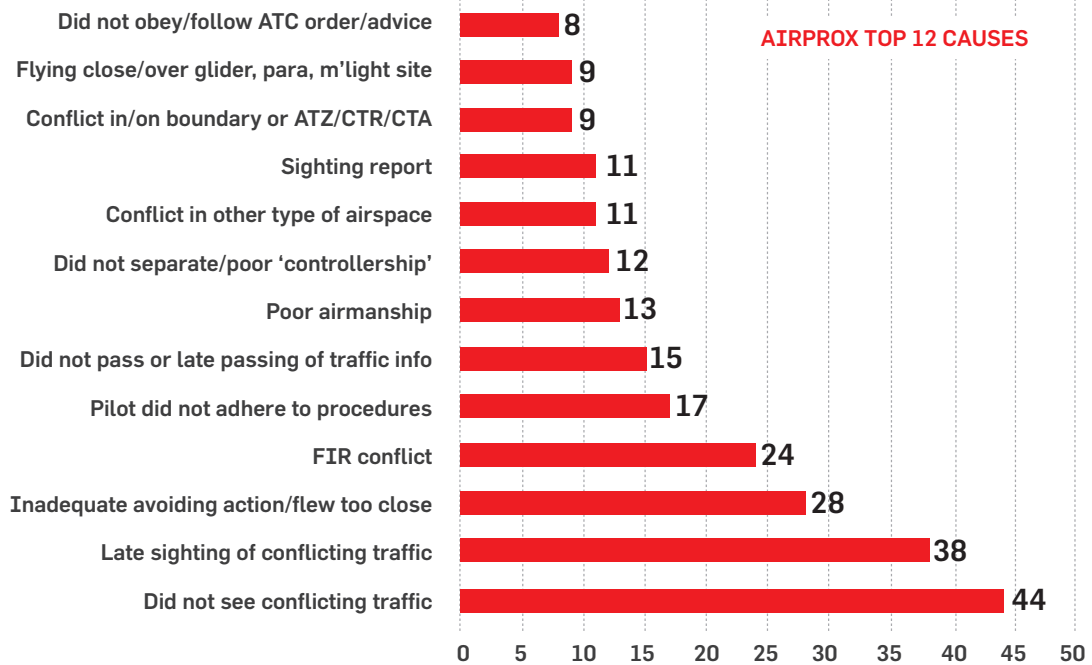
one pilot A sees aircraft B late and files a report, but pilot B saw aircraft A in good time and avoided. The breakdown of 319 causes for the 161 airprox in 2012 (Figure 3) was typical of every year, with sighting issues accounting for between one third and one half of the total.

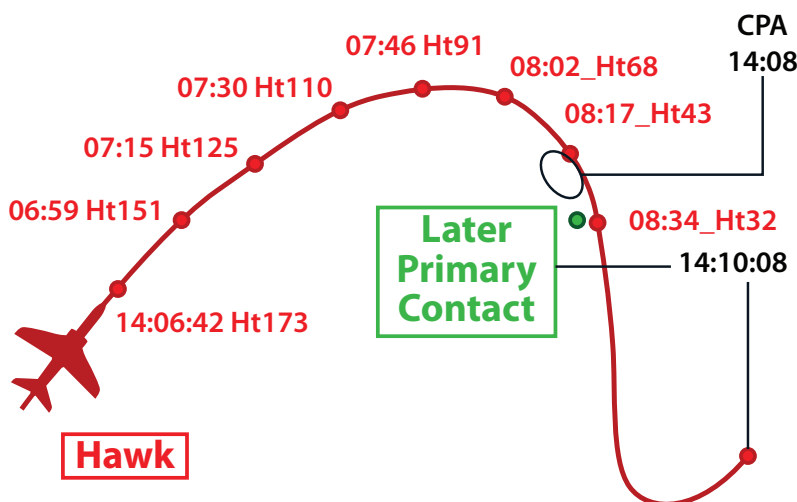
Diagram based on radar data
