# AIRPROX

THE PUBLICATION OF THE UK'S AIRPROX BOARD

2014

to the annual Airprox Report Magazine 2014

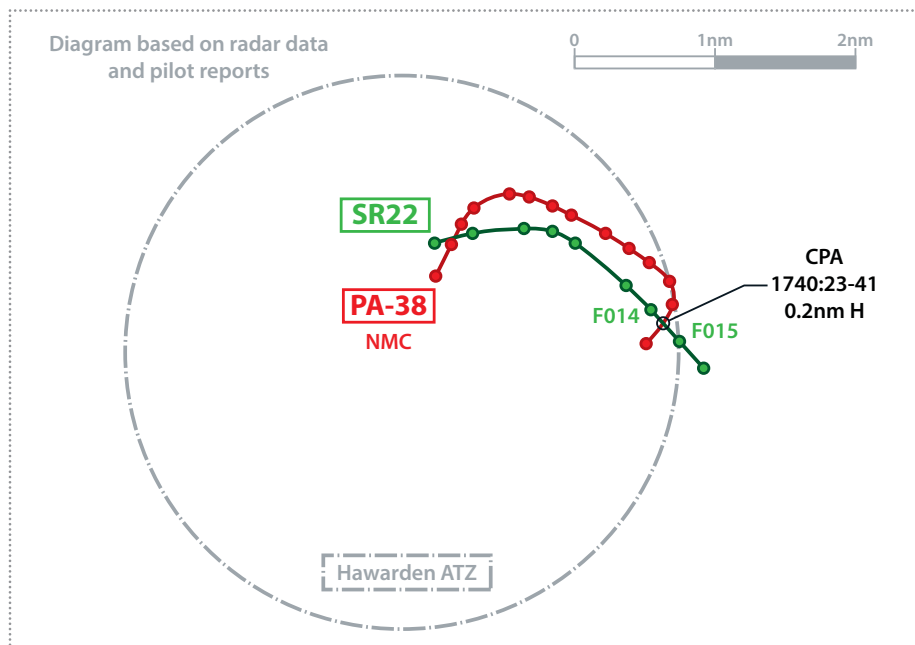
## REPORT'S DETAILS

**AIRPROX REPORT:**  
2013058

The PA-38 pilot had noted that the SR22 was considerably faster than his own aircraft and reports that he maintained visual contact with it. When he realised that the SR22 was turning inside his circuit he instructed his student to level at 900ft agl, the SR22 passing within 0.2nm of his aircraft with around 340-440ft vertical separation.

**Cause:** The SR22 pilot flew into conflict in the visual circuit with the PA-38, which he did not see.

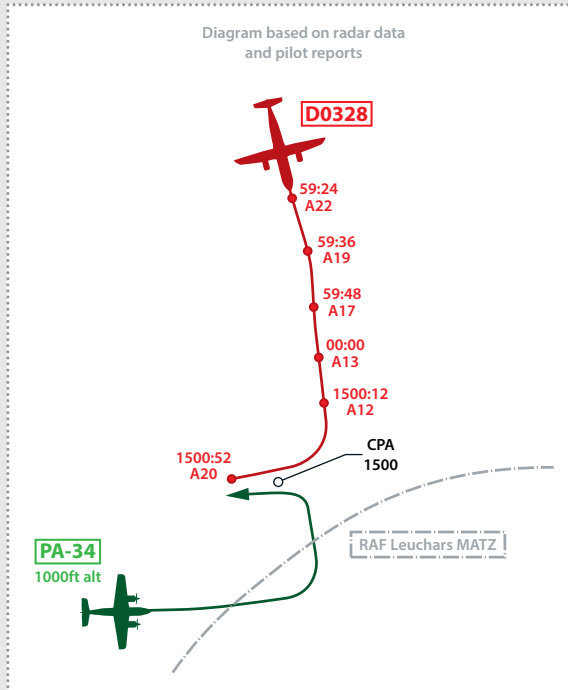
**REPORT'S DETAILS**

When the PA-34 pilot reported ready for base-leg neither he nor the controller had visual contact with the Do328. He was instructed to turn base but to maintain 1000ft. The Board considered that this precaution may have introduced a further element of doubt as to which aircraft actually was No1 in the traffic pattern. Ultimately, the Do328 continued towards final approach with no visual contact with the PA-34 and then turned into conflict with it, the Do328 pilot then reacting to a TCAS RA climb.

**Cause:** Having been told that he was No.2 in the pattern, but in the absence of effective Traffic Information, the Do328 pilot turned into conflict with the PA-34.

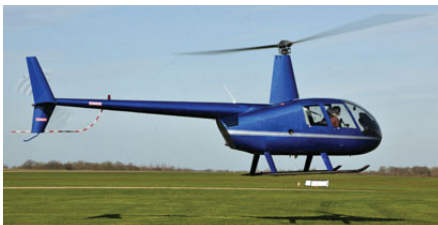
# 03 / OUT OF SIGHT ON APPROACH

**REPORTING AIRCRAFT: PA-18 – REPORTED AIRCRAFT: R44 HELICOPTER**

**A PA-18 WAS** undertaking flight training and an R44 a proficiency check. The PA-18 pilot was carrying out right-hand visual circuits on the RW18 grass strip while the R44 helicopter pilot was carrying out right-hand visual circuits from holding spot Heli 'W' [Point 'Whiskey' in the diagram]. The FISO, who was providing a Basic Service to both aircraft, expected that the helicopter would follow the standard helicopter circuit pattern centred on Heli 'W' thereby segregating the two aircraft.

Several members felt that the R44 pilot had become absorbed and was not sufficiently aware of the presence of the PA-18 even though its pilot had reported making a final approach to the grass RW18. Members found it most surprising that the R44 pilot reportedly did not know of the presence of the grass runway. The Board noted, however, that no reference was made to it in the Wellesbourne Aerodrome and FISO manuals nor is there any reference in the Wellesbourne UK AIP entry.

**Cause:** The R44 crew flew into conflict with the PA-18 which they did not see.

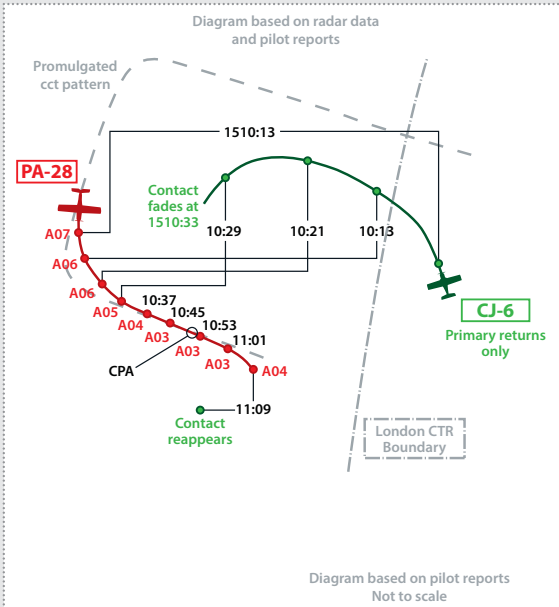
**Cause (2013002):** The CJ-6 pilot flew into conflict with the PA-28 on final approach, which he did not see.

**Cause (2013003):** The CJ-6 pilot did not conform to the pattern of traffic formed and flew into conflict with the PA-18 on final, which he had not seen.

- Degree of Risk (2013002): C
- Degree of Risk (2013003): B

around due to the Airprox with the PA-28, repositioned for a second circuit, again without conforming with the circuit pattern already established and flying into close proximity with the PA-18. The PA-18 pilot reports that he was aware from RT transmissions that the pilot of a PA-28 had just had a 'near miss' with a CJ-6. He was visual with the PA-28 as it turned early crosswind but could not see the CJ-6. Established on final approach at a height of about 240ft, the A/G operator asked him whether he had seen the CJ-6. He looked to his left and had a fleeting view of it in his 8 o'clock position before it passed underneath his aircraft.

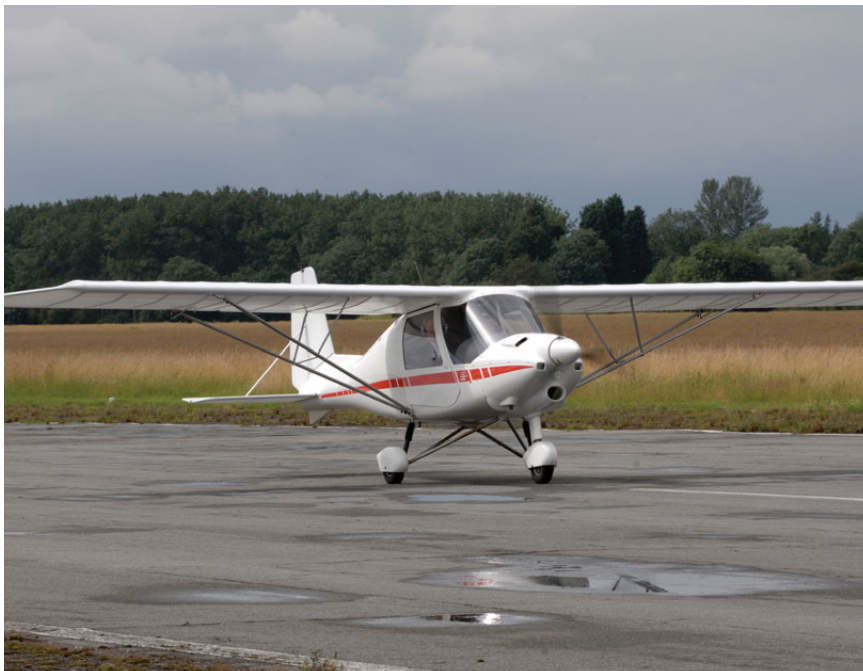
# 03 / SELF-BRIEFING MISSING THE FINER POINTS...

**REPORTING AIRCRAFT: IKARUS C42 – REPORTED AIRCRAFT: PA-28**

**THE C42 WAS** carrying out circuit training on RW23 right-hand at Lee-on-Solent. As the aircraft was climbing out after a touch-and-go, the pilot observed an aircraft positioning on final approach to RW05. He made an avoiding action left turn away from this aircraft, keeping it in sight.

**Cause:** The PA-28 pilot flew into conflict with the C42 in the Lee-on-Solent visual circuit.

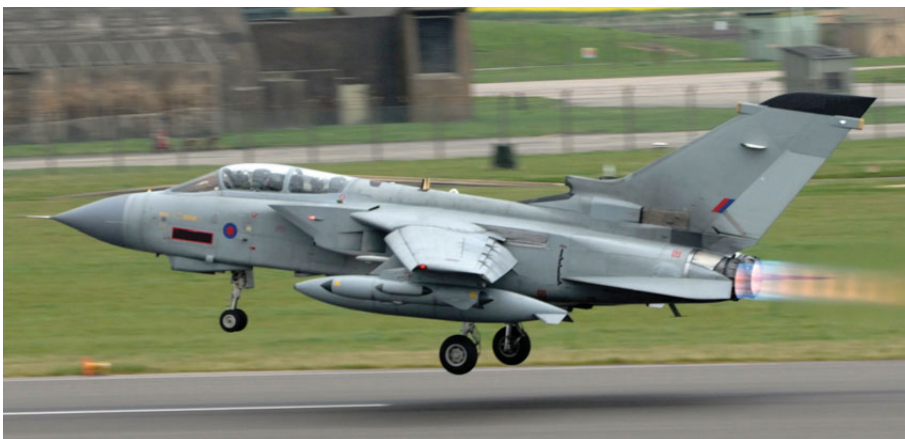
**03 / LOW? WATCH OUT**

**REPORTING AIRCRAFT: TORNADO GR4 – REPORTED AIRCRAFT: IKARUS C42**

**AN IKARUS C42** and members of a Tornado formation came into close proximity over the Lake District. All of the pilots were operating autonomously under VFR in VMC in Class G airspace. The Tornado crews were operating at low-level in accordance with military low-flying regulations. The Tornados had navigation lights and high intensity strobe lights 'on'. All four SSR transponders were selected 'on' with

The lead Tornado crew observed a white, high-wing, single-engine aircraft about 0.5nm ahead, flying in the opposite direction, about 500ft above. The crew informed the other formation, a pair following at low-level about 5min behind, using the intra-formation

Board members decided that the GA community could usefully be made more aware of aspects of flow-arrows such as their location, orientation and applicability, although they recognised that civilian pilots were not required to abide by their limitations. It was also noted that flow-arrows had previously been printed on CAA VFR charts but the Board was not convinced that their re-introduction would improve matters.

**Cause:** Sighting report.

**Recommendation(s):** CAA to review education of GA pilots to improve understanding of implications of military low-flying 'flow arrows'.

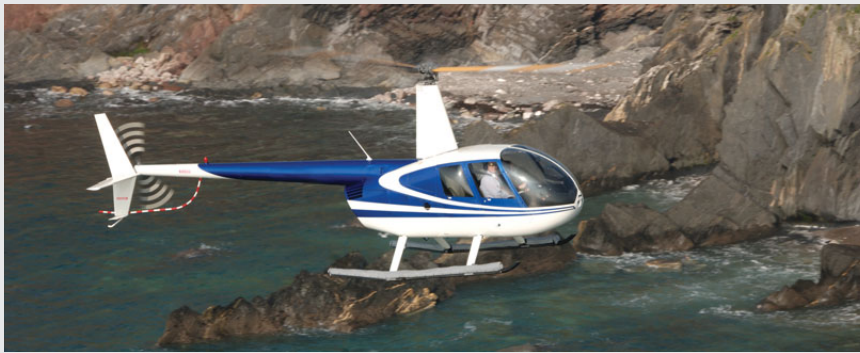
## 04 / LONDON CITY ALARM... 2

REPORTING AIRCRAFT: AVRO RJ1H – REPORTED AIRCRAFT: R44

**THE AIRPROX OCCURRED** within Class D airspace of the London City CTR. The RJ1H was operating IFR and the R44 VFR. Both the City and SVFR radar controllers complied with ATC responsibilities for flights within Class D airspace; appropriate traffic information was issued to both flights. Both pilots obtained visual contact with the other aircraft. The closest point of

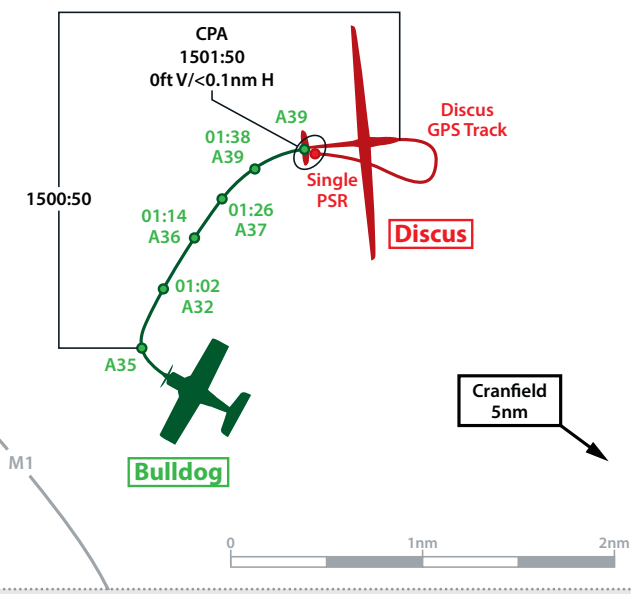
Diagram based on radar and GPS data
