**AIRPROX REPORT No 2021235**

Date: 23 Nov 2021 Time: 2017Z (Night) Position: 5125N 00006W Location: Norbury

**PART A: SUMMARY OF INFORMATION REPORTED TO UKAB**

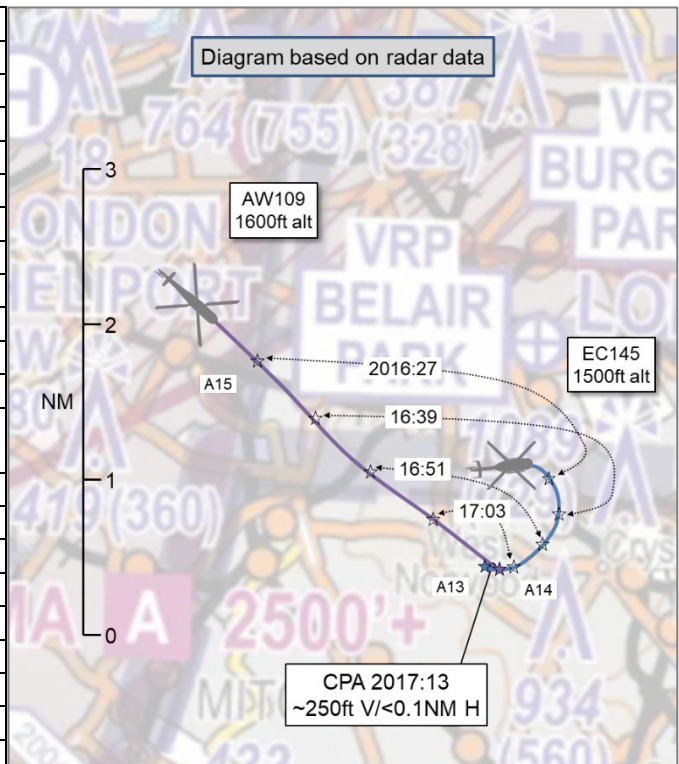
Recorded	Aircraft 1	Aircraft 2
Aircraft	EC145	AW109
Operator	NPAS	Civ Helo
Airspace	London FIR	London FIR
Class	G	G
Rules	VFR	VFR
Service	Basic	Basic <sup>1</sup>
Provider	Heathrow SVFR	Heathrow SVFR
Altitude/FL	~1350ft	1600ft
Transponder	A, C, S	A, C, S
Reported		
Colours	Dark blue, yellow	Silver, red
Lighting	Anti-col, position, strobes	Anti-col, nav, landing
Conditions	VMC	VMC
Visibility	>10km	>10km
Altitude/FL	1400ft	1600ft
Altimeter	QNH (1031hPa)	QNH (NK hPa)
Heading	Orbiting right	~135°
Speed	NK	155kt
ACAS/TAS	TAS	TAS
Alert	Alert	Information
Separation at CPA		
Reported	~200ft V/<100m H	100ft V/200-300ft H
Recorded	~250ft V/<0.1NM H

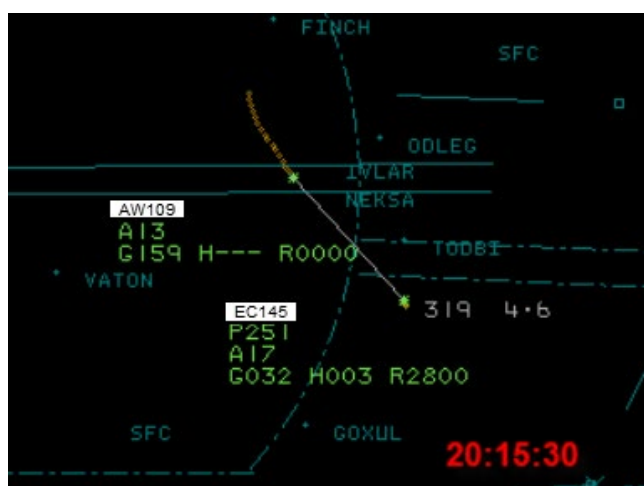
Figure 1

Further traffic information was provided to the pilot of [AW109] at 20:15:30 (see Figure 1), stating that [EC145] was in their “twelve o’clock, about three miles, similar level.” The pilot responded that they were visual. The pilot of [EC145] also stated that they were visual with [AW109]

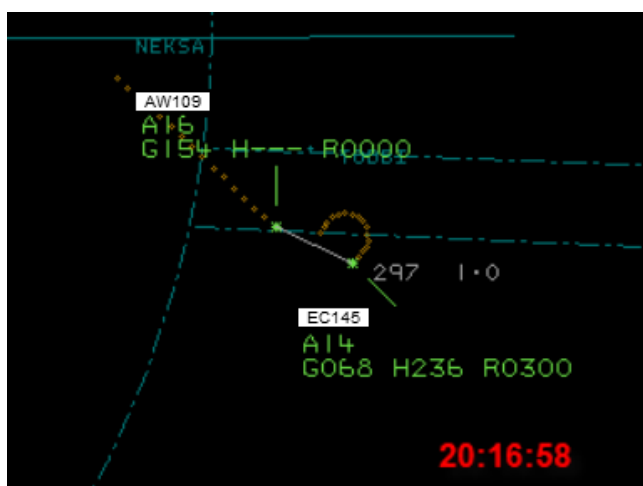
Figure 2

The pilot of [AW109] reported level at altitude 1600 feet at 20:16:58 and were visual with [EC145], which displayed a Mode-C altitude of 1400 feet whilst manoeuvring through an orbit (see Figure 2). The pilot of [EC145] responded that they were also visual with [AW109].

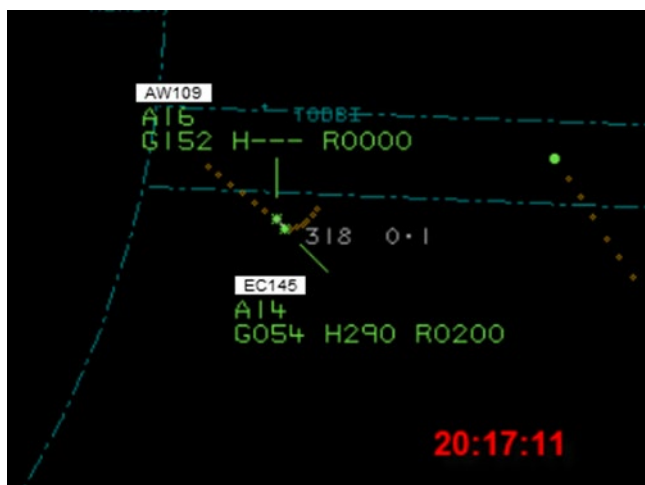
Figure 3

The closest point of approach between the two aircraft occurred at 20:17:11 immediately prior to the two radar returns crossing and was measured on the Multi-Track Radar Display as 0.1nm and 200 feet. (see Figure 3). The next radar update displayed the two targets had crossed with 0.1nm lateral and 300 feet vertical distance.

Closest Point of Approach occurred at 20:17:11 and was recorded on Multi-Track Radar as 0.1nm and 200 feet.
