**UK AIRPROX BOARD**

**Analysis of  
Airprox in UK Airspace**  
Report Number 3  
July 1999 to December 1999

Report by the UK Airprox Board,  
'Analysis of Airprox in UK Airspace'  
(July 1999 to December 1999)

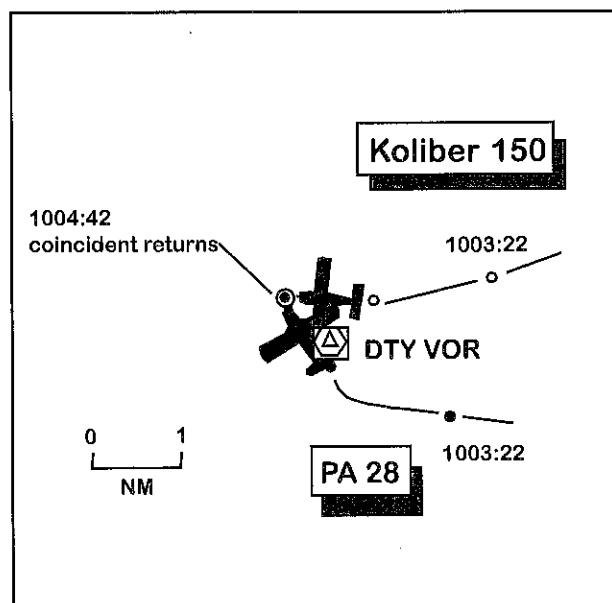
**AIRPROX REPORT No 107/99**

Date/Time: 8 Jul 1005  
Position: N5211 W0108 (-75 NM NW DTY VOR)  
Airspace: FIR (Class: G)  
Reporting Aircraft Reported Aircraft  
Type: Koliber 150 PA28  
Operator: Civ Pte Civ Club  
Alt/FL: 2000 ft n/k (QNH)  
Weather VMC NO CLOUD VMC NO CLOUD  
Visibility: 25 km >10 km  
Reported Separation: 0 ft V/100-150 ft H  
Recorded Separation: returns merged

**THE KOLIBER PILOT** reports that he was flying from Seething to Halfpenny Green in VMC. There was no cloud, visibility was 25 km and cockpit workload was low. His ac is predominantly white with blue stripes, and he had a rotating red light on the tail. He was squawking 7000 (no Mode C fitted) and listening out with Birmingham ATC prior to calling them for a FIS and transit clearance. When about 3 NM WNW of the DTY VOR, heading 290° at 100 kt and level at 2000 ft on the Lakenheath QNH, he saw a low-wing single engined ac, white/deep blue in colour, as it crossed his track from L to R in level flight 100 – 150 ft away, at exactly his altitude. There was no time to take avoiding action and he thought that there had been a major risk of collision.

In the reported circumstances the PA28 pilot was required to give way in accord with the 'Rules of the Air'. The Board noted that the predominately white colour scheme of the Koliber 150 did not aid visual conspicuity. However, in full VMC, with excellent visibility and the marked absence of cloud a GA member was dismayed at the apparent non-sighting of the Koliber by the PA28 pilot, especially with a very experienced pilot occupying the RHS. This Airprox is a prime example of the need to exercise a vigilant all-round lookout when flying VFR in Class G airspace, especially when routing overhead a VOR at a commonly used transit altitude. Whilst noting the possibility of obscuration caused by the cockpit window frame and insect debris, members were similarly concerned at the late sighting of the PA28 by the reporting Koliber pilot. Consequently, the Board unanimously concluded that this Airprox resulted from a breakdown in effective lookout; the PA28 pilot did not see the Koliber at all and a late sighting of the PA28 by the Koliber pilot. Turning to risk, it was clear from the Koliber pilot's report that this was a close encounter, as evinced by the

Cause: The PA28 pilot did not see the Koliber and a late sighting of the PA28 by the Koliber pilot.

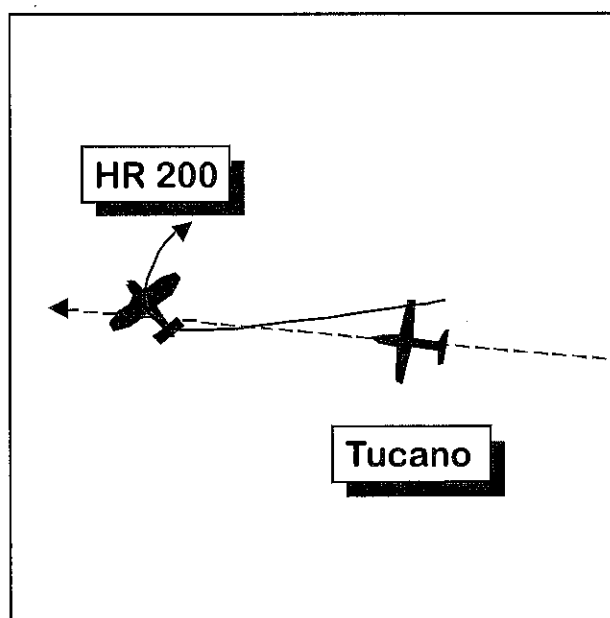
### **AIRPROX REPORT No 108/99**

Date/Time: 8 Jul 1027  
Position: N5402 W0145 (7 NM NW of Harrogate)  
Airspace: FIR/LFS (Class: G)  
Reporting Aircraft Reported Aircraft  
Type: Robin HR200 Tucano  
Operator: Civ Trg HQ PTC  
Alt/FL: 2000 ft 250 ft  
 (RPS 1031 mb) (msd)  
Weather VMC CLBC VMC CLBC  
Visibility: 30 km 8-10 km  
Reported Separation: 250 ft/250 ft  
Recorded Separation: NK

**THE ROBIN PILOT** reports heading NE at 95 kt on a general handling sortie, receiving a FIS from Leeds, when he saw a Tucano as it was about to pass underneath on a westerly heading. He held his attitude until he saw it reappear having passed 250 ft beneath with a high risk of collision.

Cause: The Tucano pilot flew close enough to the Robin to cause its pilot concern for the safety of his ac.

It appeared that the Tucano pilot's memory of this particular sortie was not all that clear in terms of the height he was flying at as he encountered the Robin. The radar confirmed the Robin pilot's view that the Tucano passed close below and almost directly beneath him. There was sufficient room for the Tucano to manoeuvre and members agreed that, if it was 1 NM ahead when seen, the Robin should have been given a wider berth. The Board concluded that the cause of the incident was that the Tucano pilot had flown close enough to the Robin to cause its pilot concern for the safety of his ac. However, the Board accepted that having seen it the Tucano pilot was always in a position to ensure that he would not collide with it.

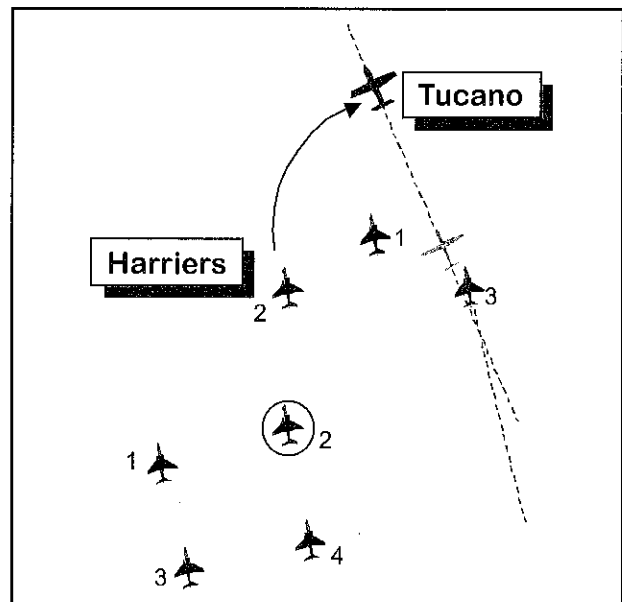
**AIRPROX REPORT No 109/99**

Date/Time: 9 Jul 0951  
Position: N5502 W0213 (6 NM NW of Hexham)  
Airspace: LFS (Class: G)  
Reporting Aircraft Reported Aircraft  
Type: Tucano Harrier  
Operator: HQ PTC HQ STC  
Alt/FL: 250 ft 410 ft (agl) (Rad Alt)  
Weather VMC CLOC VMC CLBC  
Visibility: 10 km 25 km  
Reported Separation:  
 100 ft/150-200 ft, 500-1000 ft H  
Recorded Separation: 200 ft

**HQ STC** comments that the Harrier pilot, in contrast to the Tucano pilot, did not consider the event to be significant and so there is clearly some doubt as to which 2 ac were involved in this Airprox. The Harrier pilot did take what he considered to be positive avoiding action on at least one Tucano around the time of the subject incident; it is disappointing, however, regardless of exactly which Tucano he was avoiding, that he passed close enough to cause concern to the pilot of the other ac. Given the weather conditions at the time, additional manoeuvre in the vertical plane was perfectly feasible and would have emphasised his intention to avoid the Tucano. Lateral separation alone is seldom sufficient to placate all parties, particularly in the dynamic low level environment.

Cause: A Harrier had flown sufficiently close to the Tucano to cause its pilot concern for the safety of his ac.

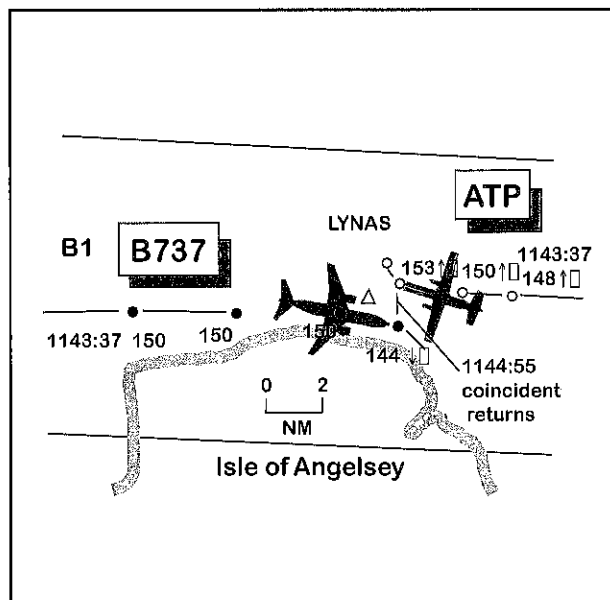
**THE B737 PILOT** reports that he was cruising at FL 150 and heading 090° at 400 kt, about 50 NM W of Wallasey. He was receiving a radar control service from Manchester on 125.1 and squawking with Mode C. The visibility was 50 km in VMC. ATC instructed him to turn R onto 150° and then to descend immediately to FL 110. Neither he nor his co-pilot saw another ac.

**ATSI** reports that the Manchester W Sector Radar Controller was in position about 15 min prior to the incident. He described his workload as medium. He was operating with an inexperienced trainee, who was at the unit to gain experience prior to commencing an Area Radar course. The presence of the trainee, he explained, was a distraction and, in his opinion, a major contributory factor to the Airprox.

When the controller concerned took over the W Sector, the ATP was climbing to FL 160 direct to Wallasey (WAL). He confirmed that the ac's FPSs, correctly annotated, were in position on the display. He could not recollect whether those for the B737 were displayed at the time but he believed, according to its ETA at Liffey, it was likely that they were in place. The controller explained that his trainee had been operating the RT for about 10 min when the B737 contacted the frequency, reporting maintaining FL 150 direct to WAL. He commented that around this time, with the number of transmissions increasing, he was having to instruct his trainee what to say. At his suggestion, the trainee acknowledged the B737's initial call with "Roger". In the ensuing period he discussed the operation of the sector with his trainee, to the extent that he did not monitor the radar display as much as he would have done had he been operating alone. He added that, inexplicably, he believed the ATP was maintaining FL 160 and, consequently, was separated from the B737. The FPS did not indicate that the ATP had reached its cleared level because the arrow in the level box, which indicates that a climb clearance had been issued, had not been annotated with a line through it (the recognised method of showing an ac reaching its cleared level). The controller confirmed that he did not always carry out this strip marking.

The Radar Controller said that at 1144, during a routine scan of his radar display from his position behind the trainee, he noticed the ATP's SSR Mode C return was showing the ac at FL 150. Taking a few seconds to assimilate this information and to stand up in order to switch the transmitter to his headset, he instructed the ATP to turn R heading 010°. Although he did not use the term 'avoiding action' to the ATP, he did use it in his next transmission to the B737. The latter was given a R turn heading 180° followed by immediate descent to FL 100. As soon as the B737's pilot replied to the last instruction, the ATP pilot reported visual with the traffic. Consequently, the controller said, traffic information was not passed to either flight. He commented that the STCA did activate during the incident but only after he had started the remedial action.

Cause: The Manchester West Radar Controller allowed the ATP to continue to climb into conflict with the B737.

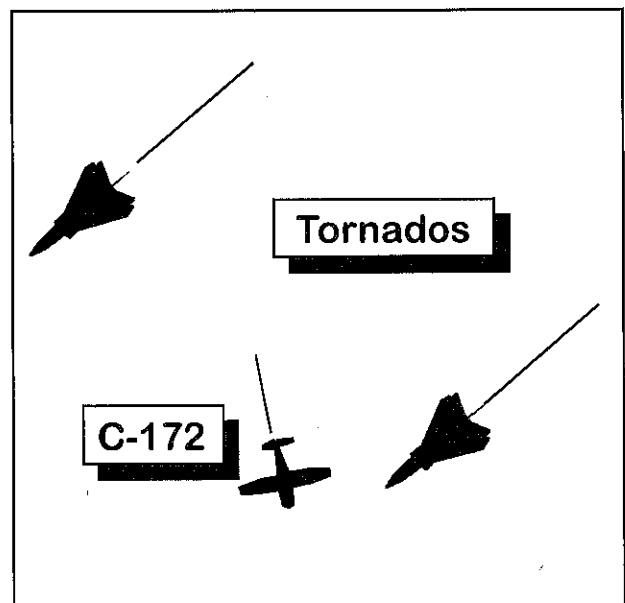
**AIRPROX REPORT No 111/99**

Date/Time: 6 Jul 1056  
Position: N5059 E0125 (9 NM SSE of Dover)  
Airspace: FIR (Class: G)  
Reporting Aircraft Reported Aircraft  
Type: C172 Tornado F3  
Operator: Civ Pte HQ STC  
Alt/FL: 2000 ft 3000 ft  
(RPS) (QNH)  
Weather VMC CLBC VMC CLAC  
Visibility: 10 km+ 15-20 km  
Reported Separation: 200 m/1500 ft  
Recorded Separation: NK

**THE C172 PILOT** reports heading 175° at 102 kt cruising at 2000 ft en route to Le Touquet and receiving a FIS from Manston. His ac was white and green. He first saw a Tornado when it was

Cause: Late sighting by the Tornado pilot.

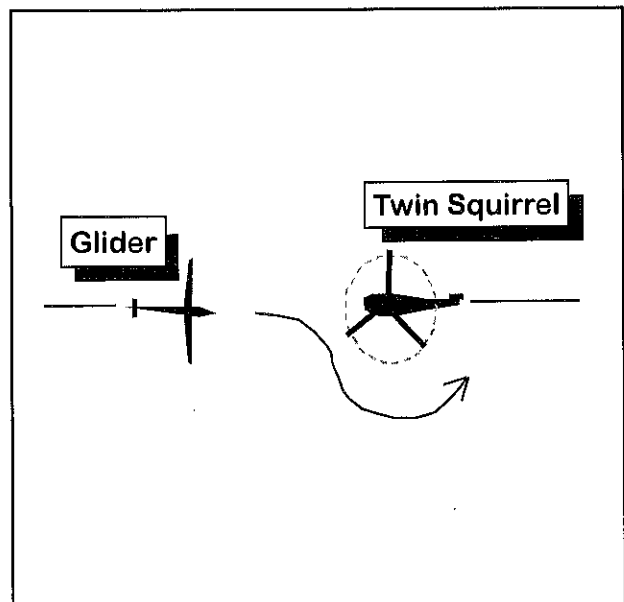
**AIRPROX REPORT No 112/99**

Date/Time: 9 Jul 1625  
Position: N5705 W0250 (Aboyne airfield - elev 460 ft)  
Airspace: FIR (Class: G)  
Reporting Aircraft Reported Aircraft  
Type: Puchacz glider AS355 Twin Squirrel  
Operator: Civ Trg Civ Pte  
Alt/FL: 1300 ft 1300 ft  
(QFE) (QNH 1007? mb)  
Weather VMC CLBC VMC  
Visibility: 20 NM  
Reported Separation: 300 yd H/50 ft V  
500 m H/50 ft V  
Recorded Separation: N/A

**THE PUCHACZ PILOT** reports demonstrating a deadside descending airbrake rejoin to his student over Aboyne. The visibility, 1600 ft

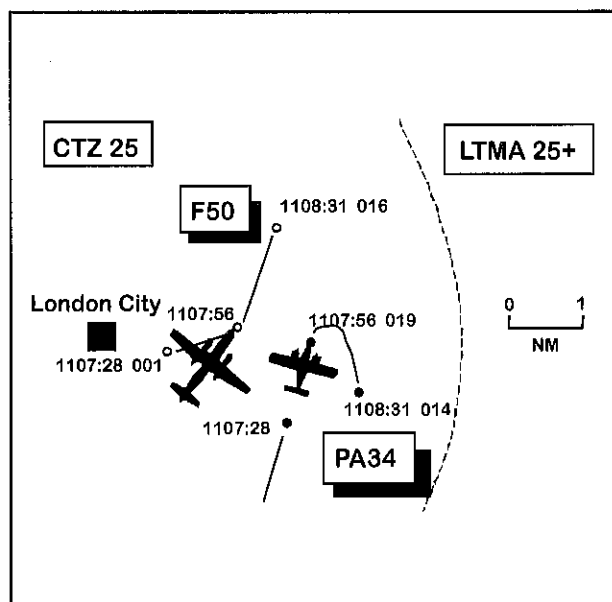
### **AIRPROX REPORT No 113/99**

Date/Time: 10 Jul 1108 (Saturday)  
Position: N5130 E0007 (2.3 NM E London City airport - elev 17 ft)  
Airspace: CTZ (Class: D)  
Reporter: Heathrow  
First Aircraft Second Aircraft  
Type: Fokker 50 PA34  
Operator: CAT Civ Pte  
Alt/FL: 3000 ft 2000 ft  
(QNH) (QNH 1024 mb)  
Weather VMC VMC  
Visibility: >10 km  
Reported Separation: not seen  
Recorded Separation: 1 NM/

**THE THAMES RADAR CONTROLLER**, acting as mentor, reports that the PA34 pilot contacted the frequency (13207) requesting a VFR crossing clearance of the London City Zone via the River Lea Valley (W of London City Airport). A squawk was allocated but no radar response was seen and clearance to enter the CTZ was not given. The pilot was asked to recycle the squawk, whereupon a return was immediately observed about 2 NM E of London City Airport tracking N; prior to this, no primary return had been seen. At this time a F50, which had previously been released on a DVR 3U SID, was seen climbing straight ahead from RW 10 towards the PA34. The controller under training immediately instructed the PA34 pilot to turn R 130° then telephoned the London City Tower controller to instruct him to turn the F50 L onto 360°. When the conflict had been resolved, both pilots were advised that reporting action

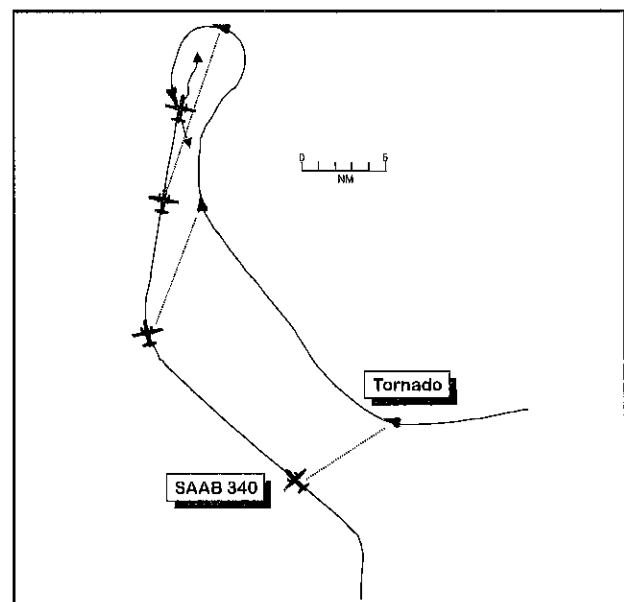
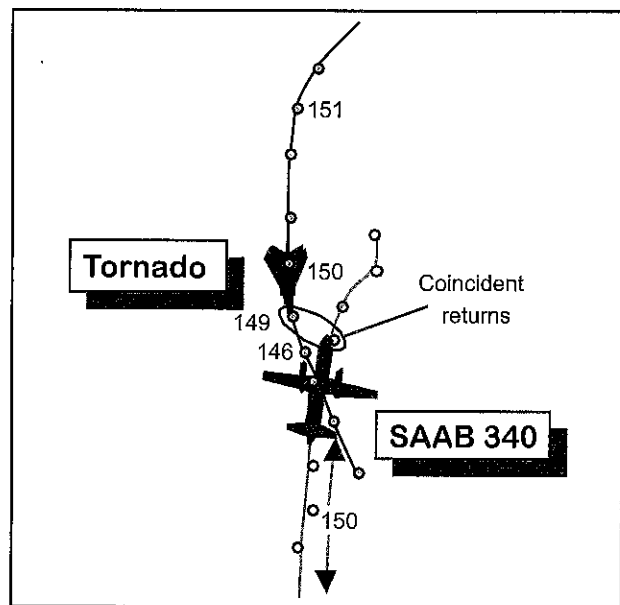
**AIRPROX REPORT No 114/99**

Date/Time: 12 Jul 0923  
Position: N5552 W0225 (8 NM WSW of St Abbs Hd)  
Airspace: FIR (Class: G)  
Reporting Aircraft Reported Aircraft  
Type: SAAB 340 Tornado GR  
Operator: CAT HQ STC  
Alt/FL: FL 150  
Weather VMC CLOC VMC CLOC  
Visibility: 50 km 50 km  
Reported Separation: 0.5 NM/200 ft  
Recorded Separation: 0.57 NM/200 ft

**THE SAAB PILOT** reports heading 010° at 200 kt en route from Manchester to Aberdeen at FL 150; Scottish Military, from whom he was receiving a RAS, warned him of traffic converging from the right at a similar level. The controller offered avoiding action (a turn onto NW) which he accepted. He saw the traffic which turned N when about 5 NM away and when the separation had increased he resumed heading, keeping an eye on the other ac. About 2 minutes later the controller advised that the ac was heading S. He saw it in his 12 o'clock on a steady bearing so he switched on his landing lights. Becoming concerned about the situation, they took avoiding action; the FO disconnected the autopilot and turned right at

**HQ MATO** reports that the SAAB340 was receiving a RAS from ScATCC (Mil) Console 4 (CON4) on 134.47 at FL 150. At 0915:23, CON4 transmitted "C/s traffic R 2 o'clock 20 NM crossing R to L indicating FL 150, if not sighted turn L heading 310" and the call was acknowledged by the SAAB340 pilot: "OK turning L heading 310 c/s." CON4 updated traffic information (TI) at 0916:45 "....now R 3 o'clock, crossing R to L indicating FL 140," to which the SAAB340 pilot replied "Yes we're visual with that..... Looks like it's going round behind us." When asked whether he was happy to turn back towards Aberdeen, the SAAB340 pilot replied "We'll just give it a short delay." CON4 updated TI at 0918:51, ".....due N of you 7 NM, northbound indicating FL 135." The SAAB340 pilot indicated that the crew were still visual and that the other ac was ".....doing

*some manoeuvring obviously,"* following which the SAAB340 resumed track for Aberdeen. Three min later, at 0922:21, CON4 transmitted "C/S previously reported traffic's now R 1 o'clock 10 NM crossing R to L indicating FL 140," with the SAAB340 pilot replying "Ah yes visual with that. I don't think (2 sec unintelligible) I don't think...he's higher than we are." CON4 offered a turn to the pilot, although the pilot replied "No, we're fine for the moment." CON4 advised the pilot that the other ac appeared to be climbing through FL 145, to which the SAAB340 added "...he's definitely higher than that" at 0923:14 and "Yeh c/s, this is unnecessarily close altogether." When asked by CON4, the SAAB340 pilot identified the other ac as a grey Tornado. The pilot indicated that the confliction was "...not an Airmiss in that way. We saw him and he clearly saw us, but I just think it's strange that in the open FIR he turns and flies towards us so that we have to turn away from him." The pilot went on to state that it would be raised as a point of concern with his company safety bureau.

The ATC radar recording shows the SAAB340 tracking N towards St Abbs at FL 150, with its mode 3/A squawk converted to read the C/S. The ac turns L 310° and later R 010° in response to CON4's vectoring instructions. The Tornado can be seen squawking 7000 with

Mode C, crossing the coast in the vicinity of Newton Point and when about 5 NM inland, turning northbound to parallel the coastline. In the first encounter, at 0917, the Tornado passes 4 NM to the R of the SAAB340 in a gentle descent from FL 140. At 0922:20, the Tornado is 4 NM NW of St Abbs, in a L turn passing 320° and indicating FL 139 in a climb. At this point the SAAB340 is 10 NM SSW of the Tornado heading about 010°; these positions accurately correspond with CON4's TI call at 0922:21. At 0923:10, the Tornado has steadied on a track of 185° in a climb through FL 148; both ac are now 3 NM head on, as their SSR labels begin to flash (conflict alert). The closest point of approach recorded on radar is shown at 0923:40, with both ac in a 10 o'clock position relative to each other, with the processed radar contacts partly overlapped and the Tornado's Mode C indicating FL 149 (in the previous sweep it indicated FL 150). The subsequent sweep shows the ac both in a 7 o'clock position, with the edges of the radar contacts just separating and the Tornado indicating FL 146 in a descent. Neither ac appears to alter track significantly until after they pass. (UKAB Note: The CPA is between radar returns; by interpolation the radar separation is about 0.5 NM.)

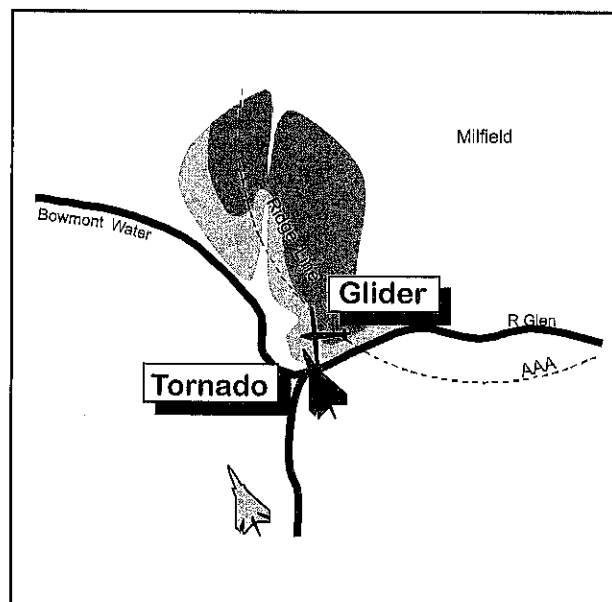
### **AIRPROX REPORT No 115/99**

**THE GLIDER PILOT** reports heading 270° at 45 kt while ridge soaring at a position on the edge of the Milfield low flying avoidance area. He saw a Tornado a few seconds before it passed on a track from his 8 o'clock to his 2 o'clock. It was about 150-200 ft ahead and below and appeared to be following the contours. He could hear a second Tornado further away on the opposite side of the valley. He thought the risk of collision was moderate. On landing he heard that a member of the public had phoned the gliding club to say he had seen a Tornado almost collide with a glider. The pilot provided time, track and height data printouts from his barometric logger.

Cause: The Tornado pilot did not see the reporting glider.

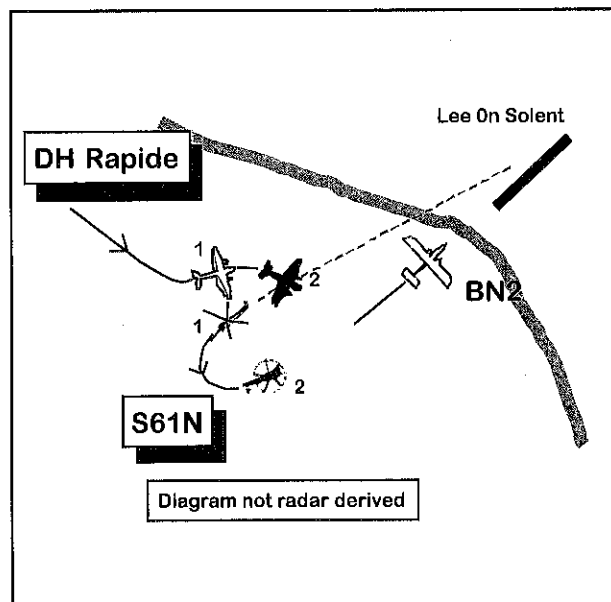
**AIRPROX REPORT No 116/99**

**THE S61N PILOT** reports that he had taken off from Lee-on-Solent airfield for a local area training flight. There was no weather and the visibility was over 20 km. Immediately after departure he was informed that an Islander was returning to Lee-on-Solent with an engine problem. He assumed his coastguard rescue callsign, co-ordinated with the Islander pilot on

Cause: Late sighting by the S61N Helicopter pilot.

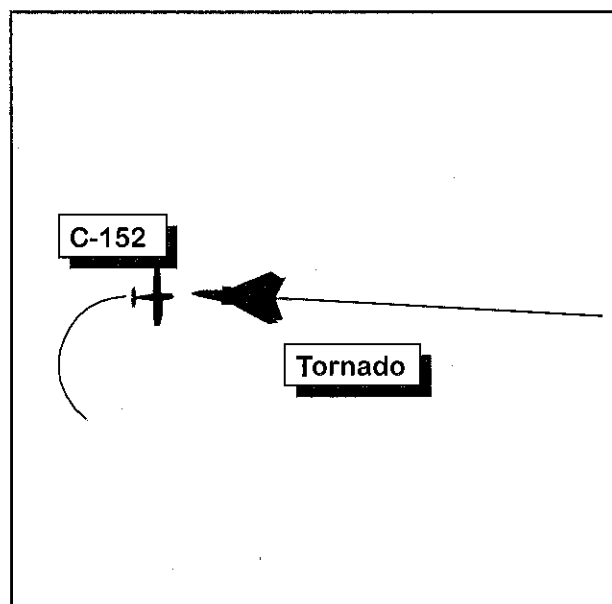
UKAB Note: LATCC radar recordings show the Cessna, identified from its Leeds/Bradford squawk turning R from NW onto E at 2000 ft Mode C as the Tornado, identified from LATCC and Linton squawks, tracks 275° directly above the Cessna at 3400 ft Mode C, at a

groundspeed of 466 kt. Its high rate of angular change as it passed the Cessna at a closing speed of some 560 kt may have given the Cessna pilot the impression that it was less than 1400 ft above him.

Cause: Mistaken impression of a lack of vertical separation by the Cessna pilot.

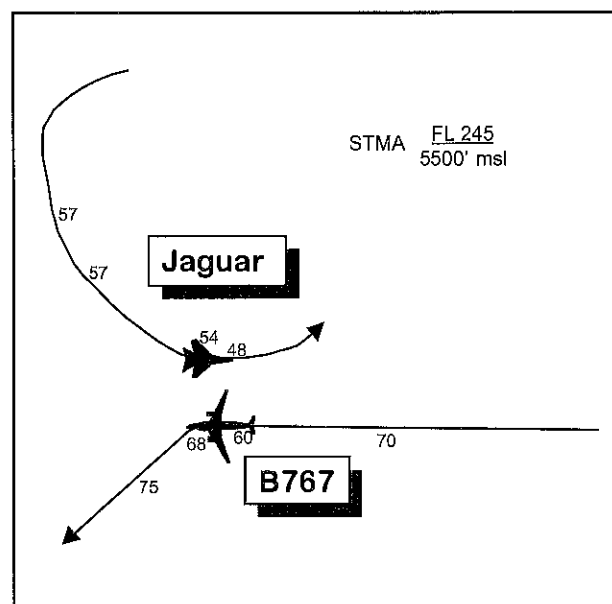
**AIRPROX REPORT No 118/99**

**THE B767 PILOT** reports heading W at 250 kt under radar control from Prestwick Approach on 120.55, maintaining 6000 ft on the Prestwick QNH in IMC and following vectors for the ILS to RW 31. He received a TCAS alert indicating traffic from the right followed 5 seconds later by a RA to climb. ATC advised of fast closing military pop-up traffic and gave avoiding action to turn left onto 210° which he followed with the

Cause: While carrying out a low level emergency weather abort, the Jaguar pilot penetrated controlled airspace.

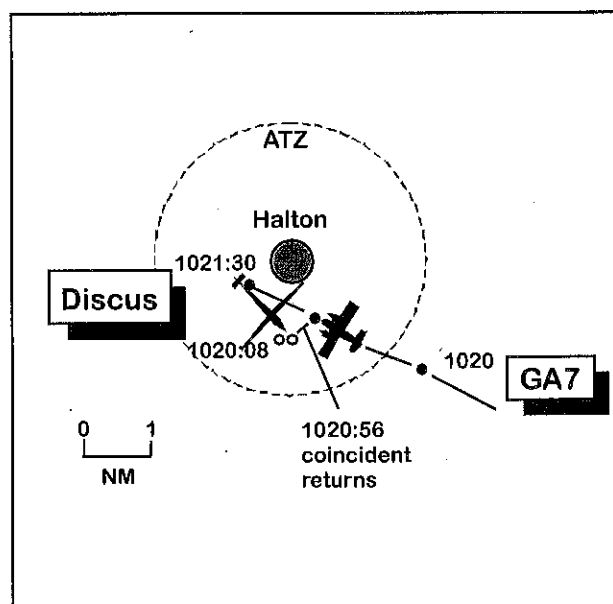
**AIRPROX REPORT No 119/99**

**THE GLIDER PILOT** reports that he was established in a stable thermal in the SE sector of the Halton ATZ and climbing in a R turn through about 1800 ft (QFE). The visibility was over 10 km in VMC. He had completed 3 or 4 turns when a low wing twin ac, Aztec or similar, appeared from the Bovingdon direction about 250 m away at the same height. He tightened up his turn to about 65° AOB and the other ac passed in a northwesterly direction down his port side less than 100 m away; it then tracked directly through the middle of the ATZ, at a speed he estimated around 120 kt, and continued towards the Aylesbury area with no apparent alteration of heading or indication that he had been seen. He felt there had been a very high risk of collision and reported an Airprox to Luton approach on 129055.

Cause: The GA7 pilot flew close to the vertical extent of the Halton ATZ and into conflict with the glider, which he did not see.

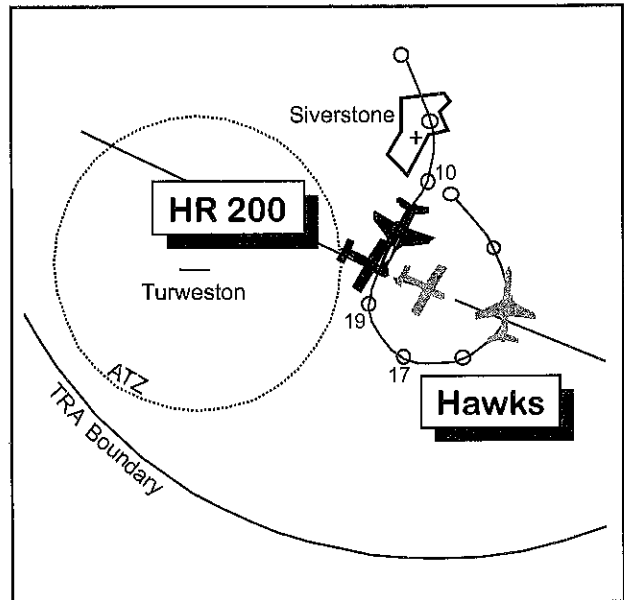
### **AIRPROX REPORT No 120/99**

**THE HAWK PILOT** reports heading S at 360 kt while leading the Red Arrows in a display at Silverstone. He was warned by Brize, from whom he was receiving a RIS, about crossing traffic so he started to reverse bank and pull up into a left wing over. The formation was nose-up and committed to a climb to 2000 ft in a left turn when a team member saw a single engine light ac 500 ft away. It was very alarming for the whole formation and there was no opportunity for avoiding action due to the late sighting. The risk of collision was very high; with the formation passing about 150-300 ft in front of the other ac. He had been receiving a RIS from Brize Norton and a TRA up to 7000 ft amsl had been promulgated out to 6 NM from the centre of the racing circuit. He added that it takes about a mile of airspace to reverse a formation turn from 60° AOB to 60° AOB the other way; this was the 4th infringement of a RAFAT TRA this year.

Cause: The Robin pilot penetrated the TRA and did not see the Hawks.

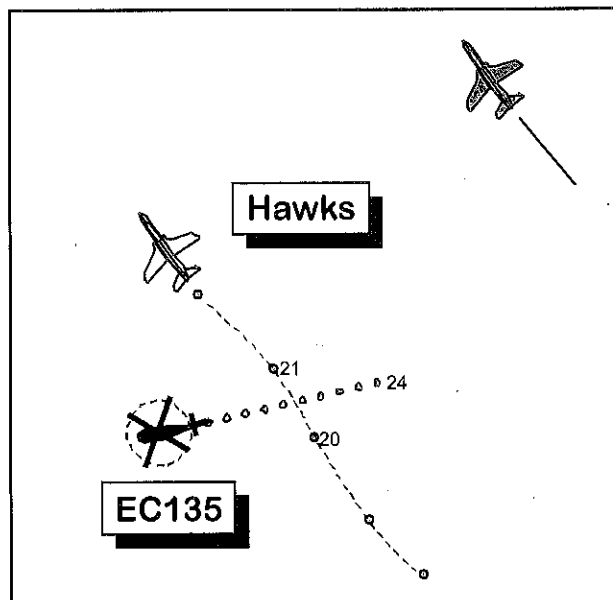
## AIRPROX REPORT No 121/99

**THE EC135 PILOT** reports heading 250° at 130 kt in a transit at 2400 ft. He had been watching a pair of Hawks for several minutes before the incident; they were manoeuvring to the S of his track and well below. TCAS had drawn his attention to them when they were 6 NM away. The Hawks then turned N and entered a climb, passing 4-500 m astern and 50-100 ft below, without making any sign of having seen him. He considered the risk of collision would have been high if the Hawk pilot had not seen him, and he only saw one of them at the time of the Airprox. He suggested that fitting TCAS to the Hawk would eliminate collision risks and added that although the equipment was a tremendous bonus, the helicopter's lack of manoeuvrability compared with a Hawk meant that even having seen a fast jet there was often not much the helicopter pilot could do about it. The TCAS in question is TCAS1 which provides traffic information only.

Cause: Sighting report.

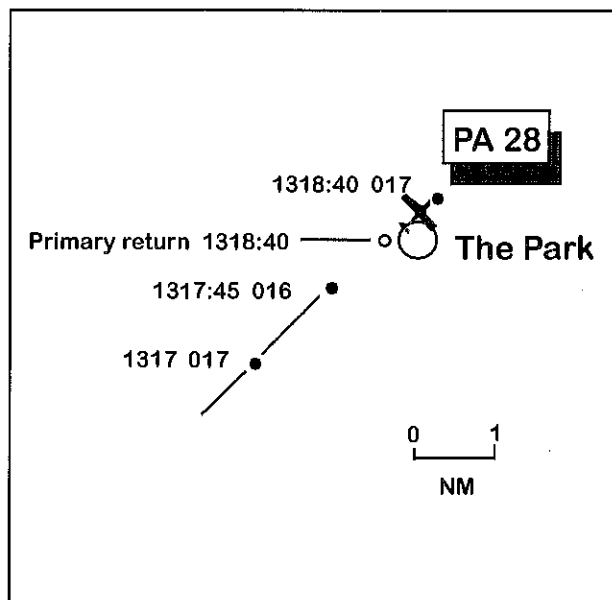
**THE GLIDER PILOT** reports that he was being winch-launched solo from The Park gliding site. The visibility, 500 ft below cloud, was 10 – 15

Cause: The PA28 pilot did not see the glider on the winch, which he flew into conflict with over a notified glider site.

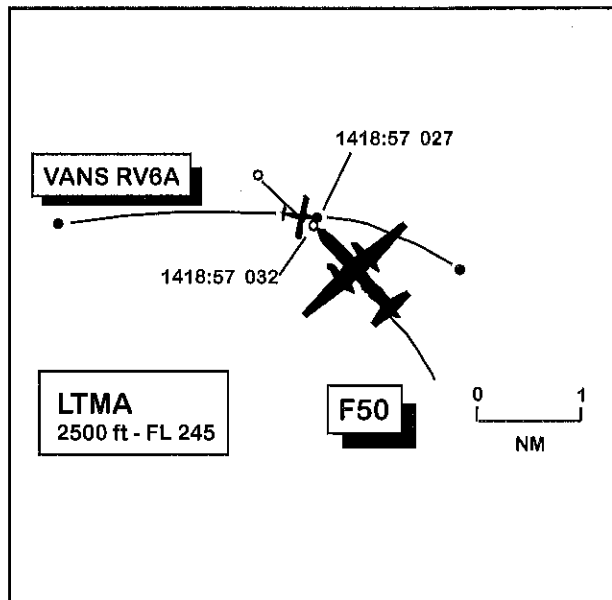
LATCC TC (NE DEPS LOREL) reports that the F50, outbound from London City to Manchester, called on the DEPS frequency at 3000 ft on the departure SID. STCA then alerted on a 7000 squawk tracking W to E without an apparent Mode C. The F50 pilot was instructed to expedite a climb to 5000 ft. Traffic information was passed and avoiding action given, though the latter was not required because the unknown return then displayed a Mode C altitude of 2800 ft (London QNH 1018mb); as the F50 was showing 3200 ft climbing at the time, vertical separation was assured and the F50 pilot was instructed to resume normal navigation.

UKAB Note (3): A replay of the LATCC radar at 1418 shows the F50 about 5 NM N of London City airport turning L through N and indicating 2900 ft Mode C. At the same time a 7000 return, indicating 2600 ft and previously observed departing from Wycombe Air Park, is heading E at the F50's 10 o'clock 5.5 NM. The F50 continues a sweeping climbing L turn towards the NW and at 1418:57, 5.5 NM WSW of LAM, the radar contacts of the ac partially merge as they pass starboard to starboard with the F50 indicating 3200 ft and the other ac 2700 ft. Lateral separation cannot be measured precisely but, as the radar returns were touching, it is likely to have been in the order of 300 m or less.

Cause: Apparent penetration of the London TMA by the VANS RV6A.

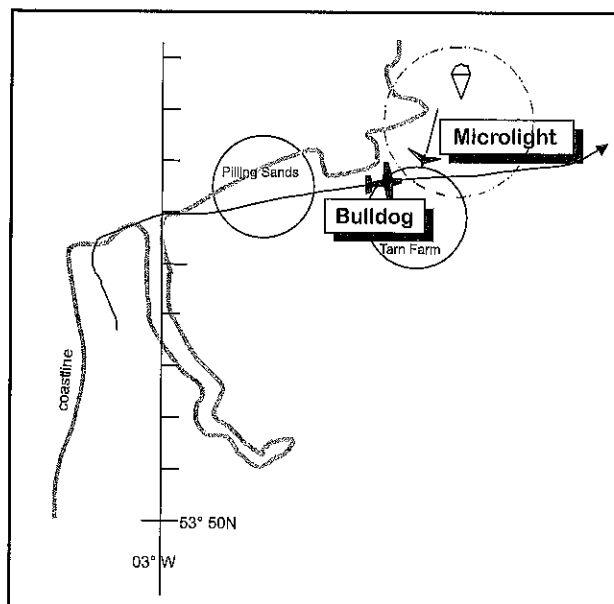
### **AIRPROX REPORT No 124/99**

**THE MICROLIGHT PILOT** reports heading 200° at 55 kt descending through 600 ft on finals to land at the Tarn Farm microlight airstrip when a military trainer ac passed right to left about 2-300 m in front and 200 ft below him. It had passed before he could react and he thought the risk of collision was fairly high. It was a single engined low wing ac, either a Bulldog or a Tucano which passed directly over the microlight site. He described its colour as 'RAF training livery.' When asked later what he meant by this, he said the ac was red and white, and thought it was probably a Bulldog.

Cause: Non-sighting of the microlight by the Bulldog pilot and the late sighting of the Bulldog by the microlight pilot.

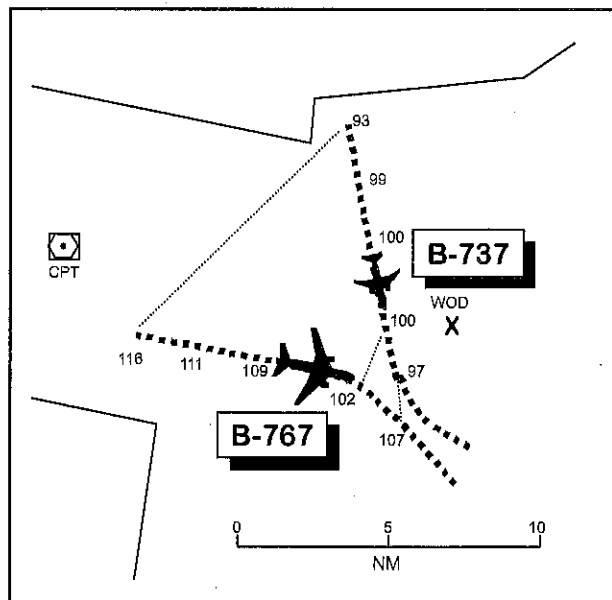
**THE B767 PILOT** reports following a 110° vector at 220 kt and had been cleared to descend from FL 140 to FL 110. He was then cleared direct to OCK and, he believed, to maintain FL 100. His FO (PNF) read back the clearance, he thought, to FL 100. While the FO was programming the FMC to take them to OCK, he selected FL 100 in the ALT window and started a descent in flight level change mode (FLCM). The FO, busy with the FMS, did not notice this. At about FL 105 the controller, sounding obviously distressed, gave him a turn of 20° to the right and told him to maintain FL 110. He started the turn and selected 'Alt Hold'. At that point he received a TCAS RA to climb at

Cause: The B767 pilot descended through his cleared level.

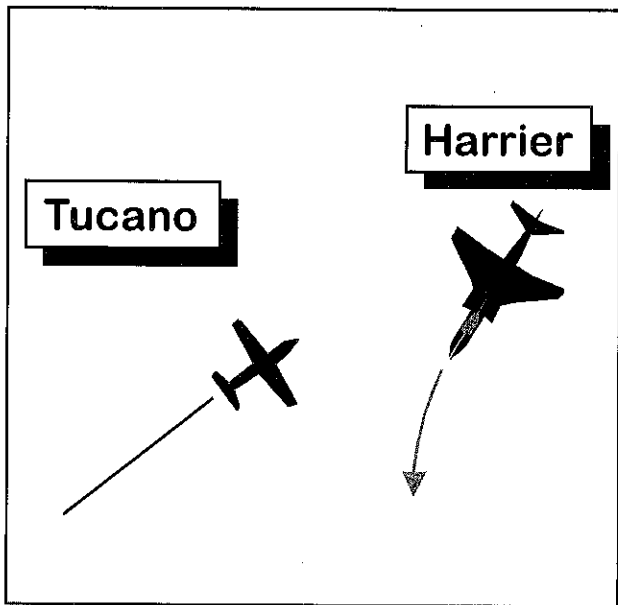
**AIRPROX REPORT No 126/99**

**THE TUCANO PILOT** reports that whilst at 250 ft MSD, heading 066° at 195 kt on a low flying training sortie, the rear-seat pilot (instructor) saw 2 Tornados manoeuvring in his 11 o'clock and another high in his 5 o'clock also tracking N. Having satisfied himself that there was no

The Board concluded that the cause of the Airprox, which contained a very high risk of collision, was a late sighting of the other ac by each pilot. This was not a criticism of their lookout (which in both cases had obviously been heightened by the knowledge that there was a lot of activity in the area) but was more a statement of fact. A 600 kt closing speed, ac camouflage and a terrain background all played a part. Added to that was an acknowledgement that lookout cannot cover 360° in 2 planes and 180° in the third simultaneously which meant that, occasionally, conflicting ac would not necessarily be seen at the instant they became visually observable objects. It appeared that the Harrier pilot had almost achieved such a sighting, but he had not seen the Tucano in time to analyse the sighting as well as take effective avoiding action.

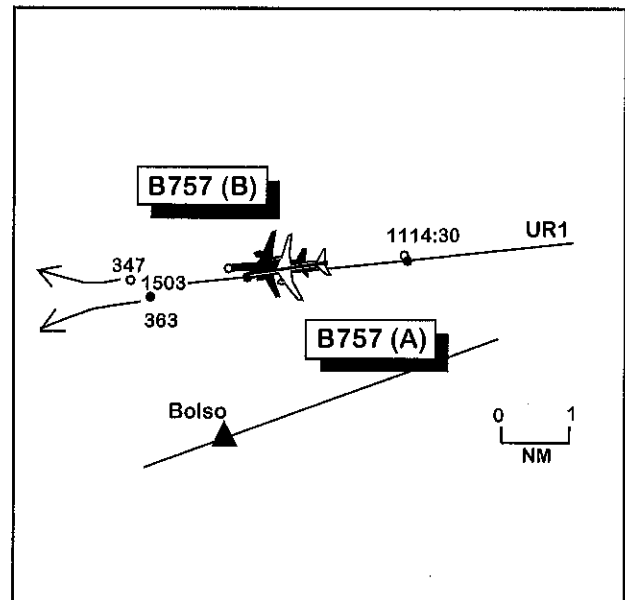
LATCC reports that all systems were serviceable. The ac involved in the incident were two B757s inbound to Heathrow, which were in the vicinity of REFSO, one at FL 350 and the other at FL 390. They were virtually coincident in plan and, as the lower B757 was on an unconverted non ORCAM code of 4117, it was displayed as a background track which was shown relatively dimly when compared with the foreground track of the ac above it, which was callsign converted. The two controllers concerned were respectively handing over and taking over the CLN sectors 13 and 14 which were combined at the time. Traffic loading was moderate to heavy and the trainee CSC, who had identified a peak in the traffic between 1115 and 1120, had considered splitting the sector. However, his mentor assessed that the traffic situation was sustainable by the combined sector.

repeat of the message. However, at 1114:27 the higher ac reported being in a TCAS climb followed immediately afterwards by the lower ac reporting a TCAS descent. Realising immediately what had happened, the controller instructed the former to turn L heading 200° and the latter to turn R heading 300°, and then passed each pilot traffic information. The ac turned expeditiously onto these headings and standard lateral separation was quickly restored. Minimum vertical separation of 1100 ft occurred at 1114:46.

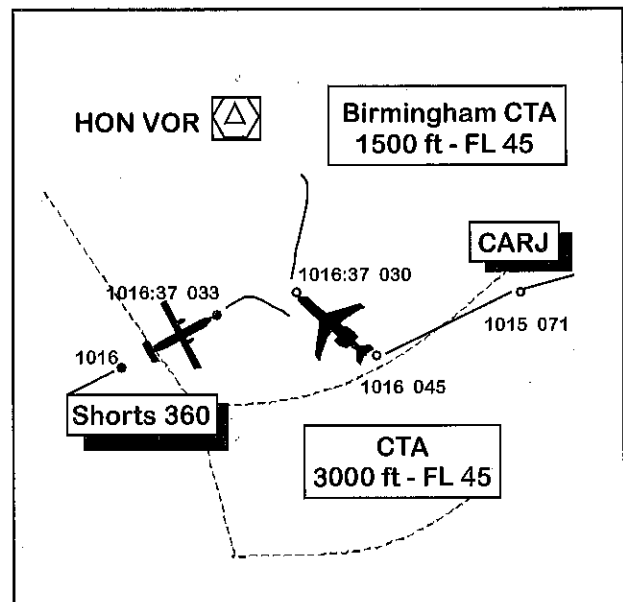
**BIRMINGHAM ATC** reports that the CARJ (Canadair Regional Jet), inbound to Birmingham from Stuttgart, reported on the RADAR DIR 2 position at 1013, descending to FL 80 and reducing speed to 250 kt. The pilot was instructed to turn L 10°, descend to FL 50 and to report the new heading, which was given as 270°. At 1014 he was instructed to turn further L heading 250° (to give more track miles

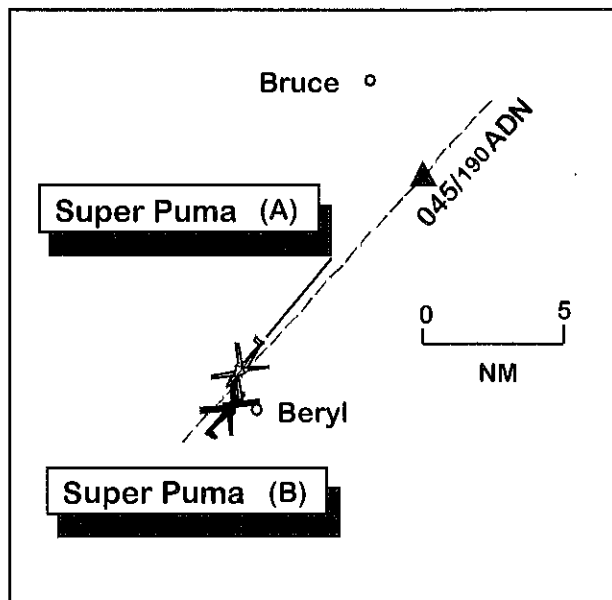
**THE SUPER PUMA (B) PILOT** reports that he was climbing to FL 50 on a heading of 060° at about 80 kt after a second missed approach from the Beryl platform; his intention was to divert to Bergen on minimum fuel. Owing to the extreme range he was unable to contact Aberdeen. On passing FL 38 he was VMC on top; when climbing through FL 45 in the vicinity of the platform he saw another Super Puma about a mile away at his 11 o'clock tracking in the opposite direction at FL 40. It passed 005

NM down his port side and 500 ft below with a low risk of collision. He then established 'two-way' contact with Sumburgh Radar who instructed him to change to Stavanger on 125.55.

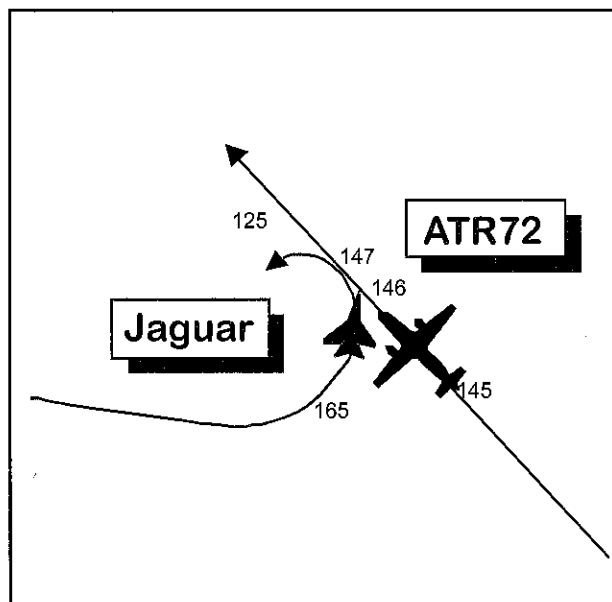
**THE ATR72 PILOT** reports heading 330° at 170 kt in an en route climb from Bournemouth to Glasgow via BCN. He was receiving a RIS from London Mil who advised him of a fast moving target on a reciprocal heading at FL 140; he was passing FL 135 at the time. He did not see it. When passing FL 145 both pilots saw a Jaguar closing fast from the port. When it was very close it began a tight left descending turn which continued to a much lower level. The Jaguar passed 1-200 m away, descending through his level as he turned hard right and pitched up. He did not assess the risk of collision.

**THE JAGUAR PILOT** reports heading NW at 500 kt while carrying out a 'wind-up turn' from FL 168 to FL 95. He did not see the ATR72. He was receiving a RIS from Boscombe Down and had been warned about traffic 10 NM to his SE while heading 105° at 400 kt, climbing through

FL 145. 20 seconds later while passing FL 158 and heading 095 he received a second call advising that the traffic was 6 NM to the E. He visually cleared the area ahead and to the left and then started his manoeuvre. During the turn he concentrated his lookout on his intended flightpath and saw no other ac.

Cause: The Jaguar pilot did not see the ATR72.

Having said that, the Board agreed that the cause of the incident lay primarily with the Jaguar pilot who had flown very close to the ATR72 without seeing it. In particular members noted that he had not assimilated the traffic information given to him or asked for more detail before carrying out a manoeuvre into an area where he should have expected to encounter the traffic he was being warned about. It was suggested that with the nature of the exercise being performed, it was easy to become task oriented and unconsciously to exclude distracting information. However, members agreed that if a RIS was being used, then the onus was on a pilot to pay attention to the information he was being given and to ask for more if there was a possibility of any sort of conflict. In this incident the Jaguar pilot could have delayed the onset of his manoeuvre for a few seconds until advised the traffic was clear.

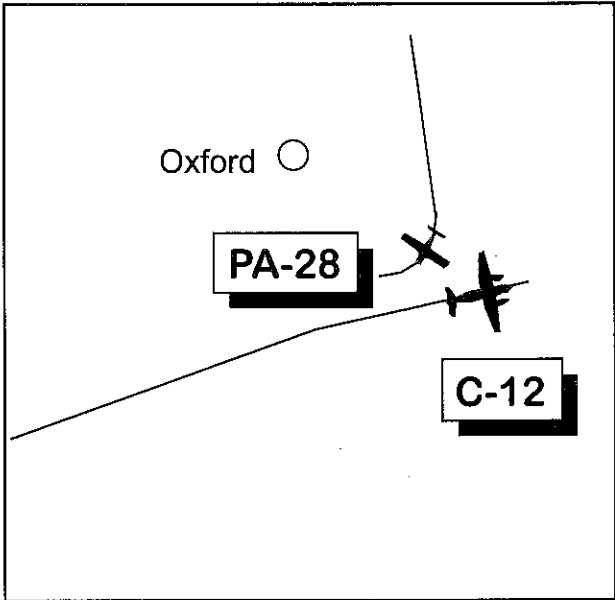
Date/Time: 21 Jul 0812  
Position: N5150 W0117 (1.5 NM SE of Kidlington - elev 270 ft)  
Airspace: FIR (Class: G)  
Reporting Aircraft Reported Aircraft  
Type: PA28 C12  
Operator: Civ Trg Foreign Mil  
Alt/FL: FL 55 FL 60

Weather IMC IICL VMC CLBL  
Visibility: 4 km  
Reported Separation:  
200 ft, 400 m/0.25-0.5 NM  
Recorded Separation: 0.25 NM, 100 ft

**THE PA28 PILOT** reports heading 190° at 100 kt on the outbound leg of the RW 20 hold at the OX NDB, descending through FL 55 to FL 50 between banks of cloud and receiving a procedural approach service from Oxford ATC. A T-tailed twin either came out of or from behind a cloud in his 2 o'clock, straight through the area of the hold, passing right to left across his nose 200 ft below and 400 m in front. He immediately reported an Airprox.

Cause: The C12 pilot flew close enough to the PA28 to cause its pilot concern for the safety of his ac.

In this incident, the C12 pilot had seen the PA28 from 1 NM away and although he turned to avoid it, removing any risk of actually colliding with it, members considered he could have turned further to remove any impression of a collision risk. While the incident was not much more than a confliction of flightpaths resolved by the C12 pilot, the Board agreed that the C12 pilot had flown close enough to the PA28 to cause its pilot concern for the safety of his ac.

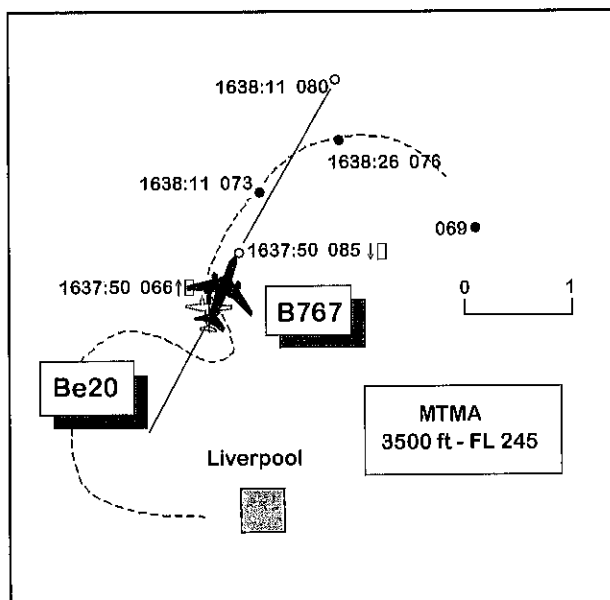
## AIRPROX REPORT No 132/99

Date/Time: 22 Jul 1638  
Position: N5322 W0252 (2 NM NW  
Liverpool airport)  
Airspace: MTMA (Class: A)  
Reporter: Manchester TMA W  
First Aircraft Second Aircraft  
Type: B767 Beech 200  
Operator: CAT Civ Exec  
Alt/FL: ↓ FL 60 ↑ FL 70  
Weather VMC VMC  
Visibility:  
Reported Separation: 1.5 NM/300 ft  
Recorded Separation: 1.5 NM/400 ft

The **MANCHESTER TMA W RADAR CONTROLLER** reports that he was acting as mentor to an advanced ab-initio trainee. The B767 was inbound to the MIRS1 hold and had been given descent clearance to 6000 ft. Meanwhile, the BE20 was climbing out from Liverpool on a Stock 2T SID and reported on the Manchester radar frequency (125.1). The descent clearance to the B767 was then amended to FL 80, which the pilot acknowledged, and the BE20 was instructed to fly a radar heading of 120° and to climb to FL 70, which was also acknowledged. Shortly afterwards the STCA activated, but this was not unusual in such circumstances. Seeing that the BE20 had not turned onto 120°, the trainee controller instructed its pilot to turn further R onto 160°. By this time the data blocks of both ac were garbling, but the level displayed in the conflict alert box for the BE20 indicated FL 77. The trainee controller immediately instructed the pilot to descend back to FL 70 (UKAB Note (1): the RT recording for 125.1 shows that the controller used the correct avoiding action phraseology when issuing this instruction). The BE20 pilot responded that he was already descending to FL 70. Minimum separation was believed to be in the order of 1.5 NM and 300 ft.

The root cause of this Airprox was readily apparent to the Board; it stemmed from the BE20 crew climbing above their assigned level. What was not so clear was why this had occurred and undoubtedly the lack of a report from the BE20 captain did not enable a complete picture to emerge. From the information supplied in the letter from the BE20 (PF) there would appear to have been a significant breakdown in crew co-operation and crew resource management. Clearly the TMA W Controller had issued the turn instruction onto 120° which the PF reports acknowledging and complying with. However, this appears to have been countermanded by the ac captain, the PNF, who, having misinterpreted the heading instruction as 020°, assumed the PF was wrong and instructed him to fly an erroneous heading. This stressful situation apparently distracted the PF who consequently exceeded his cleared level. Members of the Board sympathised with the difficult situation which confronted the PF, but were critical that the heading was not re-checked with TMA W when it was questioned by the PF. They wondered if this was indicative of inadequate crew resource management techniques. One member informed the Board that the CAA required those with a UK AOL to provide comprehensive CRM training through CAA approved courses.

Cause: Following a breakdown in crew co-operation, the BE20 climbed above its cleared level into conflict with the B767.

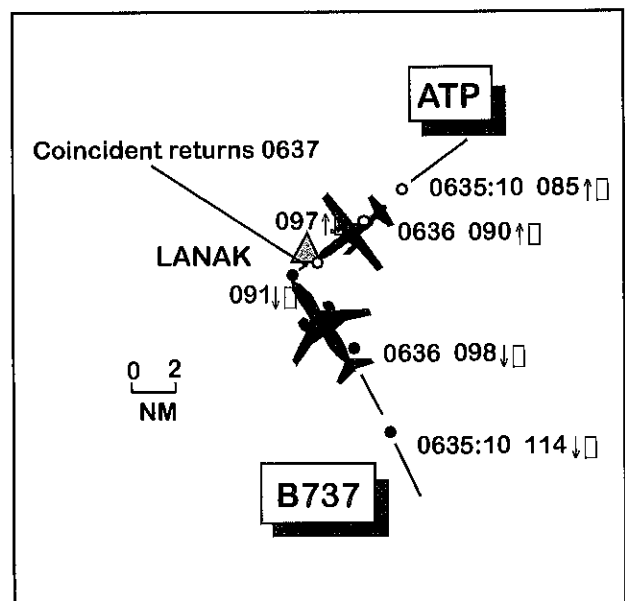
Date/Time: 23 Jul 0637  
Position: N5542 W0356 (LANAK)  
Airspace: TMA (Class: D)  
Reporter: SCACC

<u>First Aircraft</u>	<u>Second Aircraft</u>
<u>Type:</u>	ATP	B737
<u>Operator:</u>	CAT	CAT
<u>Alt/FL:</u>	↑ FL 120	↓ 5000 ft (QNH)
<u>Weather</u>	VMC	VMC
<u>Visibility:</u>	good	60 km
<u>Reported Separation:</u>	2.3 NM/100 ft/2 NM /600 ft	
<u>Recorded Separation:</u>	1.4 NM/600 ft

ScACC reports that the B737 had been under the control of the Talla Sector who had instructed it to descend to be level at FL 70 by LANAK. However, at the time of the incident, the flight was under the control of Glasgow Radar. The ATP had been instructed to climb straight ahead off RW 24 at Edinburgh and, although within the confines of the Talla sector, was under the control of Galloway and climbing to FL 120. Separation was lost as the B737 passed L to R in front of the ATP at a similar level.

Cause: The TALLA Executive Controller did not ensure standard separation between the subject ac before transferring each to separate agencies.

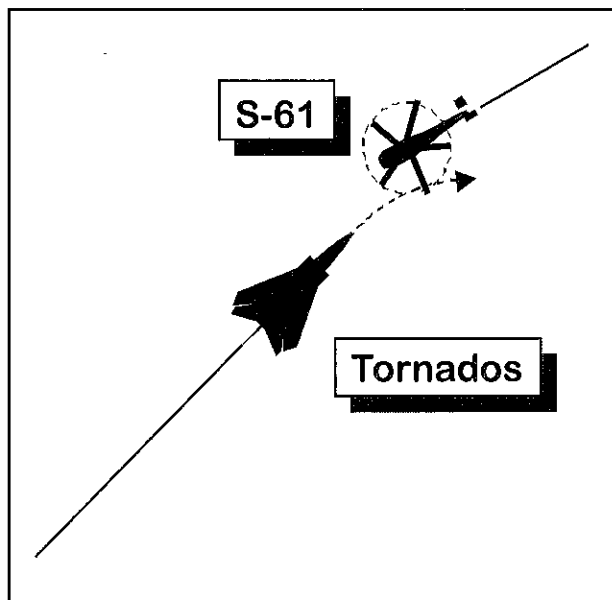
**THE S61 PILOT** reports heading 240° at 110 kt en route between Aberdeen and Benbecula at 700 ft agl when he saw a Tornado approaching from about 3-4 NM ahead. It altered course to the right passing 200 ft away and less than 100 ft above and a second Tornado, 60-90 sec behind the first, passed below and to his left rocking its wings as he turned to the right. There was a low to moderate risk of collision.

The incident occurred in a valley marked on the LFC as a helicopter route through the HRA so members thought that the Tornado pilot should not have been surprised to find a helicopter there. Members discussed whether the cause of the Airprox was late sightings by both parties, but the helicopter pilot had seen the Tornado

Cause: Conflict of flightpaths resolved by the Tornado pilot.

**THE S61 PILOT'S COMPANY** advised UKAB that there was no particular reason for the S61 to have been flying at low level on the sortie in question. The FSO said he would issue a bulletin advising pilots on such overland routes

to fly above 1000 ft unless there were overriding reasons to fly lower.

Members noted and agreed with the comments of the S61 pilot's company. While there was no regulation to bar a helicopter pilot from flying where he was at that level, and on a fine day such a transit through majestic scenery had much to recommend it, a higher transit would undoubtedly reduce the chance of a dangerous encounter with a fast jet on a low level task.

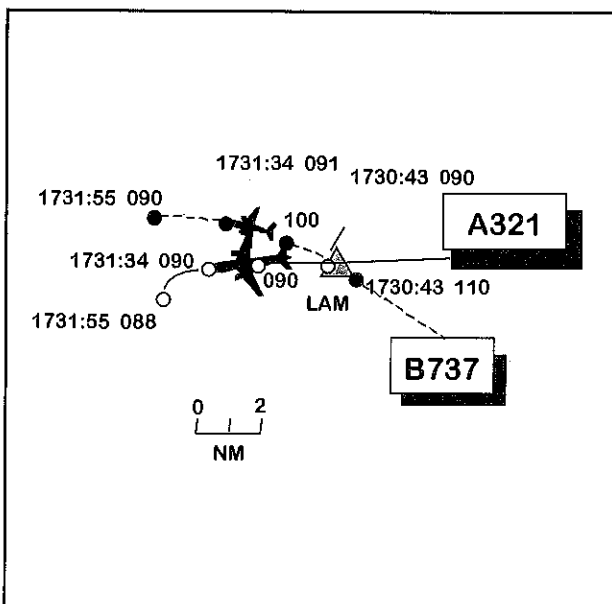
Date/Time: 13 Jul 1731  
Position: N5139 E0005 (2.5 NM W LAM)  
Airspace: LTMA (Class: A)  
Reporting Aircraft Reported Aircraft  
Type: Airbus A321 B737-300  
Operator: CAT CAT  
Alt/FL: FL 90 ↓ FL 90

Weather VMC  
Visibility: 10 km  
Reported Separation: 1 NM/same level  
Recorded Separation: 1 NM/600 ft

**THE AIRBUS PILOT** reports that he was on a radar vectored heading of 270° at 220 kt having left the LAM VOR at FL 90 under the control of the Heathrow DIRECTOR. When about 5 NM W of the VOR, a TCAS TA was received on traffic indicating 800 ft behind and above him, descending. The TA indication reverted to normal but then ATC instructed him to turn L onto 180° and advised him that there was

It was evident to the members that one of the major cause factors in this Airprox was RT difficulty. The instruction addressed to the B737

Cause: The B737 pilot reacted to a descent instruction not addressed to him and flew into conflict with the Airbus.
