**UK AIRPROX BOARD**

**Analysis of  
Airprox in UK Airspace**  
Report Number 3  
July 1999 to December 1999

Report by the UK Airprox Board,  
'Analysis of Airprox in UK Airspace'  
(July 1999 to December 1999)

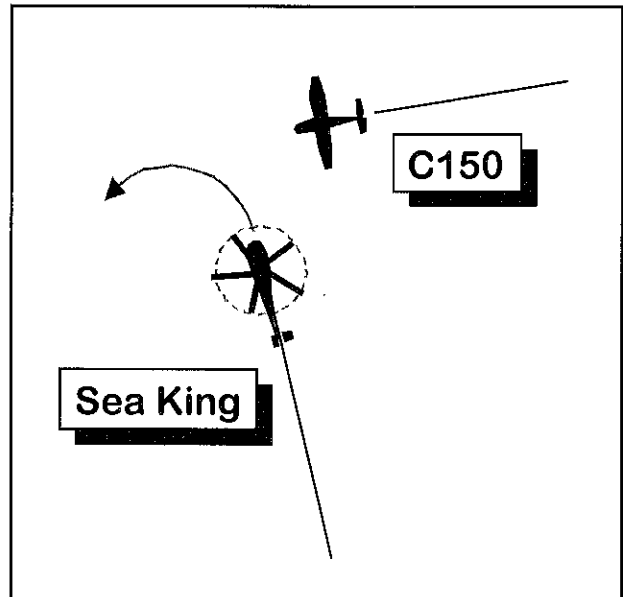
**AIRPROX REPORT No 137/99**

Date/Time: 26 Jul 1415  
Position: N5016 W0500 (10.5 NM S of St Mawgan - elev 390 ft)  
Airspace: FIR (Class: G)  
Reporting Aircraft Reported Aircraft  
Type: Sea King Cessna 150  
Operator: HQ FONA Civ Pte  
Alt/FL : 2500 ft 2700 ft  
 (RPS 1015 mb) (QNH)  
Weather IMC CLBH VMC CLNC  
Visibility: 10 km+ 15 km  
Reported Separation: 500 m/300 m  
Recorded Separation: NK

**THE SEA KING PILOT** reports heading 330° at 90 kt, level at 2500 ft RPS and receiving a RIS from St Mawgan on UHF while about to start a PAR on an IF training sortie; the PF was in the RHS under visor and PNF (safety pilot) was in the LHS. He was given information about civilian traffic 11 NM to the NE at 3000 ft and elected to continue on track due to its range. A further call indicated it had closed to 1 NM and the captain terminated IF simulation immediately to look for it. He saw a light ac 1000 yd away at the same level and turned steeply left through 360° and descended to avoid it. He then regained sight of it; it did not appear to have deviated. There had been a

Cause: Late sighting of the other ac by both pilots.

Members agreed that the cause of this encounter was a late sighting of the other ac by both pilots. Members with some surprise learned that in the Sea King the safety pilot was not the captain, which seemed a less than ideal arrangement. Sitting in the LHS the safety pilot would have had a less clear view in the direction of the advised traffic but as captain he might have been more inclined to incorporate a lookout turn into the IF training task.

The Cessna's radio problems added to St Mawgan ATC's difficulties at a crucial stage; the pilot appeared to be aware that his RT was substandard. The GA members hoped that the fault had been reported and dealt with after landing and not just been accepted as a known problem with that ac. Faulty radios can be a flight safety hazard.

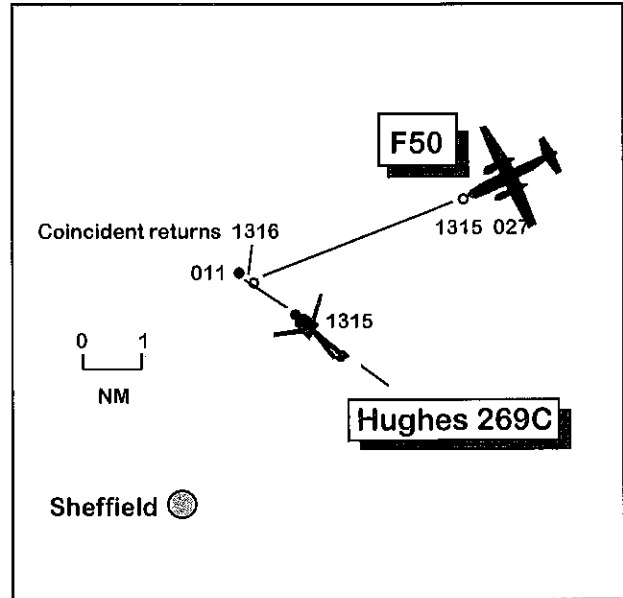
**AIRPROX REPORT No 138/99**

Date/Time: 27 Jul 1316  
Position: N5327 W0126 (305 NM NNE Sheffield)  
Airspace: FIR (Class: G)  
Reporting Aircraft Reported Aircraft  
Type: F50 Hughes 269C  
Operator: CAT Civ Pte  
Alt/FL: 1500 ft 1500 ft  
(QNH 1026 mb) (QNH 1026 mb)  
Weather VMC VMC CAVOK  
Visibility: >10 km 10 km  
Reporting Separation:  
0.5 NM/0 ft V 1 NM/0 ft V  
Recorded Separation: <0.5 NM

premature so decided to remain with Sheffield. There were only 3 ac on the frequency at the time including the F50, whose pilot he heard being advised of traffic transiting overhead the airfield; no information was passed to the F50 pilot about the subject helicopter. While heading 310° at 75 kt and level at 1500 ft (QNH 1026) in CAVOK conditions, the F50 passed from R to L behind him at the same level about 1 NM away. Avoiding action was unnecessary as the ac was already passing him when he first saw it; nevertheless, he felt there had been a high risk of collision.

Cause: A conflict in the FIR resolved by the F50 pilot.

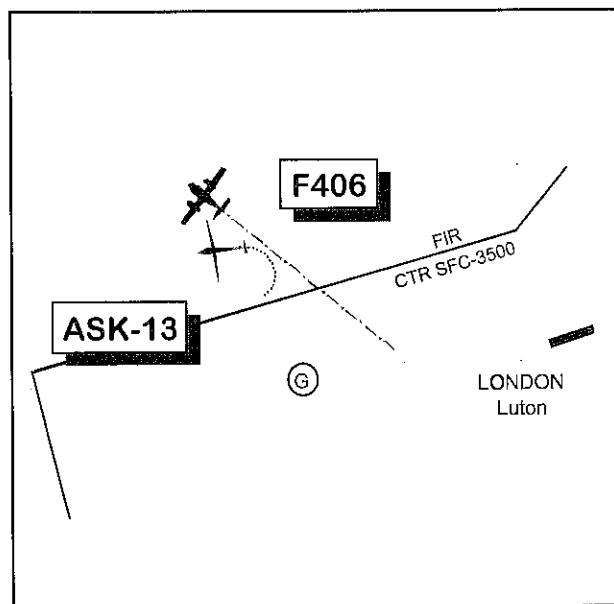
**AIRPROX REPORT No 139/99**

Date/Time: 27 Jul 99 0936  
Position: N5155 W0033 (3 NM N of Dunstable Down glider site - elev. 500 ft)  
Airspace: London FIR (Class: G)  
Reporting Aircraft Reported Aircraft  
Type: K13 Glider F406 (Caravan II)  
Operator: Civ Trg Civ Comm  
Alt/FL: 2400 ft 2400 ft  
 (QNH) (QNH 1024)  
Weather VMC CLBC VMC  
Visibility: NK  
Reported Separation: <2-300 m  
Recorded Separation: NK

**THE K13 GLIDER PILOT** reports that he was descending from 2500 ft (QNH) after release from an aerotow in a clearing L turn at a TAS of 40 kt, just before the commencement of a spinning exercise. During the turn both occupants of the glider were alerted to the

Given the apparent geometry of the encounter, the Board believed that a late sighting by the glider pilot was not unreasonable in the circumstances that pertained. Furthermore, they noted the F406 pilot’s revised recollections in that he had agreed the K13 glider he saw may have been in a L turn and not R as he originally reported. A CAT pilot member, who is also an experienced Glider pilot, reaffirmed that this was indeed a very busy and popular glider flying area. Moreover, he explained to the Board that when released from an aerotow the normal procedure is for the tug to turn to the R and the glider to the L, as in this instance. Nevertheless, it was reported that no other K13 gliders were airborne from Dunstable Down at the time of the Airprox. There remained a remote possibility that the F406 pilot had seen another K13 and not the subject glider, but given the intervening period between the occurrence and the reported pilot’s report, this was discounted by the Board who were satisfied that the subject ac had been identified. Therefore, members agreed that the F406 pilot had flown sufficiently close to cause the glider pilot concern and this was the cause of the Airprox. However, as the F406 pilot had spotted the glider at a range of 3-4 NM and had been able to monitor the situation throughout,

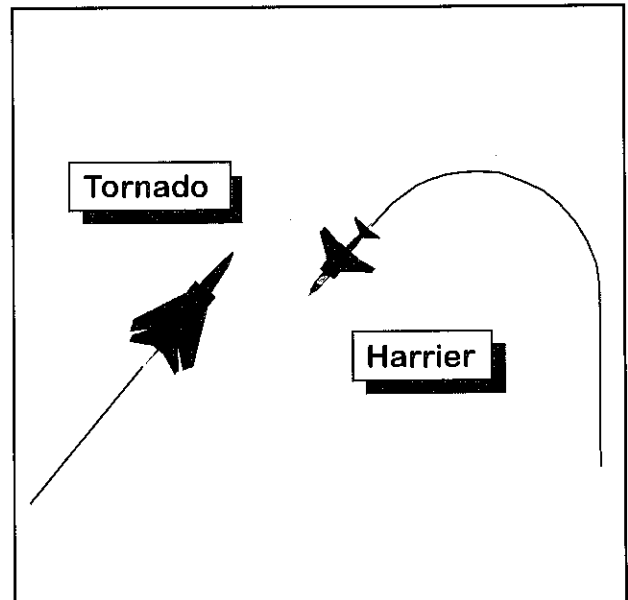
### **AIRPROX REPORT No 140/99**

Date/Time: 28 Jul 1448  
Position: N5159 W0240 (3 NM SE of Hereford)  
Airspace: LFS (Class: G)  
Reporting Aircraft Reported Aircraft  
Type: Harrier Tornado GR  
Operator: HQ STC HQ STC  
Alt/FL: 300 ft 500 ft  
(Rad Alt) (Rad Alt)  
Weather VMC CLNC VMC CLNC  
Visibility: 20 km 20 km+  
Reported Separation: 30-50 m/1000 ft H  
Recorded Separation: NK

**THE HARRIER PILOT** reports flying as part of a formation but split up by 5 NM for IP target runs. While heading N at 450 kt he saw a Tornado cross left to right 2 NM ahead doing what looked like a loft attack. Shortly afterwards he began a planned left turn onto 230° whilst searching for a possible second Tornado. On rolling wings level he glanced in for 0.5 to 1 second to check his position and track on his map display and, on looking up, was aware of a grey ac passing very close (30-50 m) down his right side at the same level; it was in sight for too little time for him to identify it. With no time for avoiding action, the risk of collision was very high.

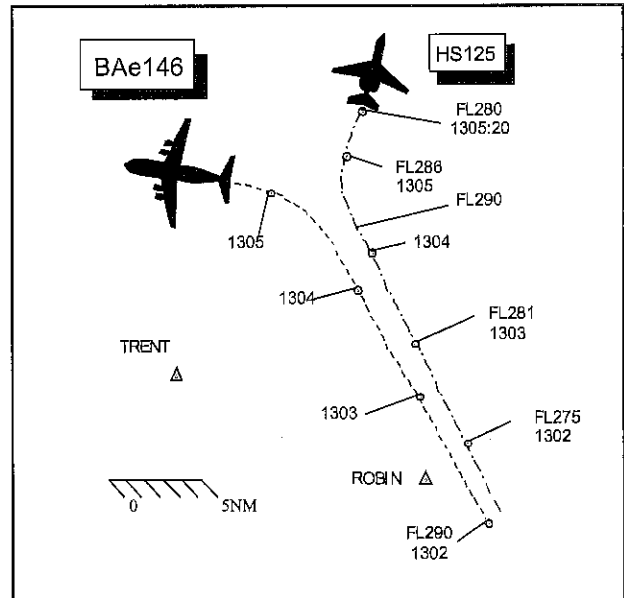
Date/Time: 29 Jul 1304  
Position: N5311 W0125 (11.5 NM NE of TRENT)  
Airspace: UAR UB4 (Class: B)  
Reporter: LATCC - LAKES S3 Sector Controller  
First Aircraft      Second Aircraft  
Type: HS125              BAe146  
Operator: Civ Pte              CAT  
Alt/FL: FL 290              FL 290

Weather      IMC CLBC              VMC  
Visibility: 8km  
Reported Separation:  
1.76NM Horizontal  
Recorded Separation: 1.9NM Horizontal

**THE LATCC LAKES S3 RADAR MENTOR** reports that he had just taken over the Sector as OJTI with a trainee, when the HS125 crew reported in on the Sector frequency climbing to FL 280, heading 350°; the trainee instructed the crew to turn L heading 335° and climb to FL 290. The BAe146 crew (shown erroneously as a SAAB2000 on the FPS) then checked in on the frequency, reported level at FL 290 and also heading 335°. The Mentor then concentrated his attention on six other ac on the sector, all at FL 310, of which 3 were in potential conflict. His attention was subsequently drawn back to the HS125 and BAe146 by the STCA, the respective SSR labels were flashing but the Mode C was garbled, so the levels were not readily apparent. Upon realising that the HS125 and BAe146 were in conflict he took over the RT from the trainee (after the latter had issued a L turn onto 310°) and instructed the BAe146 pilot to turn L onto 290°; he then instructed the HS125 pilot to turn R onto 020° and to descend to FL 280. He did not recall using the phrase 'avoiding action'. Standard separation was subsequently re established between the subject ac.

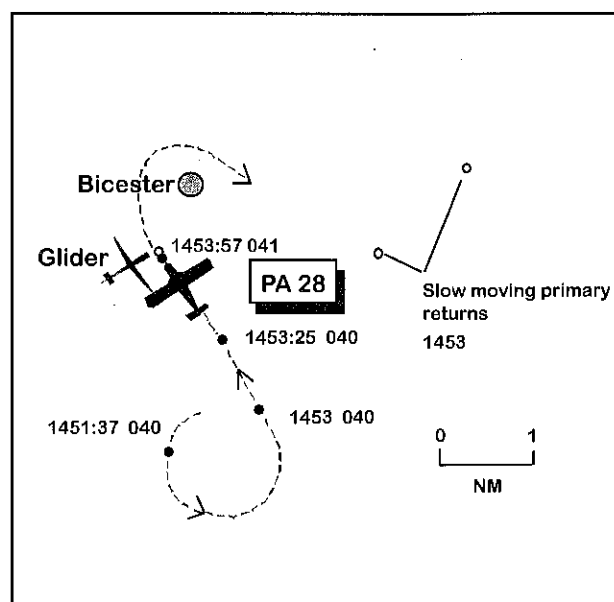
Reported Separation:  
0 ft H/100 ft V >0.5 NM/6-800 ft V

Recorded Separation: not seen

**THE DISCUS PILOT** reports that she was thermalling in a R turn in the vicinity of Bicester town at about 3800 ft (QFE) and 45 kt, and in contact with Bicester radio on 129.975. The visibility, flying out of sun, was over 40 km in VMC. Although keeping a good lookout, she did not see a white/orange low wing single engined ac until it passed about 100 ft directly over her from R to L. She was able to read the first and last two letters of the ac's registration. There had been no time to take avoiding action and she felt there had been a possible risk of collision. She believes that the other pilot had not seen her at all.

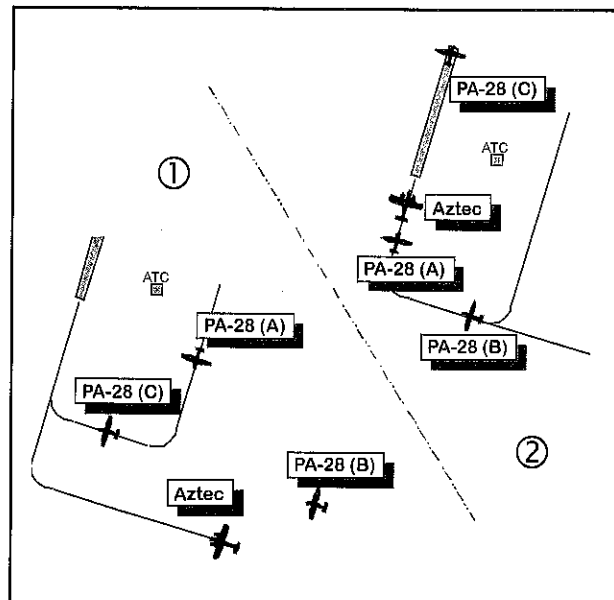
## AIRPROX REPORT No 143/99

**Date/Time:** 30 Jul 1530  
**Position:** N5148 W0119 (2 NM S of Oxford  
Apt - elev 270 ft)  
**Airspace:** ATZ (Class: G)  
**Reporting Aircraft** **Reported Aircraft**  
**Type:** PA28 (A) PA23 Aztec  
**Operator:** Civ Trg Civ Comm  
**Alt/FL:** 500 ft ↓ 500 ft  
(QNH) (QFE)  
**Weather** VMC CLOC VMC CAVK  
**Visibility:** 10 km 10 km+  
**Reported Separation:**  
< 25 m/1 NM, 1000 ft  
**Recorded Separation:** NK

**THE PA28 (A) PILOT** reports that having taken off and flown a normal circuit, he was heading 020° at 70 kt on finals to RW 02 at Oxford. He was aware of one ahead and one to join right base which was well out of the circuit. After he had turned and called final, ATC asked another pilot if he was visual with his PA28; the other pilot replied negative and was sent around. He then saw this ac, a twin, appear in a climb from below his nose; it climbed through his level about 25 m ahead with its gear retracting. Although separation was increasing when he saw it, he considered the risk of collision was high. In a later telephone conversation the reporting pilot added that his student, on a solo check, had flown a normal circuit at 1200 ft until the base turn and descended fairly steeply on base leg, as is required to achieve a normal glidepath on final. The circuit was well flown on the normal circuit track, and he had concluded that his presence in the ac would no longer be necessary when the Aztec made its sudden appearance. It was diverging slightly to the right of his track so its wake was not encountered. As to its range from him; he was used to rifle shooting at 25 and 50 m ranges and was confident in his estimation of 25 m.

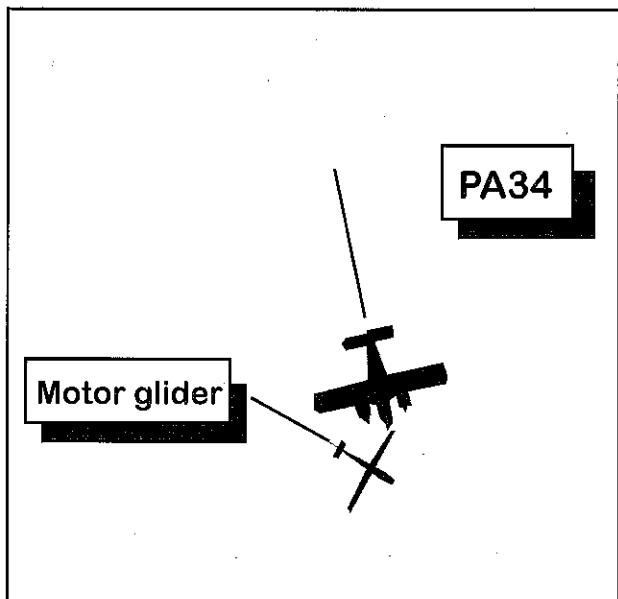
**THE SUPER DIMONA** motorglider pilot reports that he was flying about 2 NM NE of Chipping Norton with a student pilot on a local flight from Enstone. The visibility, 4000 ft below cloud, was about 15 NM. Having climbed up from Enstone, he had switched off the engine and was descending in glide mode with transponder and radio off to conserve battery power. At 1119 BST, when heading about 120° at 60 kt and descending through FL 34, he saw a red and white Piper Seneca about 3000 ft away as it approached from his L on a southerly heading at about co-altitude. He immediately dived in avoidance and the ac passed about 150 ft away with a high risk of collision. After landing he reported an Airprox to the UKAB. The pilot

comments that vision to the L had been obscured by the pupil in the LH seat.

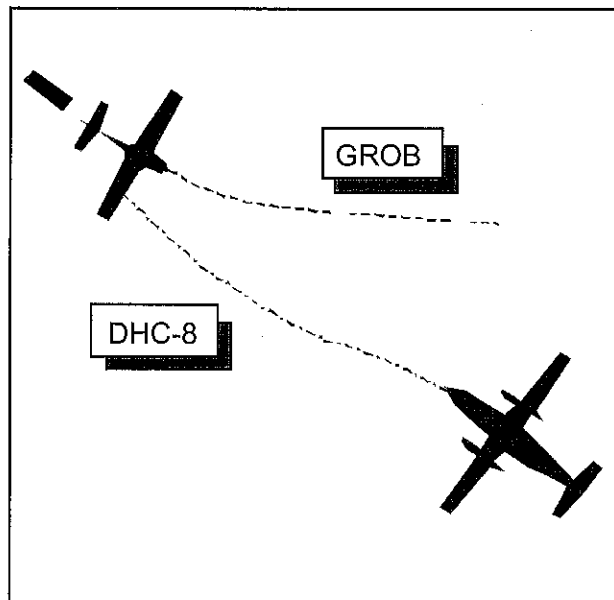
Reported Separation: 0.5 - 1 NM/0.5 NM

Recorded Separation: Not recorded

**THE DHC-8 PILOT** reports heading 310° at 120 kt on a visual approach to RW 31 at Plymouth City Airport. A Grob ac was sighted as it turned L at a range of about 2 NM and which subsequently passed down the STBD side at a range of 0.5 – 1 NM in a slight right bank. A TCAS TA was received. The DHC-8 was turned slightly L to increase horizontal separation and a normal visual approach resumed to landing. He considered the risk to be low.

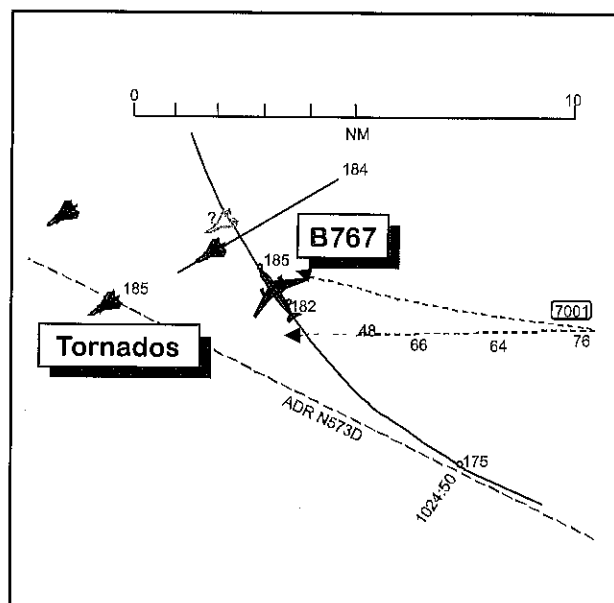
Reported Separation: 100 ftV, 2000 ft H

Recorded Separation: 0.85 NM

**THE B767 PILOT** reports heading 290° at 310 kt, climbing from Glasgow en route to N America, receiving a RAS from ScOACC on 127.275 and cleared to FL 250. At about FL 190 he was warned of traffic closing from the right at a similar level. It appeared that this traffic was not identified or in communication with ScOACC who then directed him to turn 90° right for separation. At this time traffic appeared on TCAS indicating slightly above and to the right; a TCAS RA (climb) followed with which the crew complied. The crew then saw 2 flights of 2 ac which flew through their flightpath directly ahead and while they were complying with the avoiding action; the second pair (of Tornados) was very close, passing 2000 ft away and 100 ft above.

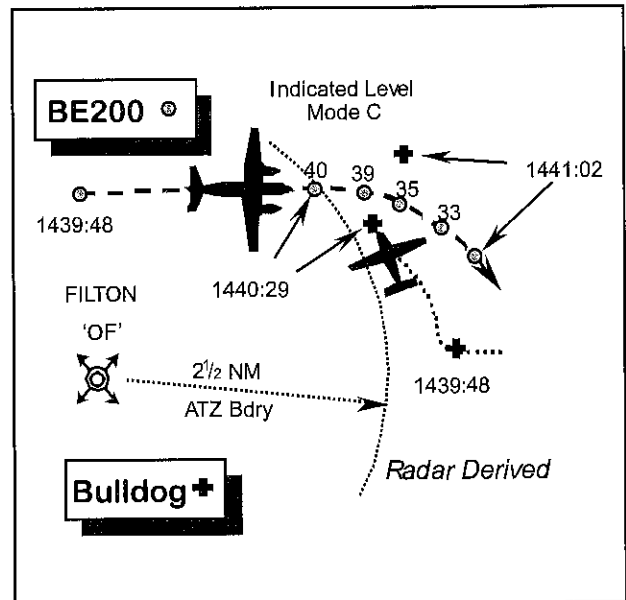
**THE BEECH 200 PILOT** reports flying at FL 40, 140 kt whilst in receipt of a RIS from Filton Approach and squawking the assigned code with Mode C. The ac colour scheme was white and blue and HISLs and anti-collision beacons were illuminated; the ac was not fitted with TCAS. Whilst heading 095 (T)<sup>o</sup> in the hold for RW 09 at Filton, a Bulldog ac was sighted crossing ahead in level flight from R to L, at the same level. A descent was executed to avoid the other ac and the minimum horizontal separation was about 3-500 ft. An Airprox was subsequently filed with Filton Approach. She adds that it was an IR renewal flight and if the IF screens had been in place, the crew of two would not have seen the Bulldog at all.

**THE BULLDOG PILOT** reports flying at FL 38, 110 kt whilst conducting a dual air experience sortie and in communication with Colerne Approach on 277-275. The assigned squawk of 3/A 4576 was selected with Mode C; his ac colour scheme was red/white and HISLs were on. Whilst heading 330<sup>o</sup> a low-wing twin was first sighted at L 9 o'clock at a range of 400 m, heading about 070<sup>o</sup> at the same level. The 'twin' passed astern and slightly below, descending wings level; it was impossible to

estimate the relative distances at the CPA. A climbing turn to the right was initiated, even without this minimal avoiding action there was no risk of a collision. Colerne Approach subsequently advised that an Airprox had been filed.

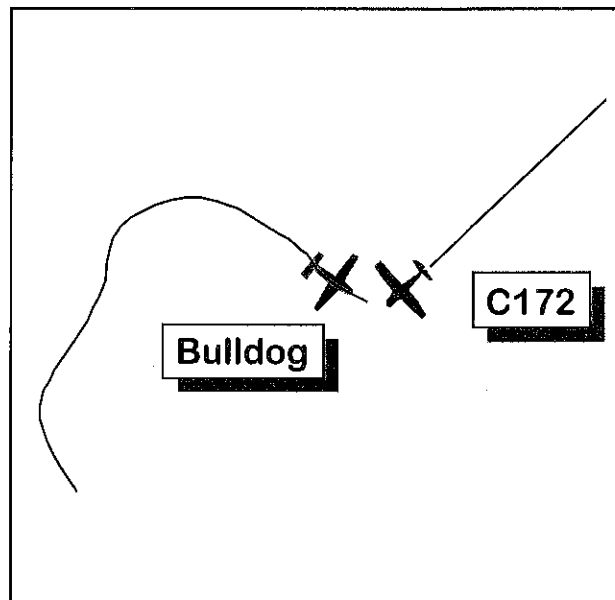
Reported Separation: 150 m/200 yd

**THE C172 PILOT** reports heading 230° at 115 kt en route to Swansea at FL 35 and receiving a FIS from Birmingham on 118.05 at FL 35. He had heard other ac being refused a radar service so he did not ask for one; the controller was busy with Birmingham traffic and other ac in transit to see the sun's eclipse. He first saw the Bulldog 200 m away in his 2 o'clock at the same level and turned steeply to the left and descended, noticing the Bulldog also turning left and climbing. It passed 150 m away and he considered there had been a very serious risk of collision. He reported the Airprox to Birmingham but the controller misunderstood the purpose of his message, saying he was in the FIR and it was up to him to see other traffic.

little time to assess the situation and both ac had descended in avoidance. The Board concluded that the safety of the ac had not been assured. Members agreed that the cause of the Airprox was a late sighting of the other ac by both pilots. The incident indicated the difficulty of detecting an ac on a collision course in one's peripheral vision and emphasised the need for a careful and continuous all round lookout.

Cause: Late sighting of the other ac by both pilots.

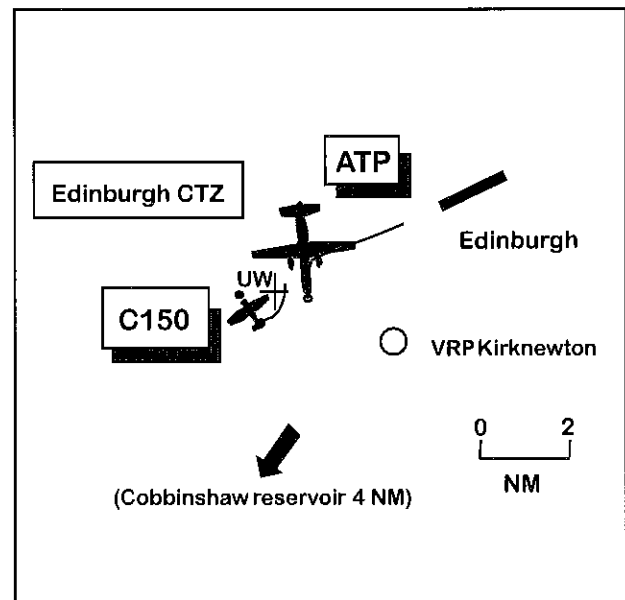
### **AIRPROX REPORT No 149/99**

Date/Time: 11 Aug 1111  
Position: N5554 W0330 (4.5 NM SW Edinburgh airport)  
Airspace: CTZ (Class: D)  
Reporter: Edinburgh  
Type: ATP C150  
Operator: CAT Civ Club  
Alt/FL: ↑6000 ft 2000 ft (QNH 1020 mb) (QNH)  
Weather: VMC HAZE VMC  
Visibility: 6 km 25 km  
Reported Separation: 1 NM/200 ft  
Recorded Separation: 1.4 NM

**EDINBURGH ATC** reports, with RT transcripts, that the C150 was given take-off clearance from RW 24 by ADC at 1107, routing VFR via Kirknewton and Cobbinshaw reservoir. The student pilot read back the take-off clearance and the instructor added "left turn out". The ATP was then instructed to line up on RW 24. As there was VFR traffic inbound to the airfield from the S, and ADC could no longer see the

off in accordance with ATC departure instructions. The instructor should have been alert to his inexperienced pupil's RT calls and anticipated possible errors in position reporting. In the event, he did not notice the student's erroneous report or that the C150 had still not diverged significantly from the extended centreline of the RW. The Board concluded that the C150 pilot had caused the Airprox by not flying his zone departure clearance accurately, and giving an erroneous report.

Cause: The C150 pilot did not fly his zone departure clearance accurately and gave an erroneous position report.

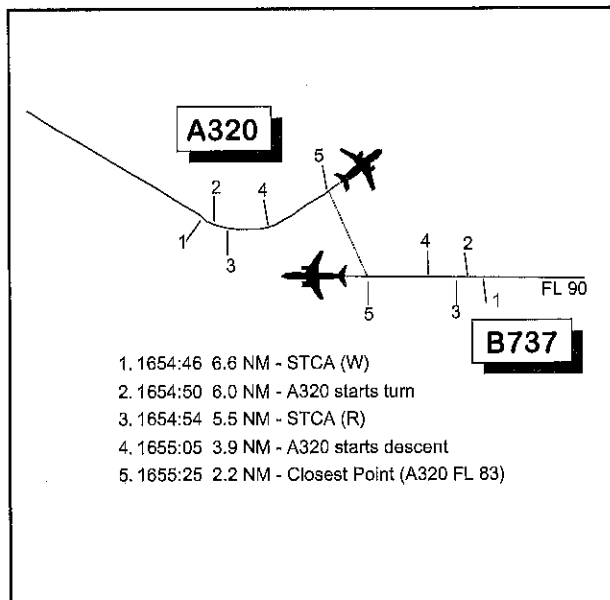
Date/Time: 13 Aug 1655  
Position: N5140 W0017 (8 NM SW of BPK)  
Airspace: TMA (Class: A)  
Reporter: LATCC TC  
First Aircraft      Second Aircraft  
Type: A320              B737-300  
Operator: CAT              CAT  
Alt/FL: FL 90              FL 90

LATCC TC reports that the LHR Intermediate Director N was controlling all four LHR stacks in a light traffic situation, with the assistance of a support controller. The B737 was told to leave the Lambourne hold heading 270° at FL 90; the pilot acknowledged and the ac did as instructed. The A320 was instructed at 1650:25 to leave the Bovington hold heading 130° at FL 90. After leaving Lambourne the B737 was instructed at 1651:55 to descend to FL 80. There was no reply to multiple transmissions to this ac. As the B737 would eventually conflict with the A320 the controller decided to descend the A320 to FL 80 instead. Again, despite multiple transmissions to the A320 there was no reply from this ac either. Multiple transmissions were made to both ac using normal equipment and the emergency handset. The support controller also tried to contact both ac to no avail. Attempts were made to see if the ac were on other frequencies. Another company flight was also asked to try and see if the A320 could be contacted on the company frequency. However, neither ac responded to these attempts to contact them. In 10 years of controlling at Heathrow this was the most helpless the controller had ever felt; he thought he was going to witness a mid-air collision without being able to do anything about it.

The Board also observed that this satisfactory outcome was in no small part due to the A320 pilot's very prompt reaction to the avoiding action instructions, and this was a lesson for others to copy. Unhappily, there remained too many examples of pilots leaving the autopilot engaged during avoiding action which greatly limited effectiveness.

Cause: Incorrect frequency selection on the B737 and a temporary loss of RT reception on the A320.

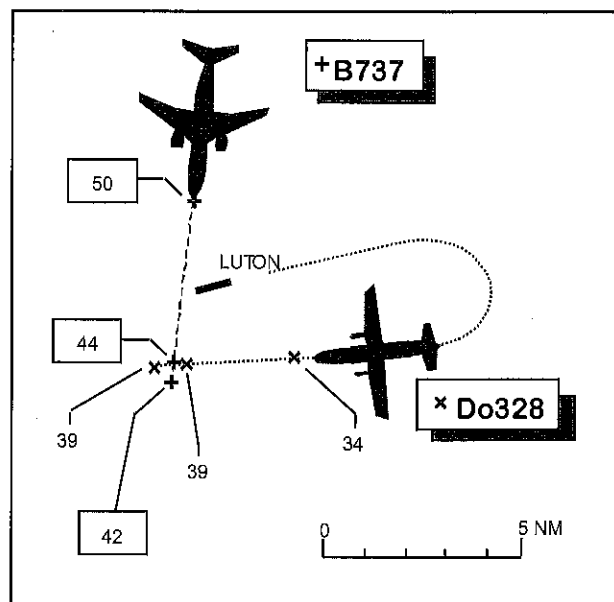
## AIRPROX REPORT No 152/99

Date/Time: 30 Jul 1013  
Position: N5141 W0022 (2 NM SSW Luton – elev. 526 ft)  
Airspace: LTMA (Class: A)  
Reporter: Luton APR  
First Aircraft      Second Aircraft  
Type: B737-300      Dornier 328  
Operator: CAT      CAT  
Alt/FL: 4000 ft ↓      4000 ft ↑  
(QNH 1017 mb)      (QNH 1017 mb)  
Weather: UNK      UNK  
Visibility: UNK      UNK  
Reported Separation: Not reported  
Recorded Separation:  
0.3 NM H & 500 ft V

**THE LUTON APPROACH RADAR CONTROLLER (APR)** reports that the Do328 departed from Luton on a CPT 3C SID, climbing to 4000 ft westbound under a Radar Control Service (RCS). The B737 was also under RCS and inbound through the 'Luton Gate', descending to 4000 ft on a radar vector to pass astern of the departing Do328. Co-ordination for a further climb for the Do328 was delayed by a protracted conversation between the APR and LATCC TC on an unrelated issue. Eventually, co-ordination for the Do328 to climb to 5000 ft was agreed. Inexplicably however, the APR did not issue the climb instruction to the Do328 crew, before a conflict with the B737 developed. Standard separation was subsequently eroded as the ac tracks crossed 3 NM SSW of Luton.

UKAB Note (3): The aspects of the altercation between the APR and a LATCC TC controller referred to in the ATSI report were covered in greater depth in an accompanying Human Factors assessment, that concluded: The controller was evidently very shaken by this call and the only reasonable explanation for his subsequent performance appears to be the after-effects of the stress and upset generated by it. This appears to have been so distracting to the controller that he failed to maintain an adequate awareness of the traffic situation or the close proximity of the subject ac which would have been evident from the radar display.

Cause: Following a distracting telephone call, the Luton APR did not ensure standard separation between the subject ac.

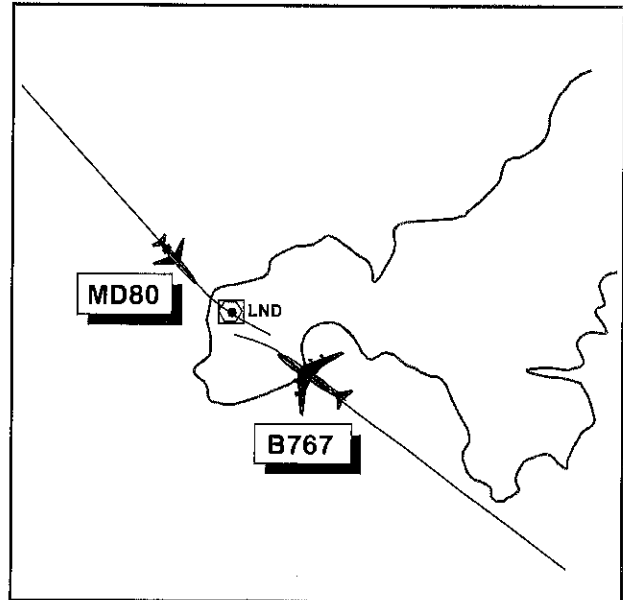
**AIRPROX REPORT No 153/99**

Date/Time: 20 Aug 0952  
Position: N5002 W0532 (1.5 NM SE of  
Lands End)  
Airspace: UAR UG4 (Class: B)  
Reporter: LATCC LND SC  
First Aircraft Second Aircraft  
Type: MD80 B767-300  
Operator: CAT CAT  
Alt/FL: ↑ FL 330 FL 330  
Weather VMC VMC  
Visibility:  
Reported Separation:  
Recorded Separation: 1.07 NM

**THE LATCC LND SC** reports operating as mentor to a trainee controller who had cleared the MD 80 to climb to FL 290 with opposing traffic at FL 310 on UG4. The pilot called level and was advised to expect further climb after passing Land's End (LND). Once the ac had crossed, the MD80 was cleared to FL 310, this time with the B767 as opposing traffic climbing to FL 330, reporting level at 0948:25. The trainee cleared the MD80 pilot to climb to FL 310 at 0949:45 and the pilot acknowledged correctly. As the ac approached LND the conflict alert activated and the MD80 was seen to be climbing through FL 312 to FL 313. He alerted the trainee who told the MD80 pilot to maintain FL 310; the pilot acknowledged and the SC, noticing the MD80's Mode C now showing FL 315, took the RT and gave the MD80 avoiding action "left turn now onto heading of 110 you were cleared to 310 there's traffic in your 12 o'clock 15 miles 330". The pilot replied "Yeah we have it in sight c/s we're very sorry about that". The controller then passed avoiding action to the B767, left onto 300°, with traffic information on the MD80, now showing FL 317. The MD80 pilot reported clear of the other traffic with profuse apologies at 0952:45; both ac were then cleared to resume navigation and the MD 80 cleared to FL 330.

*Cause:* The MD80 climbed above its cleared level.

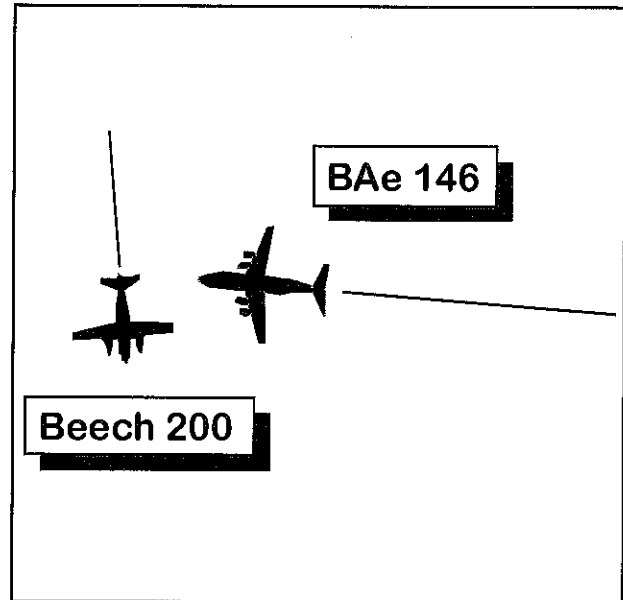
<u>First Aircraft</u>	<u>Second Aircraft</u>
<u>Type:</u>	BAe146	Beech 200
<u>Operator:</u>	CAT	Civ Comm
<u>Alt/FL:</u>	FL 160 ↑	FL 170

**THE MANCHESTER IOM SC** reports that he was acting as mentor to a 240-hr-check trainee, with a Co-ordinator also on the sector. It was a very busy session. The Beech 200, southbound, was cleared to join CAS N of WAL and cleared to climb to FL 170 at 0624. The BAe146, en route to Belfast, was cleared to climb to FL 160 and put on a radar heading of 280° at 0626:30. The pilot acknowledged "Climb one six zero left onto 280 c/s". The STCA highlighted a potential confliction and at 0627:40 the trainee reminded the BAe146 pilot "C/s maintain FL 160 on reaching" and the pilot replied "Will do c/s". Seeing a continuing STCA alert the controller saw the BAe146 continuing to FL 162 then 164. He pointed this out to the trainee who, at 0628:50, asked the pilot to confirm maintaining FL 160; the pilot replied "Affirm c/s its er six sixteen point 2 we've erred by two hundred". The ac continued to FL 165 before descending quickly to FL 160. The Co-ordinator reported having a very high workload exacerbated by problems with the FPS printer and the physical distance from the ATSAs. His tactical awareness was therefore limited and he was unable to pay close attention to the RT.

The Board agreed that the cause of the Airprox was that the BAe146 pilot had exceeded his cleared level despite receiving and acknowledging a reminder from ATC to level at FL 160 just beforehand. Although electrical problems and an unexpected visitor to the flight deck may have distracted the pilots, their

specific job at that moment was to make sure the autopilot levelled the ac at FL 160 and to do it manually if the system failed. The reminder from ATC was given because the 2 ac would coincide in plan; UK airspace is so busy that a level infringement will almost always result in a confliction with the traffic for which the level restriction has been applied. For this reason the Board considered any level infringement as a serious matter.

Cause: The BAe146 pilot exceeded his cleared level.

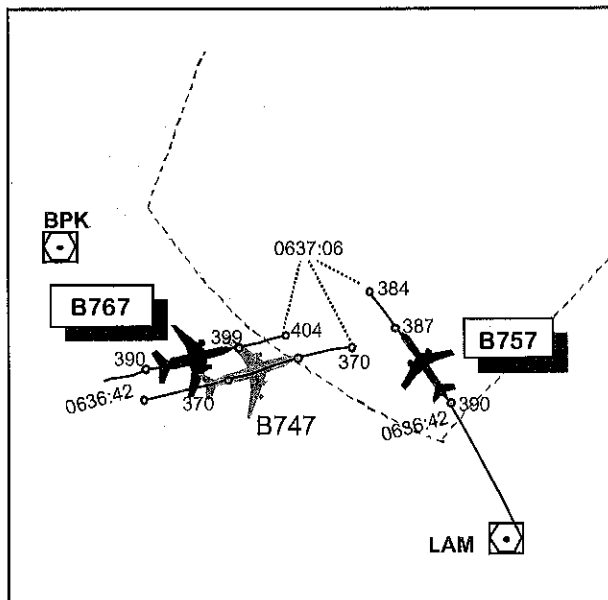
**AIRPROX REPORT No 155/99**

Date/Time: 27 Aug 0636  
Position: N5142 W0000 (5 NM SE BPK)  
Airspace: LUIR (Class: B)  
Reporting Aircraft Reported Aircraft  
Type: B757 B767  
Operator: CAT CAT  
Alt/FL: FL 390 FL 390  
Weather VMC VMC  
Visibility:  
Reported Separation: 1000 ft  
Recorded Separation: 3.2NM/1200 ft

**THE B757 PILOT** reports that he was at his cruising level of FL 390 at M 0.80 inbound to Manchester from Europe. Several minutes before the incident LATCC had instructed him to

after the handover, the potential confliction between this ac and the B767 would not have been apparent to her at the time. It was explained that the early handover was to cover staff shortages, allowing the CSC A to be released for radar duties on the sector. CSC B said that he had not been rostered as LUS CSC for the duty concerned as he was due to attend an interview later that morning concerning a previous incident. He was concerned about this interview and spent some time discussing the forthcoming interview with CSC A, who had remained by the suite in case the sector needed to be split. Although this presented a distraction, he did not consider it impaired his ability to carry out his duties effectively, especially bearing in mind the light workload during the period. While in position, at 0603, the CSC A accepted the B767 into the LUS sector at the "Opposite Direction Level" (ODL) of FL 390. In the same telephone call with the Bristol CSC another ac, a B747 eastbound to Amsterdam (not a subject ac in this Airprox but relevant) was accepted at FL 370. Both ac were reported as being 3 min late on their FPS times.

At 0635 (just before the STCA activated) CSC B co-ordinated the B747 out of the sector with the CLN CSC. The latter then enquired about the B767. CSC B could not immediately find its FPS, which may be another indication that it was in the wrong bay of the strip display, and could not remember where he found its details to pass to the CLN CSC. The significance of this flight relative to the B757 was not appreciated at the time.

Cause: The LATCC AC LUS team did not provide standard separation between the 3 ac concerned.

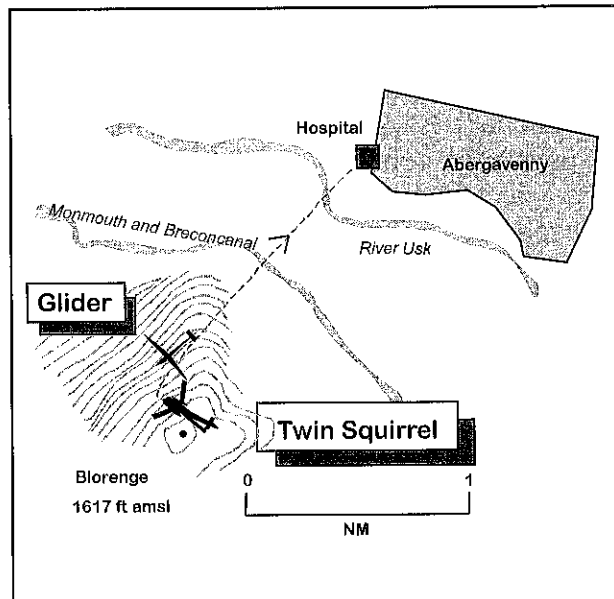
**AIRPROX REPORT No 156/99**

Date/Time: 30 Aug 1422  
Position: N5148 W0303 (105 NM SW Abergavenny)  
Airspace: FIR (Class: G)  
Reporting Aircraft Reported Aircraft  
Type: AS355 Slingsby glider  
Operator: Civ Comm Civ Club  
Alt/FL: 10 ft ↑ 2300.ft  
 (agl) (amsl)  
Weather VMC VMC CAVOK  
Visibility: 40 km 40 km  
Reported Separation:  
 15 FT V/30 ft H//50 ft V/ 300 ft H  
Recorded Separation: Not recorded

THE AS355 PILOT reports that he was scrambled to Casevac an injured hang glider pilot from Blorenge (a hill 1617 ft amsl 105 NM SW of Abergavenny), a known and marked hang gliding site; the casualty had severe neck injuries. The helicopter landed at the scene with HISLs on, although the visibility was 40 km in VMC. About 23 min later he was ready to lift off from the NW side of the hill with the casualty on board when a glider came around the corner and passed within 25 ft of the helicopter. It

The glider pilot was complying with club rules and was not in breach of any Air Regulations (the 500 ft Rule does not apply to gliders when soaring). In hindsight, having observed the accident site and helicopter, he should have considered leaving the area sooner; however, in his judgement it would have been hazardous to attempt a landing in one of the very small fields at the base of the ridge and he therefore decided to try and remain airborne in the weak lift offered by the ridge. No Airprox could have been possible until the helicopter's rotors started turning and there was, in the Safety Officer's opinion, some doubt as to whether the helicopter took the most expedient route while transitioning from the ridge.

suddenly realised, as he was entering the turn, that the now airborne helicopter was actually tracking away from the ridge towards him. At this point – judging from reports - the helicopter pilot saw the glider, apparently turning R into conflict, and felt it necessary to make a sharp R turn in avoidance. Taking this scenario into account, the Board decided on balance that the Airprox occurred because of an unexpected conflict of flight paths, which was resolved by the actions of both pilots. Owing to widely conflicting information concerning the miss distances, members found it difficult to assess the degree of risk. Nonetheless, they recognised that both ac were in critical stages of flight and there was little scope for manoeuvre by either pilot. The Board therefore concluded that the safety of both ac had been compromised.

Cause: A conflict in the FIR resolved by both pilots.

Had the helicopter operator been aware of the glider air-to-air frequency the problem might have been resolved by RT. He recommends that gliding frequencies be made known to such operators, as is already the case in mid-Wales.

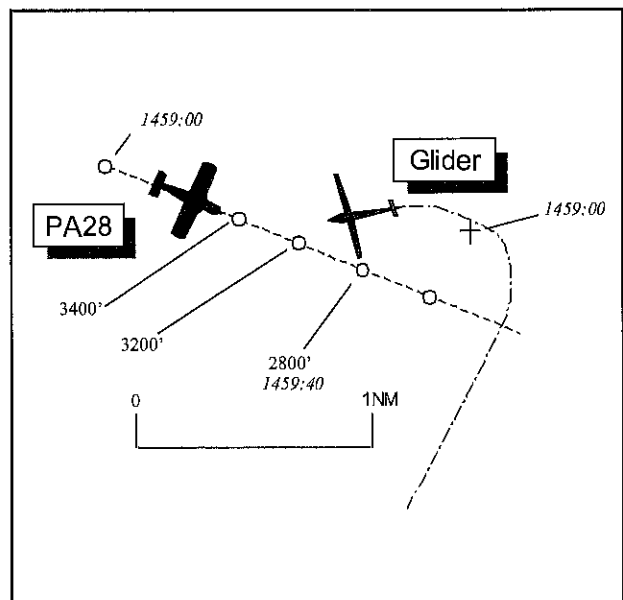
**AIRPROX REPORT No 158/99**

Date/Time: 28 Aug 1459 (Saturday)  
Position: N5139 W0125  
 (9 NM SE of Brize Norton)  
Airspace: FIR (Class: G)  
Reporting Aircraft Reported Aircraft  
Type: PA28 Untraced Glider  
Operator: Civ Trg NK  
Alt/FL: 3500 ft NK  
 (RPS 1020 mb) NK  
Weather VMC CAVOK NK  
Visibility: <10 km NK  
Reported Separation: 2-300 ft V & H  
Recorded Separation: Not Recorded

**THE PA28 PILOT** reports routeing VFR direct from Gloucestershire Aerodrome to White Waltham at 100 kt, whilst in receipt of a FIS from Brize Norton. A white low wing glider was sighted in level flight 5 NM ahead, crossing from R to L, the glider then turned onto a reciprocal heading to pass, he thought, clear down the port side. Knowing of his responsibility to 'Give Way', he was content that safe separation existed and executed a 'wing-waggle' to indicate to the glider pilot that his ac had been sighted. His student then advised that the glider had turned and was heading straight towards them. An "emergency" descent was immediately initiated and the glider passed 2 - 300 ft above and 2 - 300 ft astern of the PA28, a collision would have occurred if avoiding action had not been taken. An Airprox was filed with Brize immediately after the event.

was, therefore, fortunate that the student was able to warn the PA28 pilot when the glider suddenly turned toward their ac, which enabled him successfully to evade the glider. Members agreed that it was unlikely that the glider pilot would have turned toward the PA28 if he had seen it. However, in the absence of a report this would only be conjecture. Consequently, members concluded that the cause was a conflict in the FIR with an untraced glider resolved by the PA28 pilot. Given the reported emergency descent by the PA28, as evinced by the radar recording, the board also agreed that the safety of both ac had not been assured.

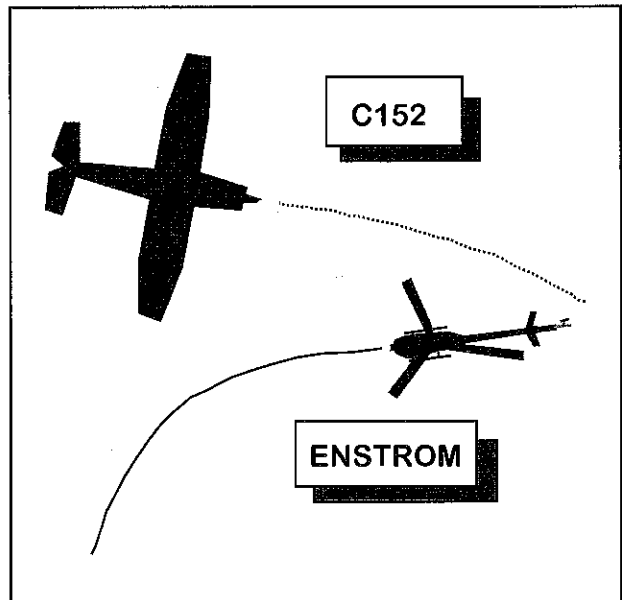
**AIRPROX REPORT No 159/99**

Date/Time: 29 Aug 99 1411 Sunday  
Position: N5114 W0023 (2 NM W of Dorking)  
Airspace: FIR (Class: G)  
Type: Reporting Aircraft Reported Aircraft  
 Enstrom F28C C152  
Operator: Civ Pte Civ Trg  
Alt/FL: 1500 ft 1700 ft ↓  
 (QNH 1020 mb) (QNH)  
Weather VMC CLBC VMC CLBC  
Visibility: <10km 8km  
Reported Separation:  
 Virtually Nil/70 ft V & H  
Recorded Separation: Not Recorded

**THE ENSTROM PILOT** reports that after departure from a private HLS he was heading 260°M, 2NM W of Dorking and flying VFR at an altitude of 1500 ft London QNH (1020 mb). A

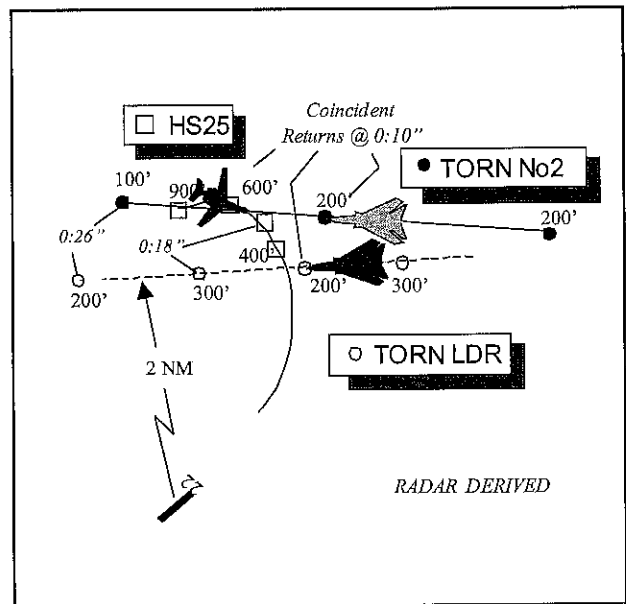
**AIRPROX REPORT No 160/99**

Date/Time: 1 Sep 1500  
Position: N5405 W0115 (2 NM NNE of Linton-on-Ouse - elev 53 ft)  
Airspace: MATZ (Class: G)  
Reporting Aircraft Reported Aircraft  
Type: Dominie Tornado GR  
Operator: HQ PTC HQ STC  
Alt/FL: 700 ft ↓ 500 ft  
 (QFE 1018 mb) (Rad Alt)  
Weather VMC CAVOK VMC CAVOK  
Visibility: 10 km 10 km  
Reported Separation:  
 <0.5 NM h + 200 ft V  
Recorded Separation:  
 Ldr < 0.75NMH +400 ftV  
 No2 Not recorded

**THE DOMINIE PILOT** reports descending through 700 ft and turning R at 30-35° AOB, passing 070° onto finals at 140 kt to land RW 22RH at Linton. Suddenly, a Tornado was unexpectedly sighted at 2 o'clock, low and fast on a steady track that passed 200 ft below crossing from L to R with less than 0.5 NM horizontal separation. No avoiding action was

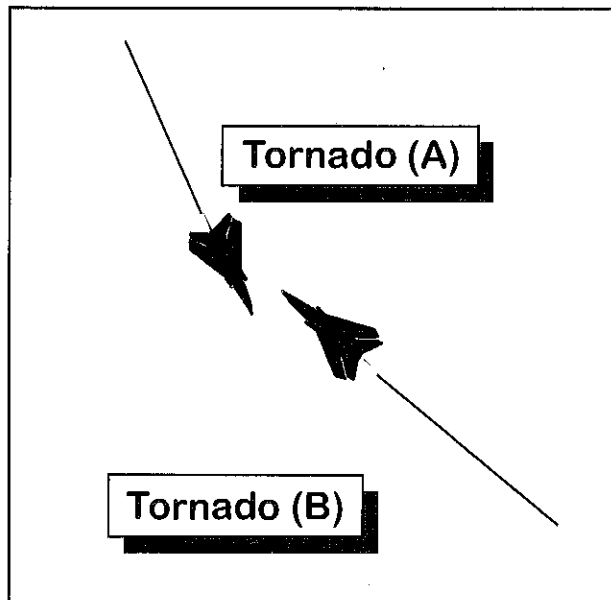
**THE TORNADO (A) PILOT** reports heading 170° at 420 kt on a low level exercise at 250 ft agl. Following a brief period of evasion he was trying to RV with his leader, believed to be in his 10-12 o'clock about 5 NM ahead. He saw an ac cresting a hill about 5 NM ahead which he took

to be his leader on a similar track. He then searched for the bounce ac last seen to the left of his leader but 5 sec before the Airprox he realised that the previously seen ac was head on to him 1 NM ahead and about 100 ft above in a slight descent. He descended immediately to avoid a collision but the other ac also appeared to bunt and a collision seemed imminent. He pushed full forward stick,

overstressing the ac by -1g. He did not think he had done enough to avoid a collision but just before colliding the other ac appeared to stop descending and passed about 50-100 ft above and slightly to his left. There had been a very high risk of collision.

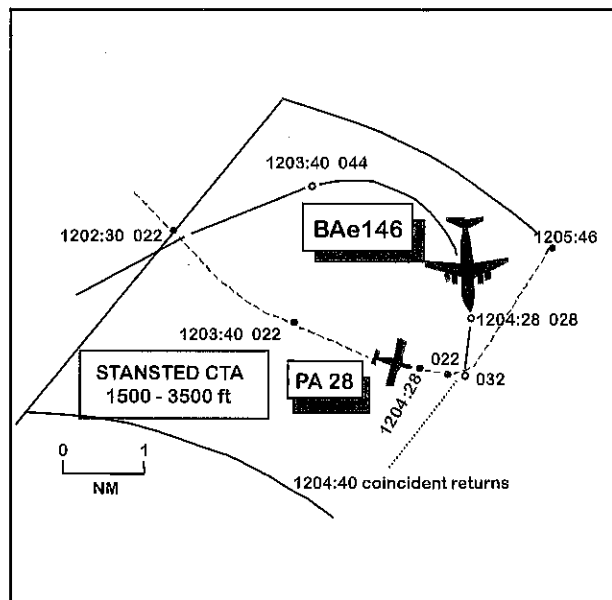
## AIRPROX REPORT No 162/99

Date/Time: 7 Sep 1205  
Position: N5201 E0025 (10.5 NM NE Stansted)  
Airspace: CTA (Class: D)  
Reporting Aircraft Reported Aircraft  
Type: BAe146 PA28  
Operator: CAT Civ Pte  
Alt/FL: ↓ 2000 ft 2000 ft  
(QNH 1011 mb) (QNH 1011 mb)  
Weather VMC CLBC VMC  
Visibility: 10 km >5 NM  
Reported Separation:  
0 ft H/400 ft V // 500 ft V  
Recorded Separation: 1000 ft V

**THE BAE146 PILOT** reports that he was being vectored for the localiser for RW 23 at Stansted under the control of Stansted Radar. The visibility, 400 ft below cloud, was 10 km in VMC. When about 10 NM NE of the airfield and descending through 2400 ft (QNH 1011) at 200 kt, he saw a low wing single engined ac at his 2 o'clock 0.5 NM away as it tracked from R to L at about 2000 ft. ATC instructed him to climb immediately to 3000 ft, which he did, and the other ac passed about 400 ft below him. He thought there had been a medium to high risk of collision.

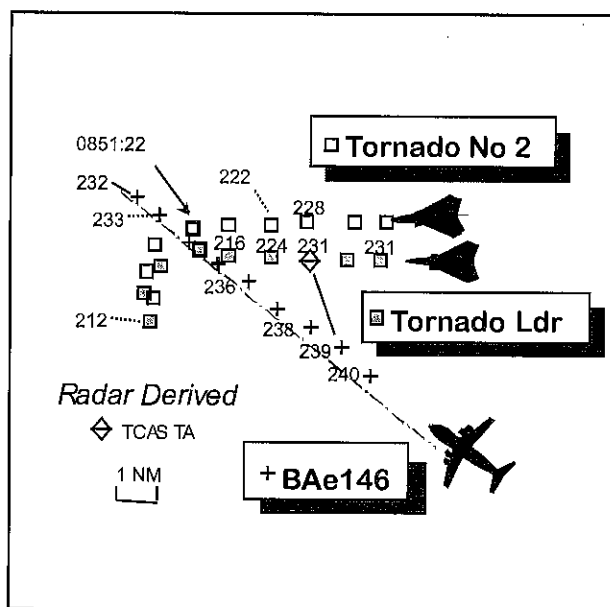
Reported Separation: 3-500 ft V

Recorded Separation:  
@ 2 NM H/800 ft @ < .75 NMH/2000 ft

**THE TORNADO F3 PILOT** reports he was the leader of a pair of F3s heading 270° at 400 kt, returning to a CAP station after a practice intercept. His formation was in receipt of an Air Defence Information Service (ADIS) from CRC Neatishead. Both ac were grey overall with HISLs illuminated. Another ac was first sighted slightly above the horizon at L 9 o'clock, range 1-1.5 NM on a converging heading of about 300°. The stranger was about 3-500 ft above his altitude in a gentle descent. He immediately descended his formation to 21000 ft, passing about 1000 ft directly below the other ac, whose crew took no apparent avoiding action. He believed that the risk of collision had been low, owing to the disciplined lookout and resultant avoiding action. However, he had received traffic information on a stranger about 2 minutes before the Airprox occurred and believed his formation had been co-ordinated not above

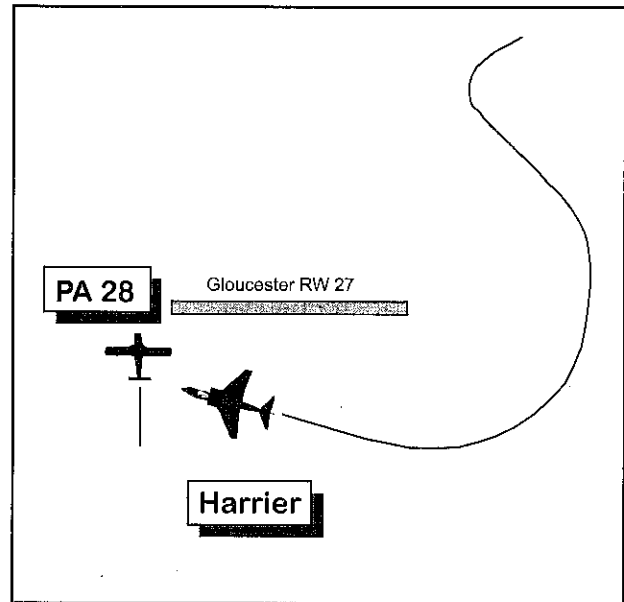
**THE PA28 PILOT** reports heading 360° at 95 kt, crosswind for Gloucester's RW 27 RH at 1100 ft, when ATC broadcast a warning and he saw a fast jet approaching from the NE. It turned steeply away to the SE and then circled right at low level. He then saw it, a Harrier, turn back towards the runway; as it reached the airfield boundary it climbed steeply and passed 100 ft behind and above him with a high risk of collision.

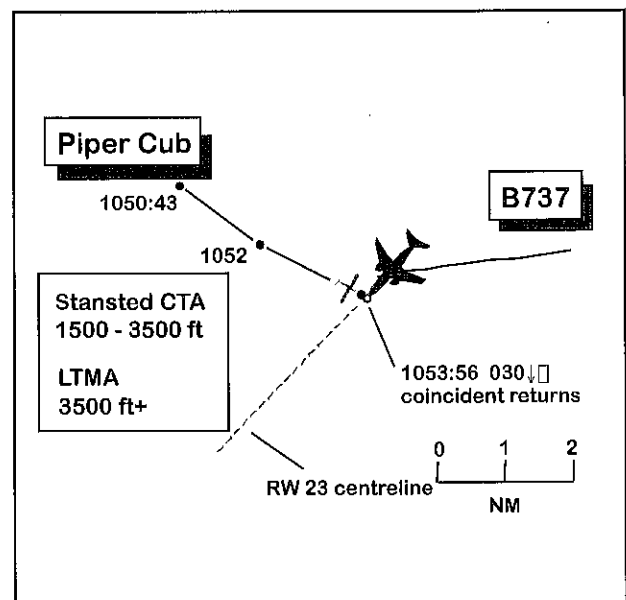
**AIRPROX REPORT No 167/99**

Date/Time: 11 Sep 1054 (Saturday)  
Position: N5200 E0025 (9.5 NM NE Stansted)  
Airspace: CTA (Class: D)  
Reporting Aircraft Reported Aircraft  
Type: B73 - 8 Piper Cub  
Operator: CAT Civ Pte  
Alt/FL: ↓ 2000 ft 3500 ft (QNH) (QNH 1015 mb)  
Weather VMC HAZE VMC  
Visibility: 5-10 km 5-10 NM  
Reported Separation: 200-400 ft V // 500 ft V  
Recorded Separation: zero lateral

**THE B737 PILOT** reports that as he was turning through a heading of about 230° and descending to 2000 ft to intercept the localiser for RW 23 at Stansted, he noticed a Piper Cub close at his 2 o'clock high position tracking from R to L. The pilot comments that despite being in VMC, he felt conditions were not ideal for VFR flight because of the hazy 5-10 km visibility. There was no time to take avoiding action and the ac passed 200 – 400 ft above and 100 – 200 m to his R. However, he did not feel there had been any risk of collision.

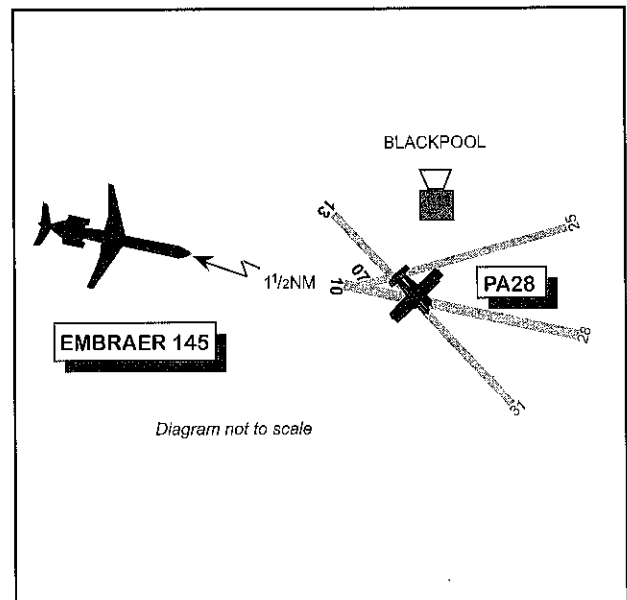
**AIRPROX REPORT No 168/99**

Date/Time: 10 Sep 1351  
Position: N5346 W0302 (Blackpool Airport - elev 34 ft)  
Airspace: ATZ (Class: A)  
Reporter: Blackpool ADC  
Aircraft No 1 Aircraft No 2  
Type: EMBRAER 145 PA28  
Operator: CAT Civ Pte  
Alt/FL: ↓ 450 ft ↑ 0 ft  
(1022mb) (1022 mb)  
Weather VMC CAVOK VMC CAVOK  
Visibility: 10 20  
Reported Separation:  
1.5 NM H & 450 ft V  
Recorded Separation: Not recorded

**THE BLACKPOOL AERODROME CONTROLLER (ADC)** reports that the PA28 was lined up on RW 13 holding for instrument traffic making an approach to RW 28. After this traffic had cleared, attempts to contact the PA28 on RT proved unsuccessful. In the belief that the PA28's radio had failed, the ADC issued a further instruction by 'White' Lamp Signal, which was also unsuccessful. Another controller was then dispatched in the ATC vehicle to escort the PA28 off the runway. However, as the vehicle vacated RW 13 onto RW 07 the PA28 departed, thereby crossing in front of the EMBRAER which was about 1 NM final to land on RW 10. After one circuit the PA28 landed on RW 13. It is reported that 'Purple' airspace was in force at the time.

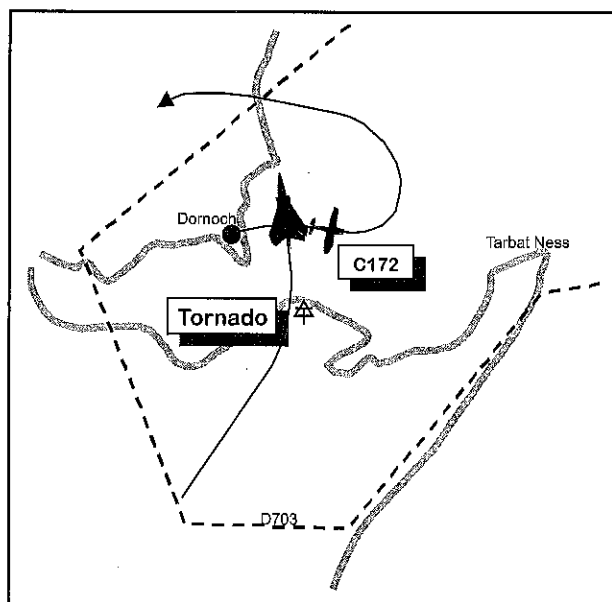
**THE TORNADO PILOT** reports that he had just made a shallow dive attack on Tgt 2 at Tain Range on a track of 035°, recovering into a climb to 600 ft and a left turn onto 355°, at 510 kt. As he rolled out he looked right and saw a light ac 400 ft above and 0.25 NM away in his 2 o'clock on an easterly heading. He continued straight on as the safest option. There was no risk of collision when he saw the other ac; however, had his recovery off the target been less positive there would have been a high risk. The ac did not appear to be in communication with Tain and was about 0.5 NM E of the target area.

**THE C172 PILOT** submitted a report on 26 Jan 00 having been abroad for much of the time since the incident. He was aware of the requirement to call Tain range on the way to/from Dornoch and had called on the way in. Before take-off from Dornoch he had tried to contact Tain but had had no reply. After take-off he completed his after take off checks, called

Tain passing 300 ft and was immediately told to clear the range. He was flying at 85 kt but could not remember his heading when he saw an ac in a left turn passing on his right 200 ft away. There did not appear to be a risk of collision when he saw it. (UKAB Note: The operator of the ac advises that the comms fit in the ac, as inherited, included a facility to enable passengers to listen to the RT. This appeared on occasions to impair the function of the RT and he was investigating the possibility of changing it.)
