**UK AIRPROX BOARD**

**Analysis of  
Airprox in UK Airspace**  
Report Number 3  
July 1999 to December 1999

Report by the UK Airprox Board,  
'Analysis of Airprox in UK Airspace'  
(July 1999 to December 1999)

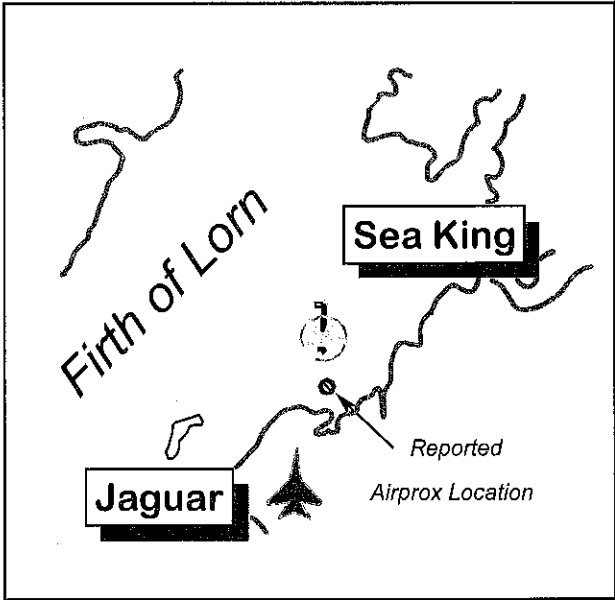
**AIRPROX REPORT No 170/99**

Date/Time: 15 Sep 1046  
Position: N5619 W0536  
 (11 NM SW of Oban )  
Airspace: LFS/Scottish FIR (Class: G)  
Reporting Aircraft Reported Aircraft  
Type: Sea King Mk 6 Jaguar  
Operator: HQ FONA HQ STC  
Alt/FL: 200 ft 250 ft  
 (QNH 1011 mb) Rad Alt  
Weather VMC CLBC VMC CLBC  
Visibility: >10 km >10 km  
Reported Separation:  
 Nil H/200 ft V 200 yd H/400 ft V  
Recorded Separation: Not Recorded

Cause: Conflict in the UK LFS resolved by both pilots.

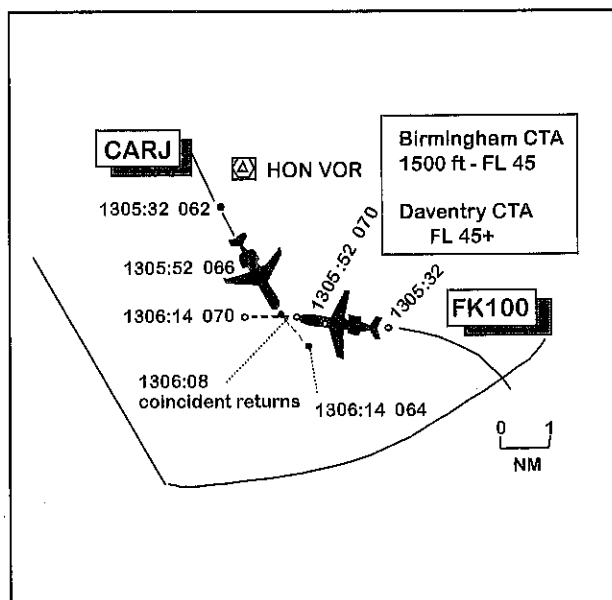
## AIRPROX REPORT No 172/99

Date/Time: 17 Sep 1306  
Position: N5218 W0138 (3 NM SSE HON VOR)  
Airspace: CTA (Class: A)  
Reporting Aircraft Reported Aircraft  
Type: CARJ FK100  
Operator: CAT CAT  
Alt/FL: ↑ FL 140 FL 70  
Weather VMC CLBL VMC  
Visibility: 10 km  
Reported Separation: <1000 ft V  
Recorded Separation: 500 ft V

Cause: The LATCC COWLY SC climbed the outbound CARJ into conflict with known inbound traffic.

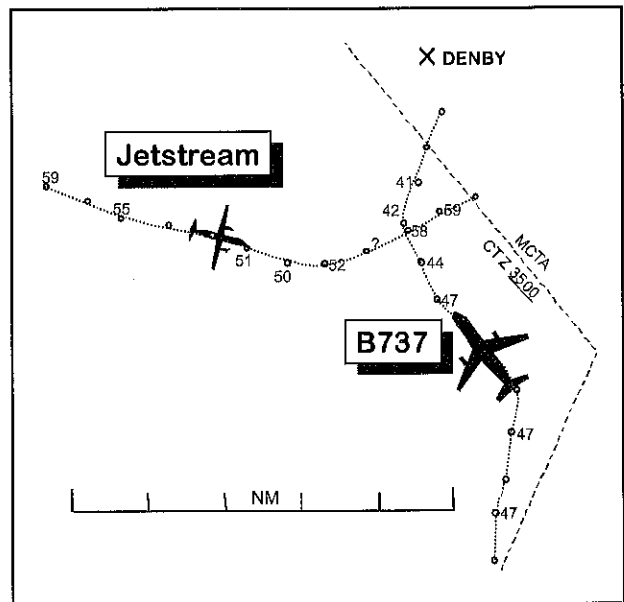
**AIRPROX REPORT No 173/99**

Date/Time: 20 Sep 1527  
Position: N5329 W0158 (2 NM S of DENBY)  
Airspace: Manchester TMA (Class: A)  
Reporter: Manchester Ribble SC  
First Aircraft      Second Aircraft  
Type: B737-200      Jetstream 41  
Operator: CAT      CAT  
Alt/FL: 4000 ft      FL 50  
                   (QNH 988 mb)  
Weather VMC CLBC      IMC IICL  
Visibility: 10 km  
Reported Separation:  
                   400 ft, 0.3 NM 700 ft, 1 NM  
Recorded Separation: 1500 ft V

Cause: The Ribble SC descended the Jetstream into conflict with the B737.

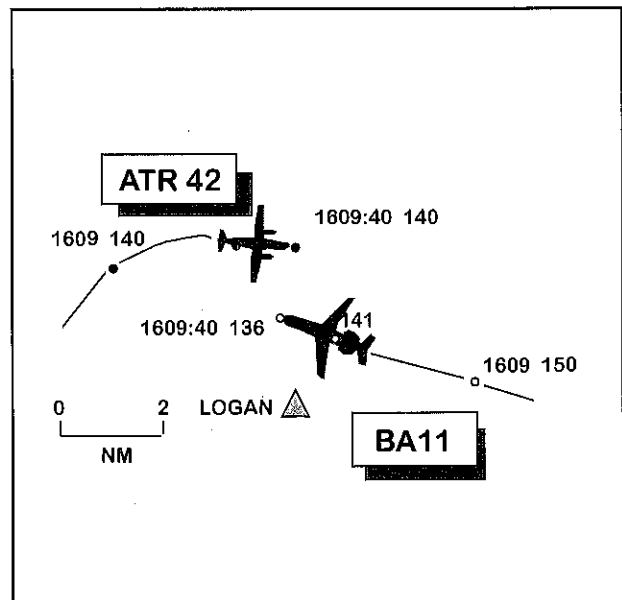
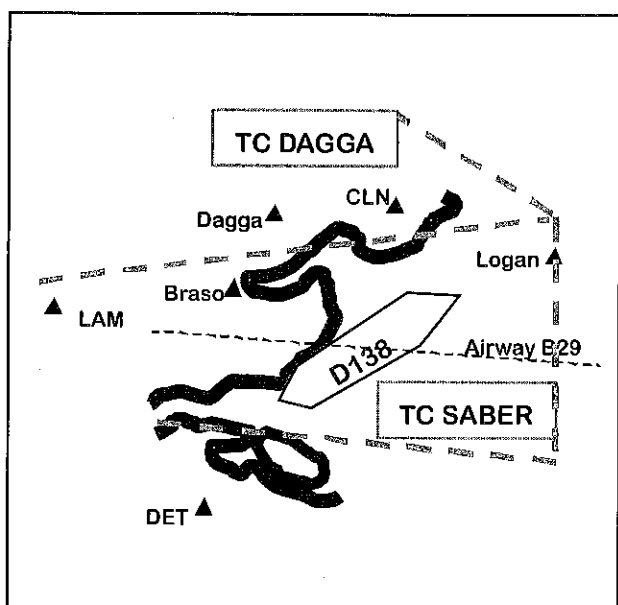
Date/Time: 24 Sep 1610  
Position: N5148 E0137 (2 NM N LOGAN)  
Airspace: Airway (Class: A)  
Reporter: LATCC  
First Aircraft      Second Aircraft  
Type: ATR42              BA11  
Operator: CAT              CAT  
Alt/FL: FL 140              ↓ FL 130

Weather      VMC              VMC  
Visibility: Not given      Not given  
Reported Separation:      1 NM/500 ft  
Recorded Separation:      1.5 NM/@400 ft

Cause: The DAGGA SC descended the BA11 into conflict with the ATR 42.

The ATSI report recommends that action should be taken either to require staff to adhere to the MATS Pt 2 or, if appropriate, the MATS Pt 2 should be amended to reflect current practice. It also recommends that the FPS distribution on the TC East sector should be reviewed so as to support sector staff more fully in their control task.

Observation: 1. UKAB endorses the ATSI recommendation on FPS distribution on the TC East Sectors.

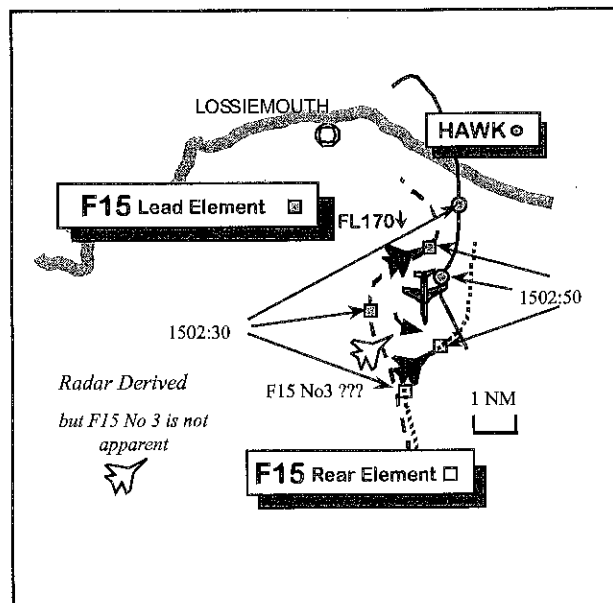
**AIRPROX REPORT No 175/99**

Date/Time: 27 Sep 1503  
Position: N5737 W0310 (7 NM SE of Lossiemouth - elev 42 ft)  
Airspace: Scottish FIR (Class: G)  
Reporting Aircraft Reported Aircraft  
Type: Hawk T1A F15E  
Operator: HQ STC Foreign Mil  
Alt/FL: FL 123↑ FL 160  
Weather VMC CLAC VMC CAVOK  
Visibility: 10 km >30 km  
Reported Separation: 200 ft V/50 ft H/UNK  
Recorded Separation: 0.5 NM H Rear F15

*Cause:* Late sighting by all ac crews.

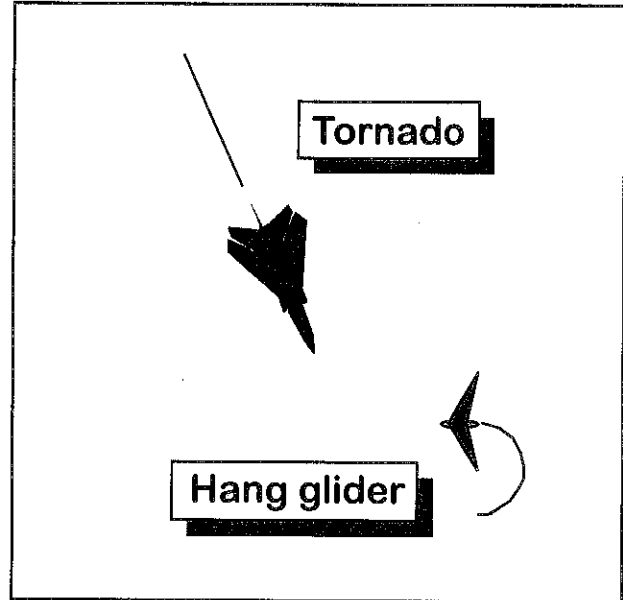
**THE HANG GLIDER PILOT** reports soaring Curbar Edge at 400 ft agl when he saw a Tornado coming straight towards him at the same level. He manoeuvred to make himself more visible, but the Tornado did not alter heading until the last moment when it was 2-300 ft away. It had to bank sharply to miss him and he considered there had been a high risk of 'wipe out'.

Cause: Confliction of flightpaths in the vicinity of a notified hang glider site.

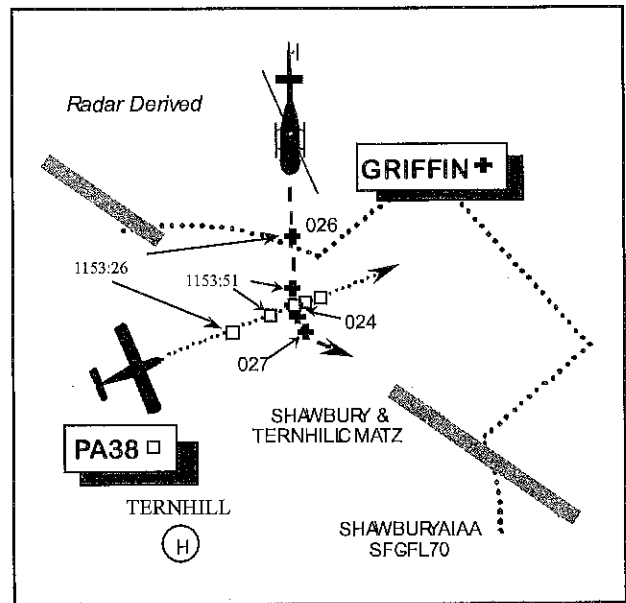
**AIRPROX REPORT No 177/99**

Date/Time: 04 Oct 1154  
Position: N5256 W0230  
 (4 NM NE of Ternhill - elev 272 ft)  
Airspace: MATZ (Class: G)  
Reporting Aircraft Reported Aircraft  
Type: Griffin HT1 Piper PA38  
Operator: HQ PTC Civ Trg  
Alt/FL: 2400 ft ↓ 2000 ft  
 (QNH 1012mb) (RPS 1011mb)  
Weather VMC CLOC VMC CLBC  
Visibility: 50 km 60 km  
Reported Separation:  
 H nil/300 ft V Not reported  
Recorded Separation: H nil/340 ft V

Cause: The Griffin pilot descended into conflict with the PA38, which he did not see.

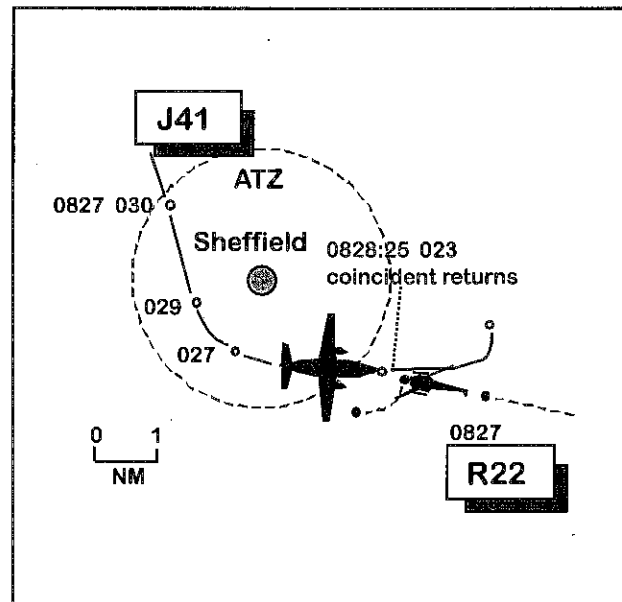
**AIRPROX REPORT No 178/99**

Date/Time: 4 Oct 0832  
Position: N5222 W0119 (2.6 NM SE Sheffield City airport - elev 231 ft)  
Airspace: FIR (Class: G)  
Reporting Aircraft Reported Aircraft  
Type: BA41 Jetstream R22  
Operator: CAT Civ Trg  
Alt/FL: ↓1500 ft 2000 ft (QNH 1014 mb) (QNH)  
Weather: VMC VMC CAVOK  
Visibility: 10 km >10 km  
Reported Separation: 200 ft/1.5 NM // 800 ft V  
Recorded Separation: <500 m

Cause: A confliction in the FIR resolved by the R22 pilot.

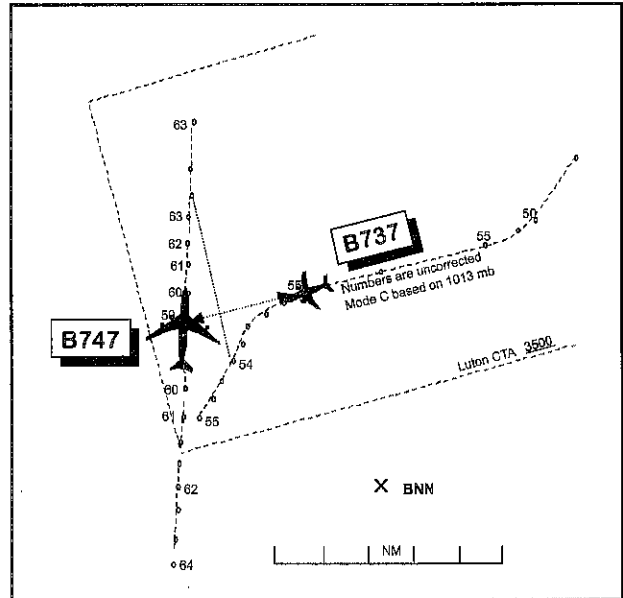
**AIRPROX REPORT No 179/99**

Date/Time: 1 Oct 1915 NIGHT  
Position: N5147 W0039 (5 NM NW of BNN)  
Airspace: LTMA (Class: A)  
Reporting Aircraft Reported Aircraft  
Type: B737-300 B747-200  
Operator: CAT CAT  
Alt/FL: ↑ 5000 ft 5600 ft  
(QNH) (QNH 999 mb)  
Weather VMC VMC  
Visibility:  
Reported Separation: 2 NM/NK  
Recorded Separation: >2 NM, 400 ft

Cause: The B747 pilot departed from his cleared altitude.

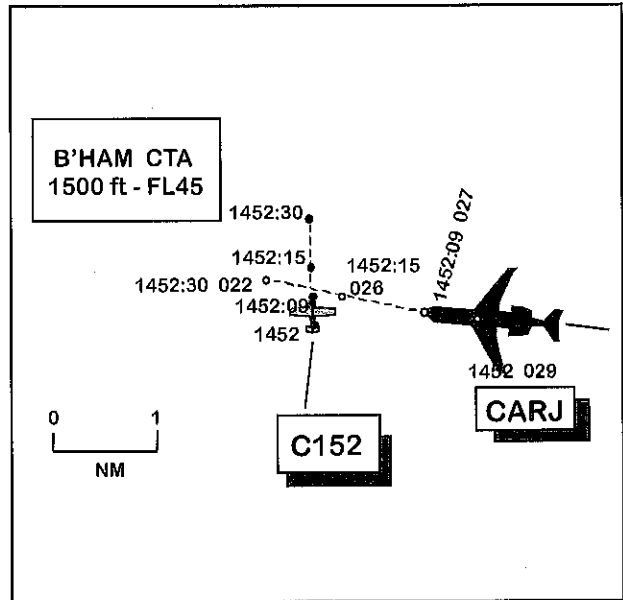
**AIRPROX REPORT No 180/99**

Date/Time: 12 Oct 1452  
Position: N5250 W0133 (4 NM SE HON VOR)  
Airspace: CTA (Class: D)  
Reporter: Birmingham ATC  
First Aircraft Second Aircraft  
Type: CARJ C152  
Operator: CAT Civ Club  
Alt/FL: 2500 ft 2400 ft  
(QNH 1030 mb) (QNH 1030 mb)  
Weather VMC VMC  
Visibility: >10 km >10 km  
Reported Separation:  
not given // not seen  
Recorded Separation: @ 0.5 NM

Cause: An inadvertent penetration of the Birmingham CTA by the C152 pilot while lost.

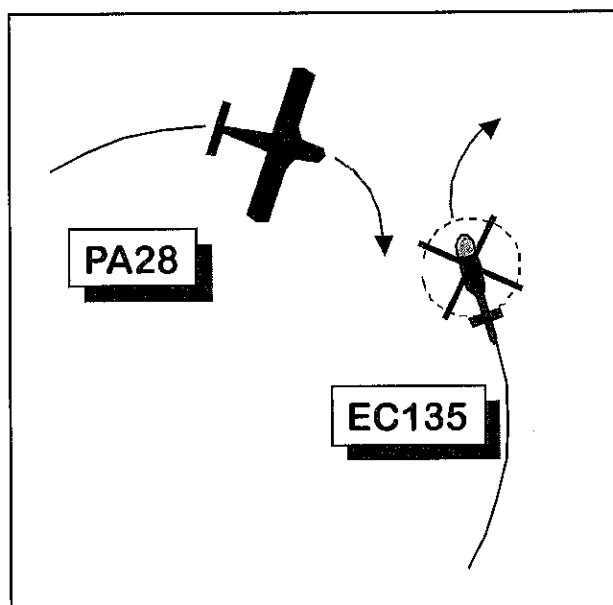
**THE EC135 PILOT** reports flying a night circuit training detail using a LH circuit at 1000 ft QFE to RW 02 at Oxford. Before a helipad takeoff he saw a fixed wing ac performing an overhead join. After take off he 'froze' one engine at max take off power giving a high initial rate of climb. His student took the appropriate actions and began to level off at 800 ft, starting a left turn whilst levelling at 1000 ft. Passing 350° at 65 kt, a conflicting ac was then seen 0.25 NM away converging from the left within the LH helicopter circuit. He took control and made a hard right climbing turn and reduced power on the 'frozen' engine; the other ac also appeared to turn right. He resumed his circuit; while at 1200 ft QFE he saw the other ac over the centre of the airfield and below his level. The other ac had passed about 1-200 ft away with a high risk of collision.

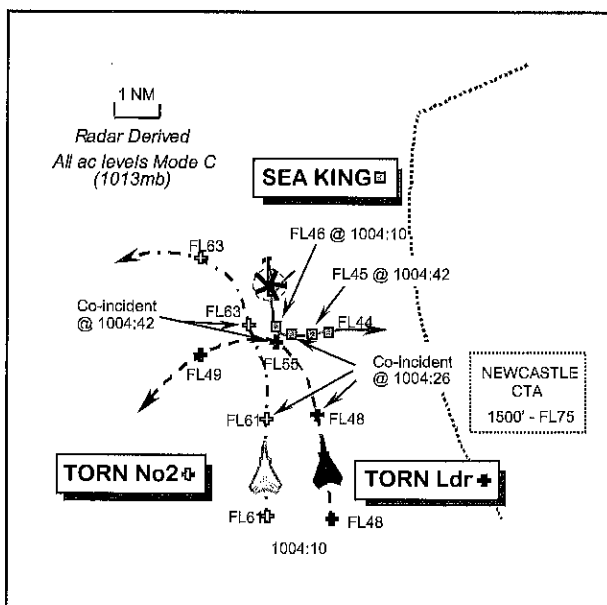
Date/Time: 14 Oct 1004  
Position: N5500 W0204 (14 NM W of Newcastle - elev 266 ft)  
Airspace: FIR (Class: G)  
Reporter: Newcastle ATC

<u>First Aircraft</u>	<u>Second Aircraft</u>
<u>Type:</u> Sea King Mk 3	Tornado F3
<u>Operator:</u> HQ STC	HQ STC
<u>Alt/FL:</u> 5000 ft (QNH 1030 mb)	6000 ft (RPS 1026 mb)
<u>Weather</u> IMC	VMC CLAC
<u>Visibility:</u> Not reported	10 km
<u>Reported Separation:</u>	1 NM H
<u>Recorded Separation:</u>	0.8 NM H/800 ft V

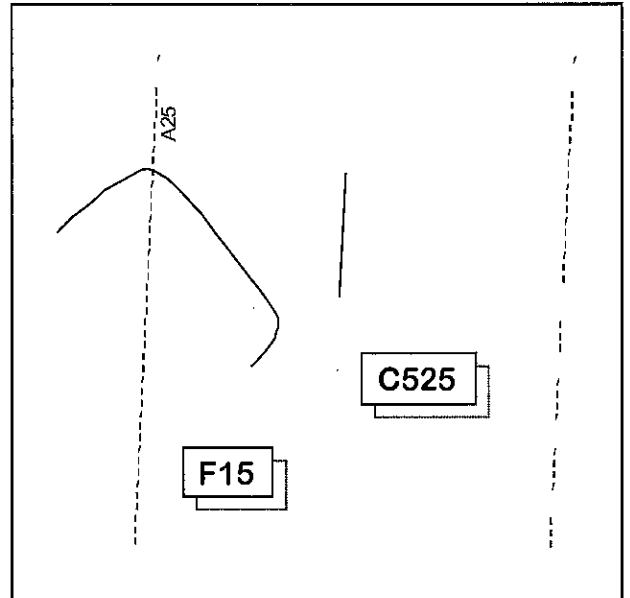
<u>First Aircraft</u>	<u>Second Aircraft</u>
<u>Type:</u> Cessna 525	F15
<u>Operator:</u> Civ Exec	Foreign Mil
<u>Alt/FL:</u> FL 175 ↑	↓ FL 140

Weather VMC CLAC VMC CLNC  
Visibility: 50 km  
Reported Separation: NK/NK  
Recorded Separation: 1 NM

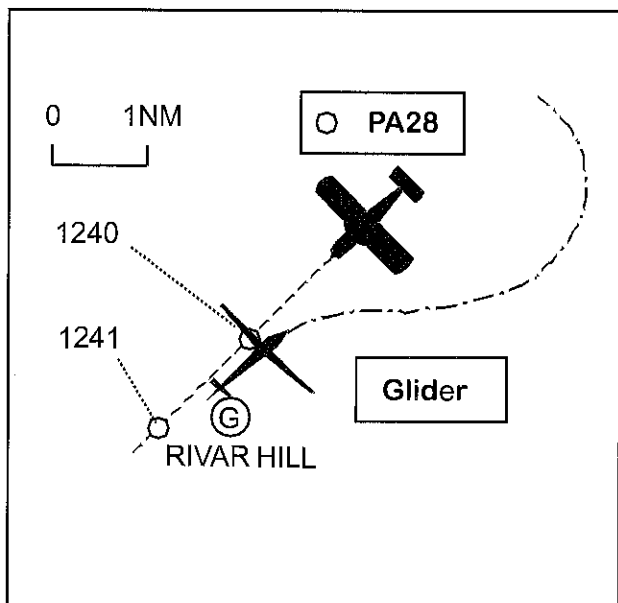
**AIRPROX REPORT No 186/99**

Date/Time: 13 Oct 1240  
Position: N5121 W0132.5 (1NM ENE Rivar Hill elev 730 ft)  
Airspace: FIR (Class: G)  
Reporting Aircraft Reported Aircraft  
Type: Ka8 Glider PA28  
Operator: Civ Pte Civ Pte  
Alt/FL: 2800 ft 3000 ft  
 (aal) (QNH 1031 mb)  
Weather VMC VMC CLBHZ  
Visibility: 15 Km 15 Km  
Reported Separation: 50-100 ft H & 50 ft  
 V400 m H & 100 ft V  
Recorded Separation: Not recorded

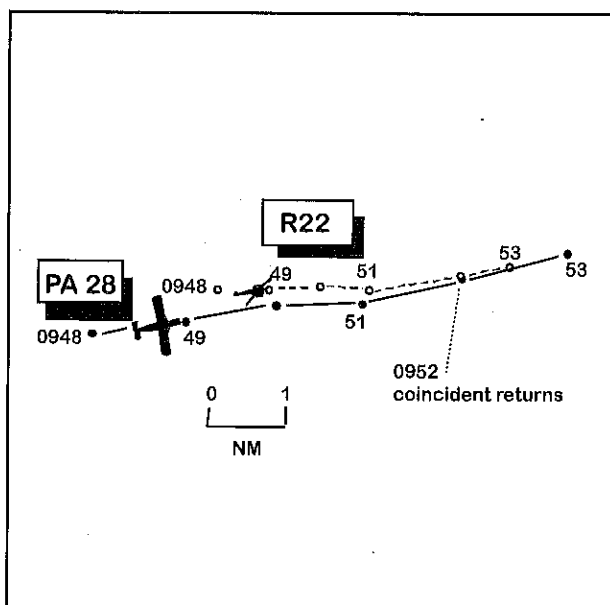
**AIRPROX REPORT No 187/99**

Date/Time: 17 Oct 0952 (Sunday)  
Position: N5051 W0003 (205 NM W Lewes)  
Airspace: FIR (Class: G)  
Reporting Aircraft Reported Aircraft  
Type: R22 Helicopter PA28 Archer  
Operator: Civ Trg Civ Club  
Alt/FL: 1800 ft 2000 ft  
 (QNH 1018 mb) (QNH 1018 mb)  
Weather VMC NIL CLOUD VMC SKY  
 CLEAR  
Visibility: 5 NM 5 - 7 km  
Reported Separation:  
 75 - 100 ft H // 005 NM H  
Recorded Separation: <200 m H

The Board noted from the radar recording that the tracks of the 2 ac gradually converged towards the point of closest passage. Contrary to the PA28 pilot's belief that they had passed the R22 by some 005 NM, it is evident that the lateral separation attained was considerably less than that. This mis-perception of distance, and the crew's inability to read the R22's registration, was probably due to the latter's very small size. Furthermore, members thought it unlikely that the small R22 would have been visible to the PA28 pilot at the 3 – 4 miles initial sighting distance he reported.

Cause: The PA28 pilot flew close enough to the R22 to cause concern to its pilot.

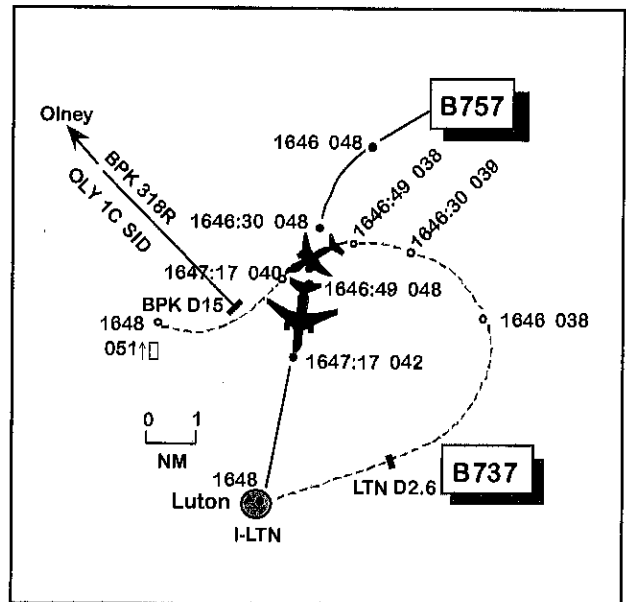
### AIRPROX REPORT No 188/99

Date/Time: 16 Oct 1647 (Saturday)  
Position: N5156 W0021 (305 NM N Luton airport)  
Airspace: LTMA (Class: A)  
Reporter: Luton ATC  
First Aircraft Second Aircraft  
Type: B73-3 B75-2  
Operator: CAT CAT  
Alt/FL: ↑ 6000 ft ↓ 3000 ft  
(QNH) (QNH)  
Reported Separation: N/A  
Recorded Separation: @1.6 NM/200 ft

in order to achieve separation from another ac departing outbound on a CPT SID. Unfortunately, in complying with this request the B757 descended more rapidly than he had anticipated which, together with the B737's unexpected turn to the SW, caused a loss of separation; however, this did not occur until after the acs' tracks had crossed.

Cause: The Luton Radar INT Director did not provide standard separation between the B737 and the B757.

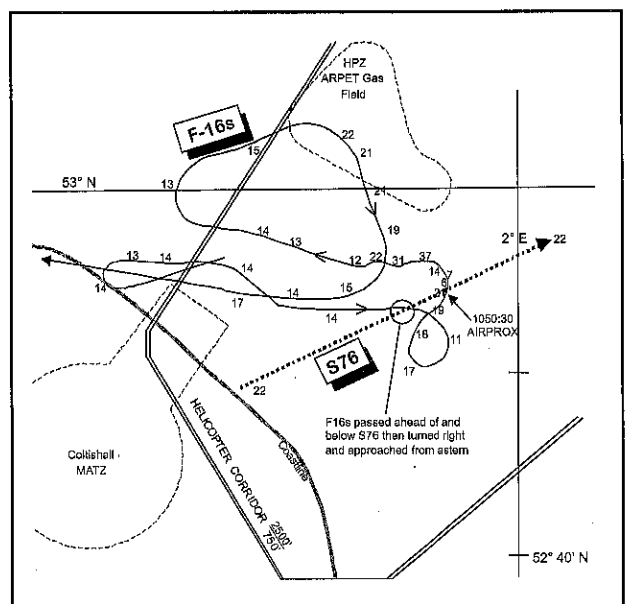
**AIRPROX REPORT No 189/99**

Date/Time: 26 Oct 1050  
Position: N5254 E0153 (21 NM E of Cromer)  
Airspace: FIR/SNSC (Class: G)  
Reporting Aircraft Reported Aircraft  
Type: S76 F16  
Operator: CAT Foreign Mil  
Alt/FL: 2000 ft ↑ 2000 ft ↓  
 (RPS 1006 mb)  
Weather VMC CLBC VMC  
Visibility: Unltd  
Reported Separation: 300 ft V, 200 yd H  
Recorded Separation: 200 ft

The Board concluded that the cause of the incident was the unapproved penetration of the SNSHC by the F16 pilot who flew close enough to the S76 to cause its pilot grave concern for the safety of his ac. While members accepted that, since the pilots had the S76 in sight, there was probably no risk of a collision with it, they appeared unaware of how close they had flown to it.

Cause: Unapproved penetration of the SNSHC by the F16 pilot who flew close enough to the S76 to cause its pilot grave concern for the safety of his ac.

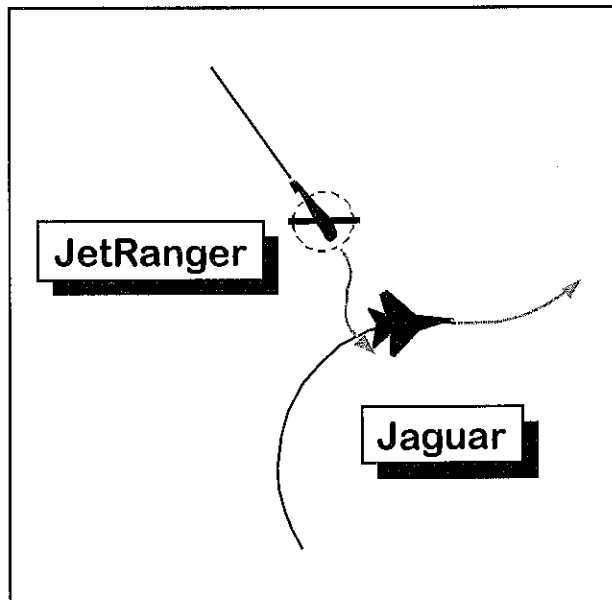
**THE JAGUAR PILOT** reports heading 010° at 450 kt while descending into Wainfleet range 10 seconds behind his leader. His navigation kit had failed and he was unfamiliar with the range so his workload was high. While in a 45° AOB right turn he saw what he believed to be a dark blue Twin Squirrel in his 11 o'clock, slightly above and 200 m away, tracking easterly. He tightened his turn and climbed to avoid it, by about 200 m, and considered the risk of collision was high. His leader had not seen the helicopter.

Cause: Late sighting by the Jaguar pilot.

Members noted the action taken by HQ MATO and Coningsby to formalise the passing of traffic information to the ranges which may in future lead to fast jets being given a 'heads-up' on such passing traffic. In the absence of this, in not the best visibility, the Jaguar pilot saw the JetRanger somewhat late and was only just in time to avoid it. Members agreed that this was the cause of the Airprox. This was not a criticism of the Jaguar pilot; it was simply a matter of fact. An earlier sighting while joining an unfamiliar range pattern on a murky day could not always be obtained.

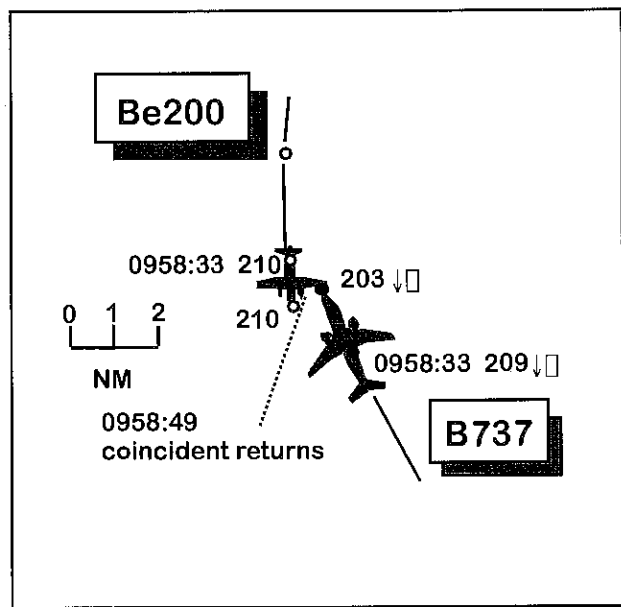
Date/Time: 27 Oct 0959  
Position: N5510 W0319 (20 NM S Talla)  
Airspace: Airway (Class: A)  
Reporter: ScACC Talla P and E controller  
First Aircraft      Second Aircraft  
Type: B73-2              Be200  
Operator: CAT              Civ Comm  
Alt/FL: ↓ FL 200          FL 210

Cause: The Talla P and E mentor controller allowed his trainee to descend the B737 into conflict with the Be200.

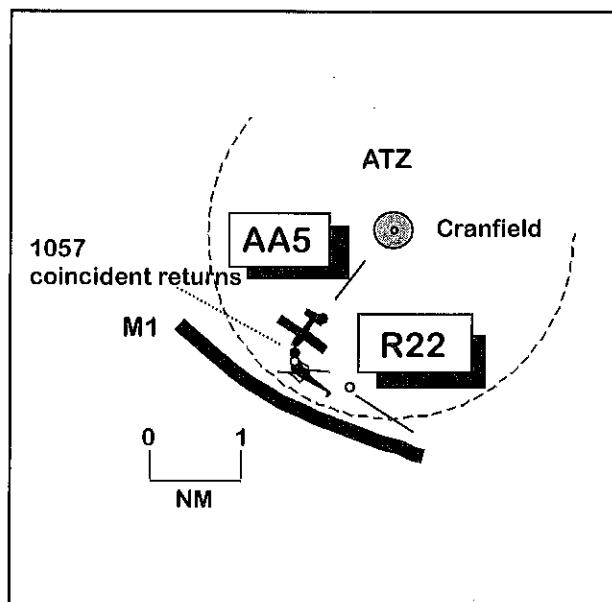
### **AIRPROX REPORT No 192/99**

Date/Time: 27 Oct 1057  
Position: N5203 W0039 (1.8 NM SW Cranfield - elev 364 ft)  
Airspace: ATZ (Class: G)  
Reporting Aircraft Reported Aircraft  
Type: R22 Helicopter AA5  
Operator: Civ Pte Civ Trg  
Alt/FL: 1100 ft ↑1000 ft  
 (QNH 1023 mb) (QFE 1010 mb)  
Weather VMC CLBC VMC CAVOK  
Visibility: >30 NM 25 km  
Reporting Separation:  
 10 m H 2 M V / 50 ft H 0 ft V  
Recorded Separation:  
 Radar returns merged

With respect to the AA5, a GA member commented that the ac had fairly low performance and he was not surprised at its extended circuit. Therefore, members felt that the locally based pilot ought to have been aware of the possibility of traffic following the motorway (using it as a navigational aid) and, notwithstanding the bright sun, should have paid more attention to lookout in that direction. Members agreed that his very late sighting of the helicopter was also a part cause of the Airprox.

Cause: Inadvertent penetration of the Cranfield ATZ by the R22 and very late sightings by both pilots.

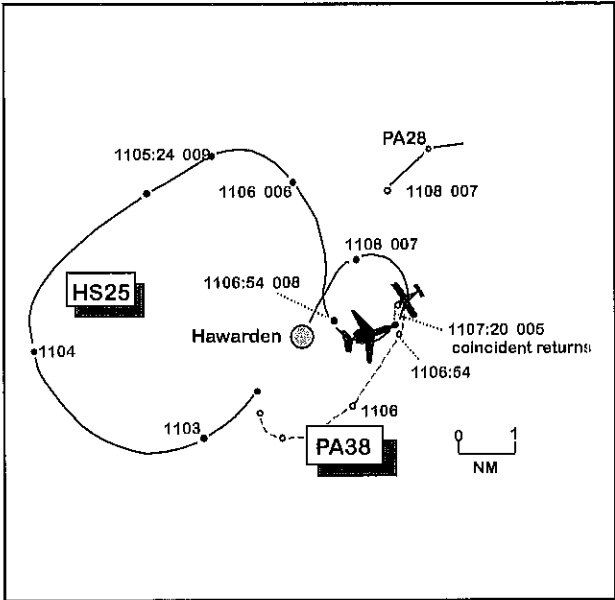
**AIRPROX REPORT No 193/99**

Date/Time: 29 Oct 1107  
Position: N5311 W0257 (1.75 NM E  
Hawarden - elev 35 ft)  
Airspace: ATZ (Class: G)  
Reporting Aircraft Reported Aircraft  
Type: PA38 HS125  
Operator: Civ Trg Civ Exec  
Alt/FL: 800 ft 1000 ft ↓  
(QFE 1021 mb) (QNH 1022 mb)  
Weather VMC VMC  
Visibility: 5 NM 10 km  
Reported Separation: 500 m/100 ft  
Recorded Separation: 500 m H

The Board concluded that the HS125 pilot's turn against to the circuit direction caused the Airprox; moreover, as he did not see the PA38, and the latter did not see the HS125 in time to take avoiding action, it was assessed that the safety of both ac had been compromised.

Cause: The HS125 pilot turned against the circuit direction and flew into conflict with the PA38 which he did not see.

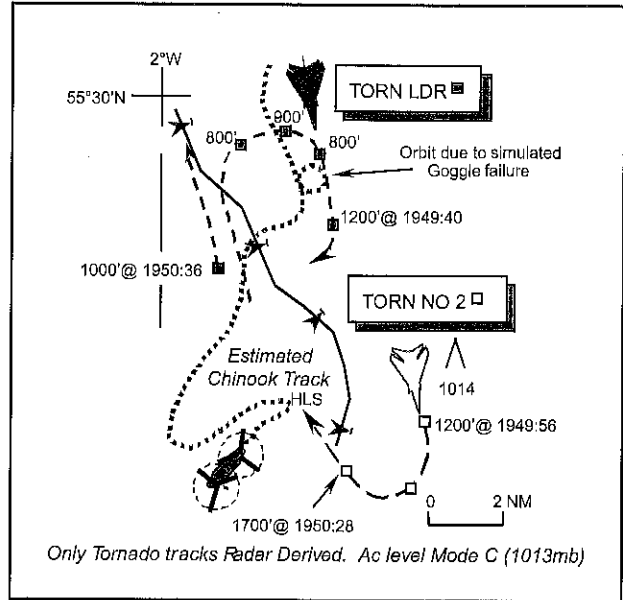
**AIRPROX REPORT No 194/99**

Date/Time: 2 Nov 1949 NIGHT  
Position: N5528 W0152  
 (10 NM NW of Boulmer)  
Airspace: LFS (Class: G)  
Reporting Aircraft Reported Aircraft  
Type: Tornado GR4 Chinook  
Operator: HQ STC HQ JHC  
Alt/FL: 800 ft <150 ft agl ↓  
 Rad Alt RPS (1001 mb)  
Weather VMC CLOC VMC CLOC  
Visibility: >10 km 40 km  
Reported Separation: <5 NM  
Recorded Separation: Not recorded

Cause: A breakdown in communication between the exercise sponsor and helicopter operator resulted in the Chinook operating at night in a low flying sector allocated to another user.

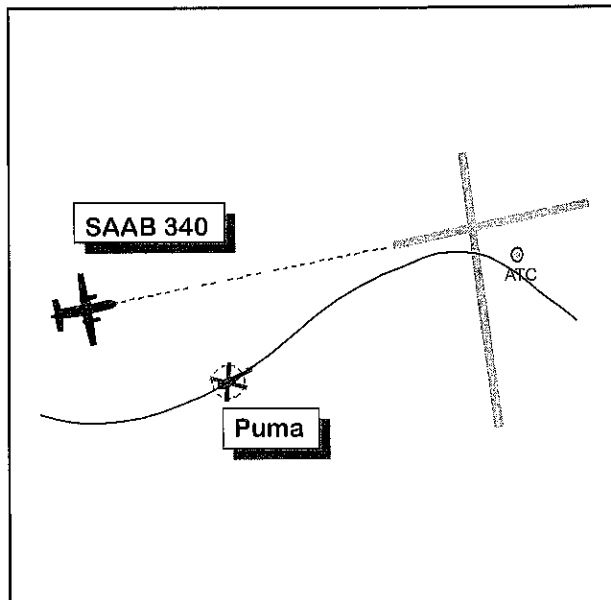
Date/Time: 18 Oct 1359  
Position: N5440 W0615 (1 NM SW of Aldergrove)  
Airspace: CTZ (Class: D)  
Reporting Aircraft Reported Aircraft  
Type: SAAB 340 Puma  
Operator: CAT HQ STC  
Alt/FL: 500 ft ↓ 50 ft  
(QNH) (Rad Alt)  
Weather VMC CLBC VMC CLBC  
Visibility: 15 km 10 km+  
Reported Separation:  
300 m, 150 ft 1.5 NM, 600 ft  
Recorded Separation: NK

There was no recorded evidence on the precise track flown by the Puma; the diagram in the report is an interpretation of the pilots' reports. The Board agreed that there was no risk of collision in the event (for which an Airprox report did not seem entirely appropriate) because both pilots could see the other ac and knew they had been seen. However it appeared that the Puma pilot had flown close enough to the runway centreline to cause the SAAB 340 pilot some concern for the safety of his flight and members agreed that this was the cause of the report. It was as much a matter of good manners and consideration as flight safety and the Board was advised that a reminder to keep well clear of commercial ac had been issued to the helicopter crews.

Cause: The Puma pilot flew close enough to the runway centreline to cause concern to the SAAB 340 pilot.

The fact remains that the proximity of the Puma gave cause for concern to the airliner crew, and Aldergrove military helicopter crews will be reminded of the requirement both to adhere strictly to ATC clearances and to ensure healthy separation from civilian ac, particularly when at critical stages of flight.

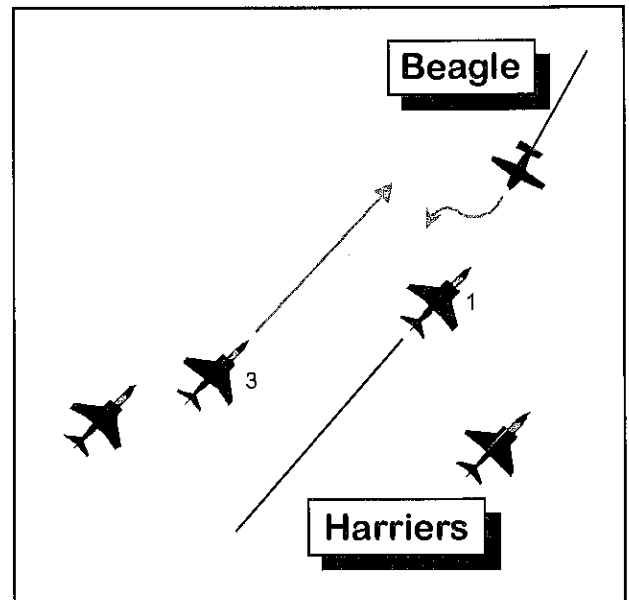
**THE HARRIER PILOT** reports heading 080° at 360 kt as No 3 of a 4 ac formation recovering to Wittering; they were flying at 1500 ft in close battle formation at 360 kt. His leader saw a light ac some 2 NM ahead, called it and bunted to avoid it, then he pulled up with No 4 to avoid it also by 500 ft with minimal horizontal separation. The white/red light ac passed on a reciprocal through the middle of the formation with a moderate risk of collision; the pilots described it as similar to a Bulldog, but not a Bulldog.

Cause: Confliction of flightpaths.

While the circumstances of the incident had defied explanation for some months due to discrepancies in the information reported to UKAB, it appeared to members that this was a fairly straightforward confliction of flightpaths in Class G airspace which was resolved in a reasonably timely manner by all the pilots involved. The closing speed had not left much time for avoiding action, or for a sighting of the Beagle by the Harrier pilots, but members considered that the pilots' actions had removed any risk of the ac actually colliding. It was noted, with approval, that the Harrier pilots had manoeuvred in the vertical plane to avoid the Beagle; it had often appeared to the Board that military pilots at low level were reluctant to use the vertical in circumstances where such a manoeuvre would produce a safer resolution of a confliction.

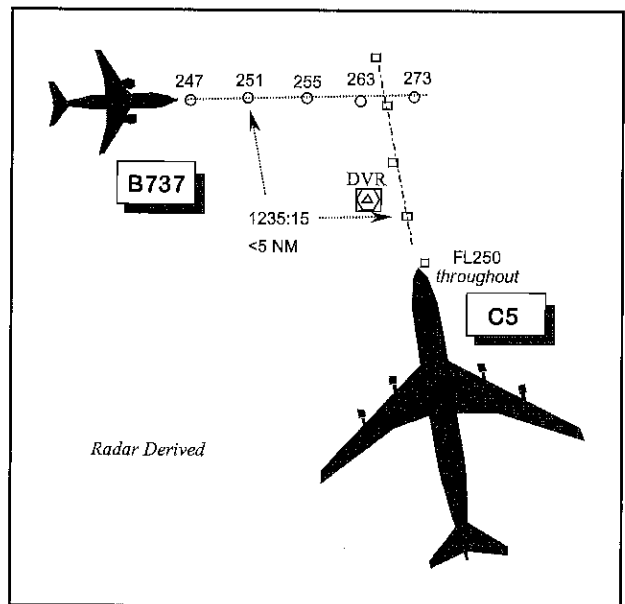
Date/Time: 3 Nov 1236  
Position: N5113 E0122  
 (3 NM N of DOVER VOR)  
Airspace: UAR (Class: B)  
Reporter: LATCC DOVER SC

<u>Aircraft No 1</u>	<u>Aircraft No 2</u>
<u>Type:</u>	B737-400	C5 GALAXY
<u>Operator:</u>	CAT	Foreign Mil
<u>Alt/FL:</u>	FL 270 ↑	FL 220
<u>Weather</u>	VMC NIL	VMC UNK
<u>Visibility:</u>	10 km	UNK
<u>Reported Separation:</u>		
	SC	1.1 NM H/600 ft
	B 737-400 Pilot	Nil H/1100 ft V
<u>Recorded Separation:</u>		2 NM H/500 ft V

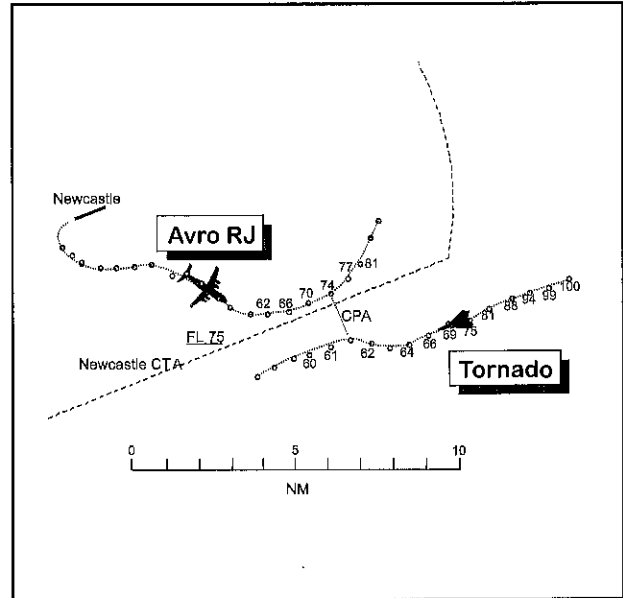
Date/Time: 3 Nov 2004 NIGHT  
Position: N5458 W0127 (9 NM SE of Newcastle)  
Airspace: FIR (Class: G)  
Reporter: Newcastle ATC  
First Aircraft Second Aircraft  
Type: Avro RJ Tornado F3  
Operator: CAT HQ STC  
Alt/FL: ↑ FL 140 FL 100 ↓

Weather IMC IICL VMC CLAC  
Visibility: NK  
Reported Separation: NK/1-2 NM  
Recorded Separation: 1.5 NM, 1200 ft

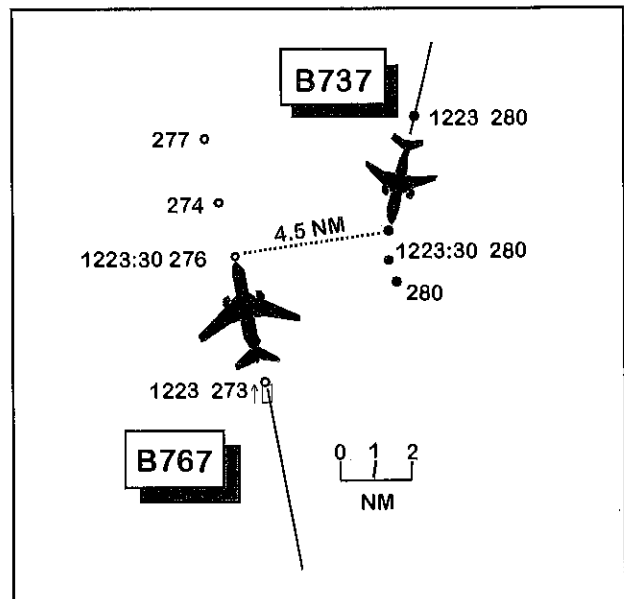
**AIRPROX REPORT No 200/99**

Date/Time: 1 Nov 1223  
 Position: N5343 E0328 (MULIT) Airspace:  
 UAR (Class: B)  
 Reporting Aircraft Reported Aircraft  
 Type: B76-3 B73-2  
 Operator: CAT CAT  
 Alt/FL: FL 280 FL 280  
 Weather IMC VMC  
 Visibility: Not given >10 NM  
 Reported Separation:  
 1 NM/300 ft / NK  
 Recorded Separation: 405 NM/400 ft

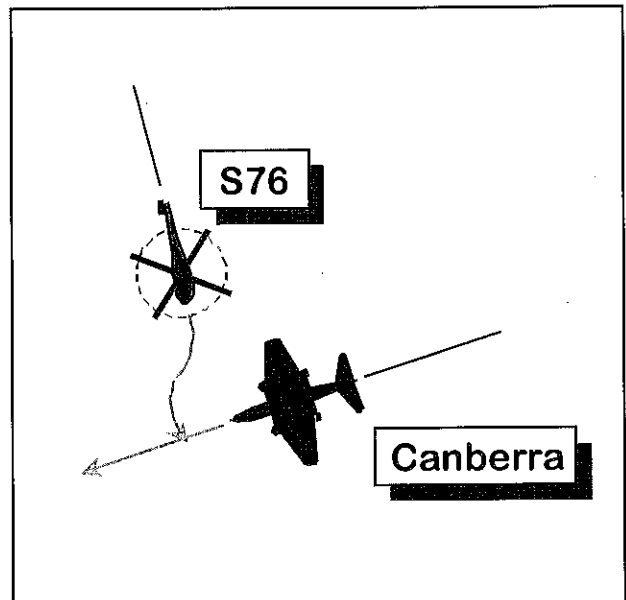
**AIRPROX REPORT No 201/99**

Date/Time: 4 Nov 1547  
Position: N5206 W0042 (1 NM N of Newport Pagnell)  
Airspace: FIR/LFS (Class: G)  
Reporting Aircraft Reported Aircraft  
Type: S-76 Canberra  
Operator: Civ Comm HQ STC  
Alt/FL: 2000 ft 2400 ft  
(RPS 1004 mb) (Rad Alt)  
Weather: VMC CLNC VMC CLOC  
Visibility: 10 km+ Unltd  
Reported Separation:  
0.25 NM, 300 ft/NK  
Recorded Separation: 0.5 NM, 100 ft

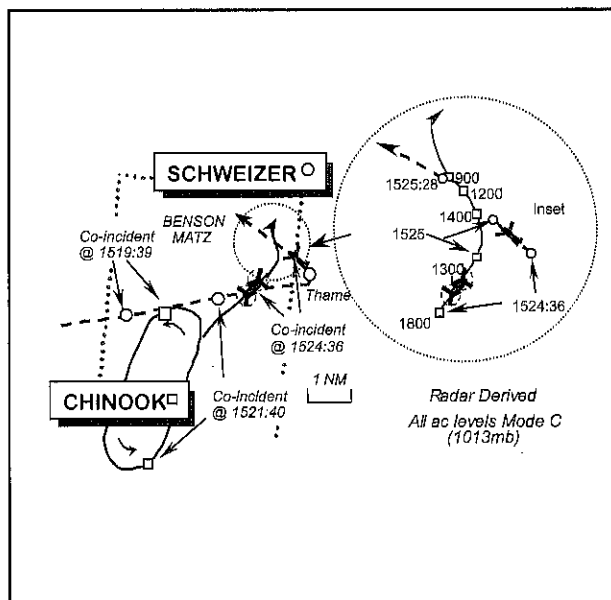
**AIRPROX REPORT No 202/99**

Date/Time: 9 Nov 1525  
Position: N5145 W0102 (8.5 NM NNE of Benson - elev 226 ft)  
Airspace: MATZ (Class: G)  
Reporting Aircraft Reported Aircraft  
Type: Chinook Mk2 Schweizer 300  
Operator: HQ JHC Civ Trg  
Alt/FL: 1800 ft 2000 ft  
(QFE 1031mb) (QFE 1031mb)  
Weather VMC CLBC VMC  
Visibility: >10 km 20 km  
Reported Separation: Nil H 100 ft V  
Recorded Separation: Not recorded

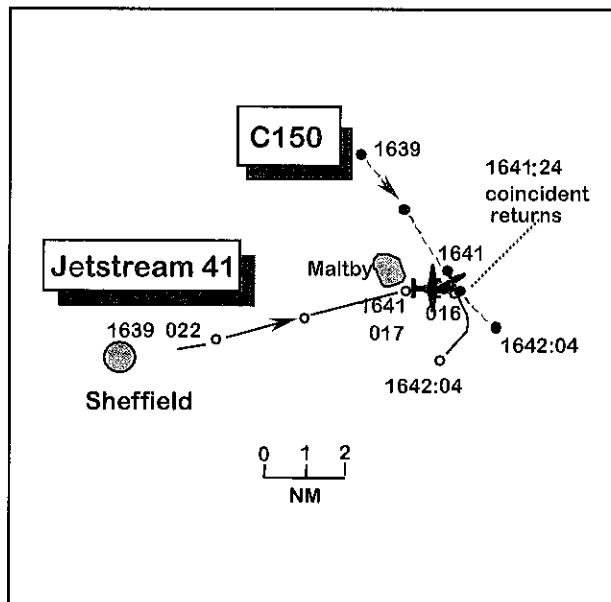
**AIRPROX REPORT No 204/99**

Date/Time: 14 Nov 1641 (Sunday) NIGHT  
Position: N5325 W0110 (8 NM E Sheffield airport)  
Airspace: FIR (Class: G)  
Reporting Aircraft Reported Aircraft  
Type: J41 Jetstream C152  
Operator: CAT Civ Pte  
Alt/FL: 1900 ft 2500 ft  
 (QNH 1023 mb) NK  
Weather VMC VMC CAVOK  
Visibility: 8 km 10 km  
Reported Separation:  
 0 ft V 200 m H 0 ft V 150 m H  
Recorded Separation: <500 m H

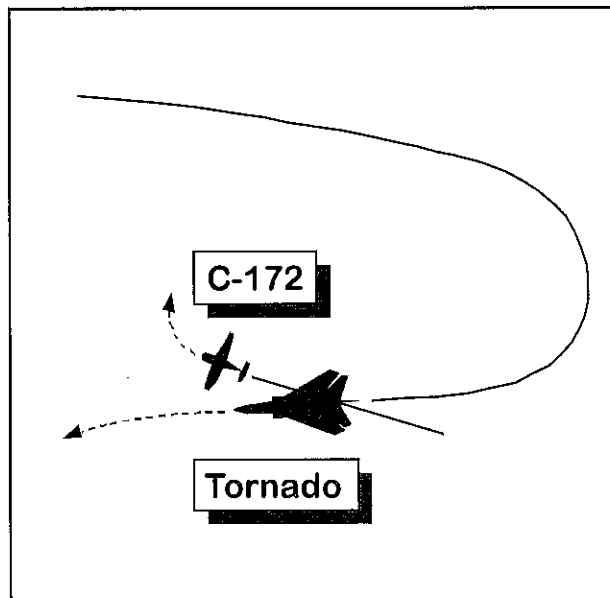
**THE TORNADO PILOT** reports flying a CAP to bounce other members of his section. He was at about 5000 ft. While rolling out from a right hand turn at 420 kt he saw a small ac slightly above and close to his flightpath; it had been concealed behind the canopy arch. He reversed his turn to the left and did not feel he had conflicted with the light ac's flightpath.

**HQ STC** comments that having established a visual CAP at 5000 ft it is likely that the Tornado crew were concentrating their lookout at low level, hoping for an early sighting of their targets. Consequently the pick-up of the Cessna may have been later than desirable but the Tornado captain's report suggests that sufficient time remained for safe and effective avoiding action to be taken.

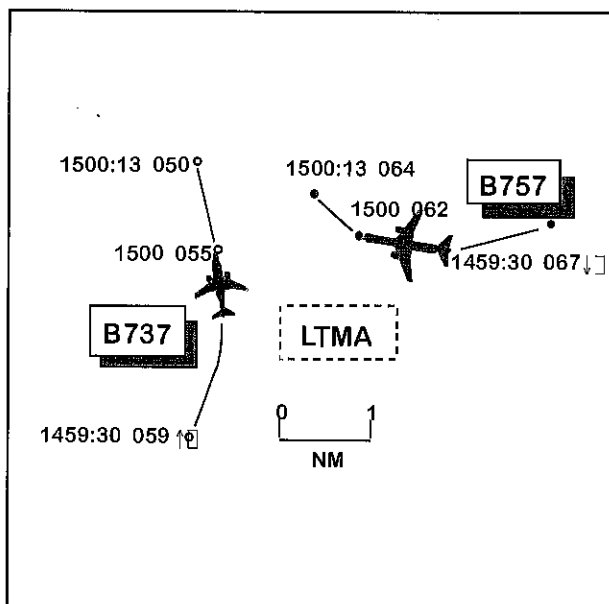
**AIRPROX REPORT No 206/99**

Date/Time: 19 Nov 1500  
Position: N5135 W0035 (8.5 NM NW Heathrow)  
Airspace: LTMA (Class: A)  
Reporter: LATCC TC  
First Aircraft      Second Aircraft  
Type: B73-4              B757  
Operator: CAT              CAT  
Alt/FL: 6000 ft              4000 ft  
                   (QNH 1019 mb)      (QNH)  
Weather VMC              VMC  
Visibility: 10 km              10 km  
Reported Separation:  
                   2 NM// 1 NM/500 ft  
Recorded Separation:              1.5 NM/700 ft

Cause: The Heathrow INT Director descended the B757 into conflict with the departing B737.

An ATSI adviser to the Board said that the Airprox occurred after the Heathrow INT Director had issued descent clearance to the B757 (the first easterly arrival from the northern stacks) without taking the B737 (the final westerly departure) into account. The Board agreed this caused the incident. No reason for this error could be established with certainty, but it was assumed that, having simply forgotten about the final westerly departure, the Director's attention to radar derived information had not extended to ac beyond his control. The adviser added that these RW change procedures were long established; experience had shown that they worked well and did not need to be changed. However, he felt it might be prudent to display on radar screens the full SSR labels of the last 3 departures during runway changes to make their radar returns more conspicuous. In addition, the provision of individual strips for each of these ac, annotated with the callsign and SID, might help prevent this type of error being repeated. Commenting on the first suggestion, an ATCO member said that the volume of traffic showing on a radar display in this area was often such that if all ac displayed full SSR information their data blocks would merge and it would become difficult, if not impossible, to retain radar identification.

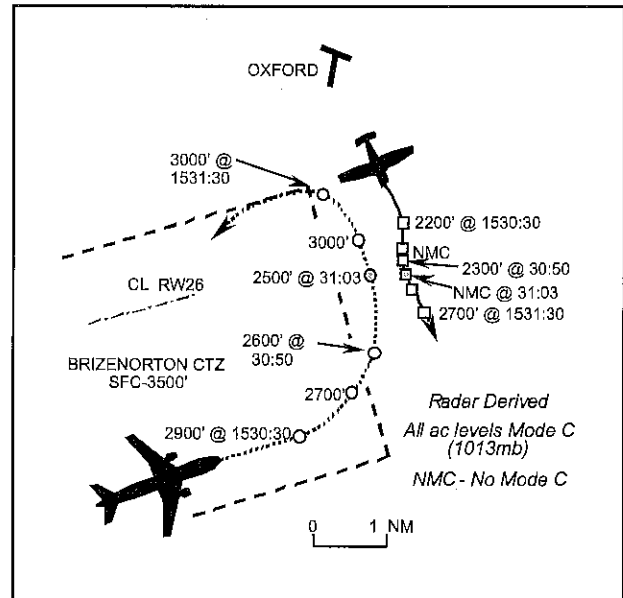
**AIRPROX REPORT No 207/99**

Date/Time: 24 Nov 1531  
Position: N5147 W0118 (11 NM E Brize Norton - elev 288 ft)  
Airspace: L FIR (Class: G)  
Reporting Aircraft Reported Aircraft  
Type: A300-600 PA28  
Operator: Civ Comm Civ Trg  
Alt/FL: ↓ 2300 ft ↑ FL 50  
 (QNH 1021mb)  
Weather VMC CAVOK VMC CLOC  
Visibility: >10 km 20 km  
Reported Separation:  
 100 ft V 300 m H 0.5-1 NM H  
Recorded Separation: 0.5 NM H

Cause: Lack of positive control by the Brize Norton APPROACH controller.

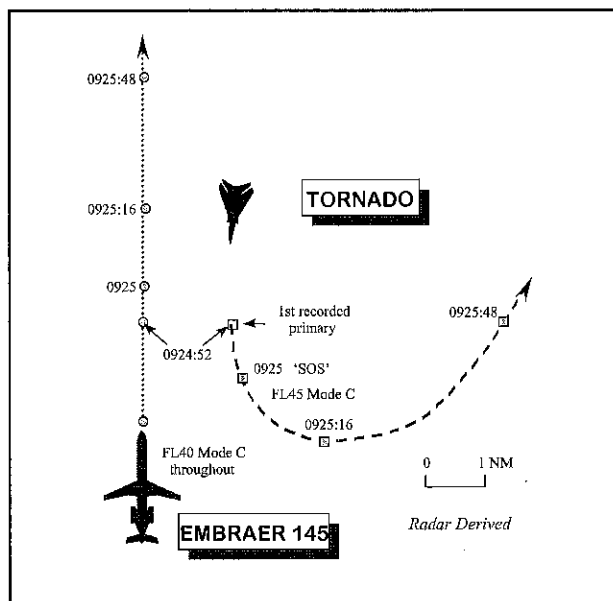
**AIRPROX REPORT No 209/99**

Date/Time: 02 Dec 0925  
Position: N5550 W0301  
 (14 NM SE of Edinburgh - elev 135 ft)  
Airspace: Scottish TMA (Class: E)  
Reporter: EDINBURGH APR Controller  
First Aircraft      Second Aircraft  
Type: Embraer 145      Tornado GR 1  
Operator: CAT      STC  
Alt/FL: 4000 ft      ↑ 4000 ft  
 (QNH 1014mb)  
Weather: VMC CLAC      VMC  
Visibility: 10 km      10 km into sun  
Reported Separation: Nil V/1.5 NM H  
Recorded Separation:  
 500 ft @ >1.5 NM H

Cause: The Edinburgh APR controller thought the Tornado had conflicted with the Embraer 145.

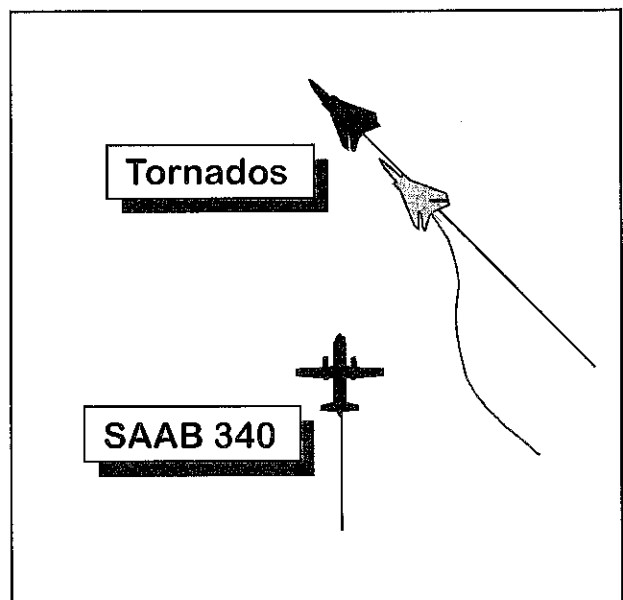
**AIRPROX REPORT No 210/99**

Date/Time: 2 Dec 1021  
Position: N5603 W0204 (10 NM NNE of SAB)  
Airspace: FIR (Class: G)  
Reporting Aircraft Reported Aircraft  
Type: SAAB 340 Tornado F3  
Operator: CAT HQ STC  
Alt/FL : FL 150 21000 ft ↓ (RPS)  
Weather VMC CLOC VMC CLOC  
Visibility: 50 km 100 km  
Reported Separation: 2 NM/2 NM  
Recorded Separation: 1 NM

**HQ STC** comments that this incident was precipitated by the Tornado's cockpit pressurisation failure and the requirement for an emergency descent. The crew were aware of their impending breach of co-ordination but, visual with the previously co-ordinated civilian traffic more than 2 NM away and satisfied that there was absolutely no risk of collision, cleared their flightpath and actioned their in-flight emergency appropriately. This descent, however, left the Buchan IC with insufficient time to re-negotiate with Scottish Military. In view of the scenario, therefore, and the probability of conflict with other traffic, the crew might have been afforded more latitude had they declared their emergency, however minor they deemed it. Their subsequent requirement to deviate from their agreed level could then have been reinforced by selecting an emergency squawk.

Cause: Sighting report.

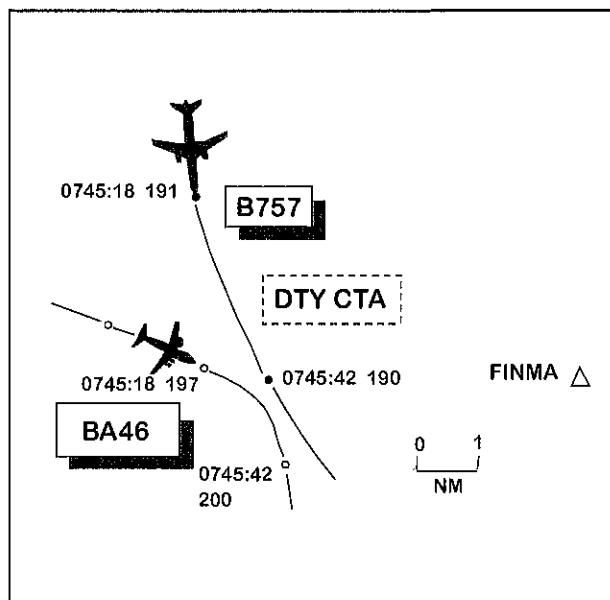
## AIRPROX REPORT No 211/99

Date/Time: 2 Dec 0745  
Position: N5202 W0114 (6.5 NM WNW  
FINMA)  
Airspace: CTA (Class: A)  
Reporting Aircraft Reported Aircraft  
Type: BA46 B75-2  
Operator: CAT CAT  
Alt/FL: FL 200 ↑ FL 270  
Weather VMC VMC  
Visibility: 10 km NK  
Reported Separation:  
not given/not given  
Recorded Separation: 2.75 NM/600 ft

UKAB Note: A recording of the Debden radar at 0745:18 shows the BA46 tracking 110° at FL 197 with the B757 2.7 NM due N indicating FL 191 on a southerly heading. This is about the time of minimum separation. (SMF data gives minimum separation distances of 2.18 NM and 500 ft at 0745:23; however, it should be noted that SMF recorded separation may differ slightly from the true separation and radar recordings because it is based on processed and predictive radar data). By 0745:42 standard vertical separation has been restored, with the BA46 showing FL 200 and the B757 FL 190.

Cause: The COWLY W SC mentor did not ensure standard separation between the B757 and The BA46.

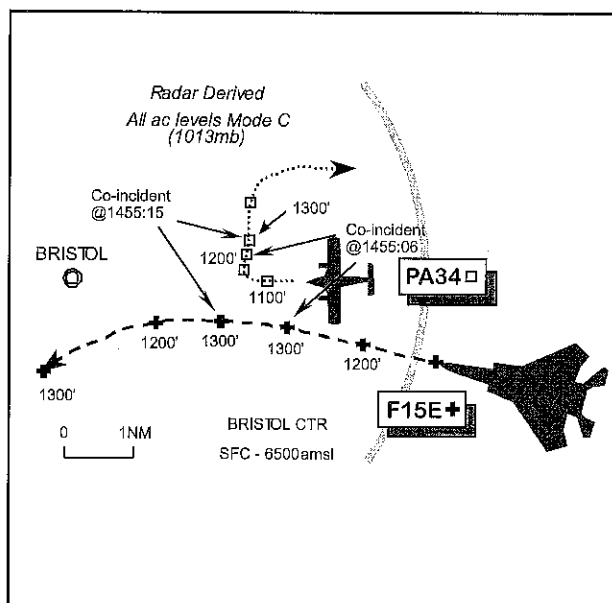
### **AIRPROX REPORT No 212/99**

<u>Date/Time:</u>	02 Dec 1455	
<u>Position:</u>	N5122 W0240 (2.5 NM E of Bristol - elev 622 ft)	
<u>Airspace:</u>	Bristol CTR	(Class: D)
<u>Reporter:</u>	Bristol ATC	
	<u>First Aircraft</u>	<u>Second Aircraft</u>
<u>Type:</u>	PA34-200T	F15E
<u>Operator:</u>	Civ Trg	Foreign Mil
<u>Alt/FL:</u>	1500 ft (QNH 1023mb)	1800 ft (RPS 1018mb)
<u>Weather</u>	VMC CLOC	
<u>Visibility:</u>	20 km	8 km
<u>Reported Separation:</u>	nil V/0.5 NM H	Not seen
<u>Recorded Separation:</u>	1 NM H/100 ft V

**HQ 3 AF** comments that this unfortunate penetration of Class D airspace came about following a partial failure of the moving map display, shortly after the pilot cancelled a radar service and continued the mission VFR. New software had been installed on the navigation suite of the ac prior to this flight, and an incompatibility caused the loss of information to the crew. Having identified the problem, a software modification subsequently cured the fault and no further malfunctions have been reported.

Cause: Inadvertent penetration of the Bristol CTR by the F15E crew whilst unaware of their position.

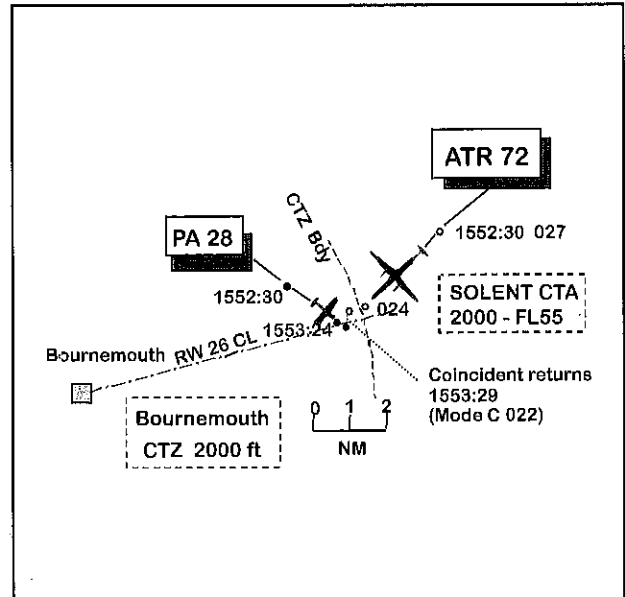
Recorded Separation: @800 m H

Cause: Unauthorised penetration of the Bournemouth CTZ by the PA28 pilot who flew into conflict with the ATR72, which he did not see.

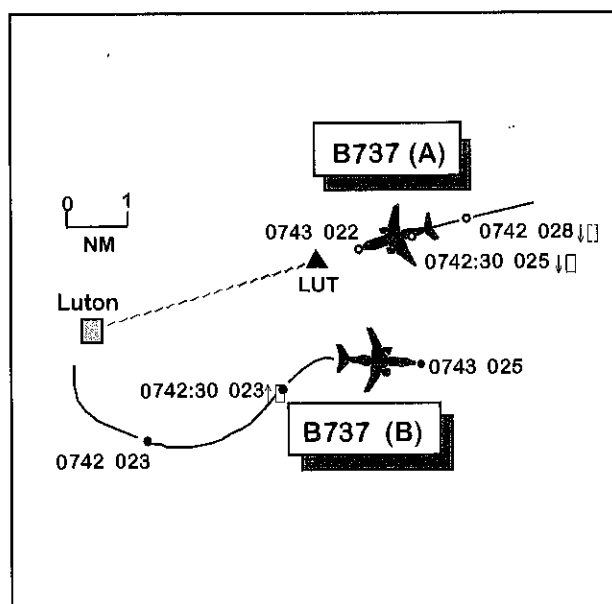
### **AIRPROX REPORT No 214/99**

<u>Date/Time:</u>	3 Dec 0743	DAY
<u>Position:</u>	N5153 W0015 (405 NM E Luton airport)	
<u>Airspace:</u>	CTZ	(Class: D)
<u>Reporter:</u>	Luton ATC	
	<u>First Aircraft</u>	<u>Second Aircraft</u>
<u>Type:</u>	B737 (A)	B737 (B)
<u>Operator:</u>	CAT	CAT
<u>Alt/FL:</u>	↓ILS	↑3000 ft (QNH)
<u>Weather</u>	VMC	VMC
<u>Visibility:</u>	NK	NK
<u>Reported Separation:</u>	2 NM same level	
<u>Recorded Separation:</u>	2 NM/200 ft

Cause: Confliction between the Missed Approach Procedure and the Approach Procedure to RW26 at Luton.
