**UK AIRPROX BOARD**

**Analysis of  
Airprox in UK Airspace**  
Report Number 3  
July 1999 to December 1999

Report by the UK Airprox Board,  
'Analysis of Airprox in UK Airspace'  
(July 1999 to December 1999)

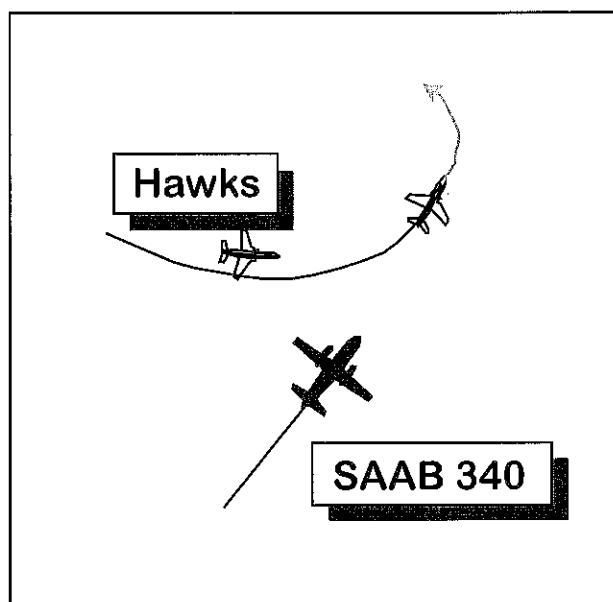
### **AIRPROX REPORT No 215/99**

Date/Time: 2 Dec 1024  
Position: N5612 W0229 (17 NM NNE of SAB)  
Airspace: FIR (Class: G)  
Reporting Aircraft Reported Aircraft  
Type: SAAB 340 Hawk  
Operator: CAT HQ PTC  
Alt/FL: FL 150 NK (RPS)  
Weather VMC CLOC VMC CLOC  
Visibility: 50 km Unltd  
Reported Separation: 2 NM/NK  
Recorded Separation: < 1 NM

Cause: Conflict of flightpaths in Class G airspace.

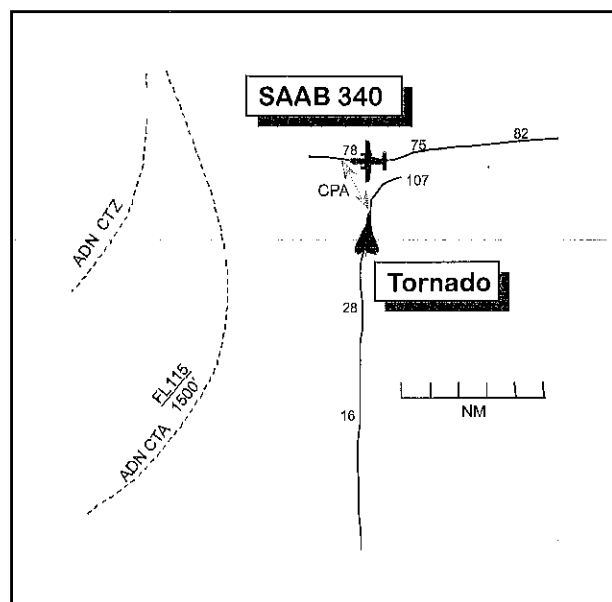
Recorded Separation: 1.8 NM

Cause: Confliction of flightpaths in Class G airspace, resolved by the actions of the pilots and controllers concerned.

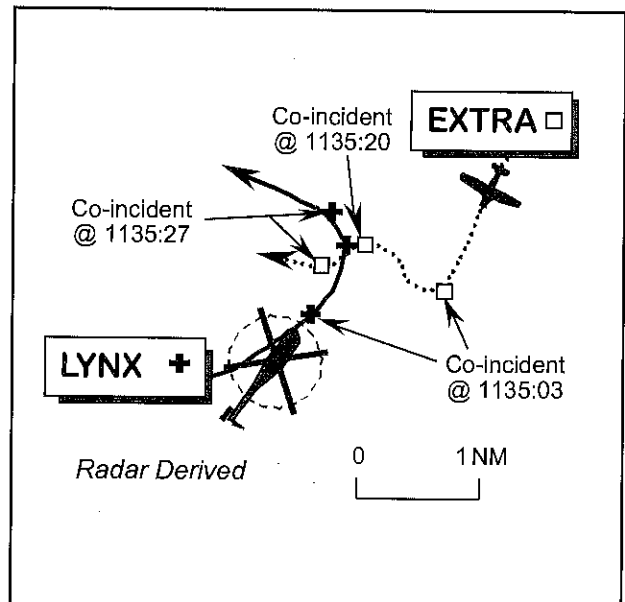
**AIRPROX REPORT No 218/99**

Date/Time: 10 Dec 1135  
Position: N5114 W0045  
 (8.5 NM ESE Odiham - elev 405 ft)  
Airspace: L FIR (Class: G)  
Reporting Aircraft Reported Aircraft  
Type: Lynx AH7 Extra EA260  
Operator: HQ DAAvn Civ Pte  
Alt/FL: 1500 ft 2500 ft  
 (QFE 989 mb) (QNH 1004 mb)  
Weather VMC CAVOK VMC CAVOK  
Visibility: 40 km+ 50 km+  
Reported Separation:  
 1-200 M H Nil V/800 ft V  
Recorded Separation:  
 Radar Contacts Merge

Cause: The Extra pilot flew close enough to the Lynx to cause its pilot concern, compounded by a late sighting by the Lynx crew.

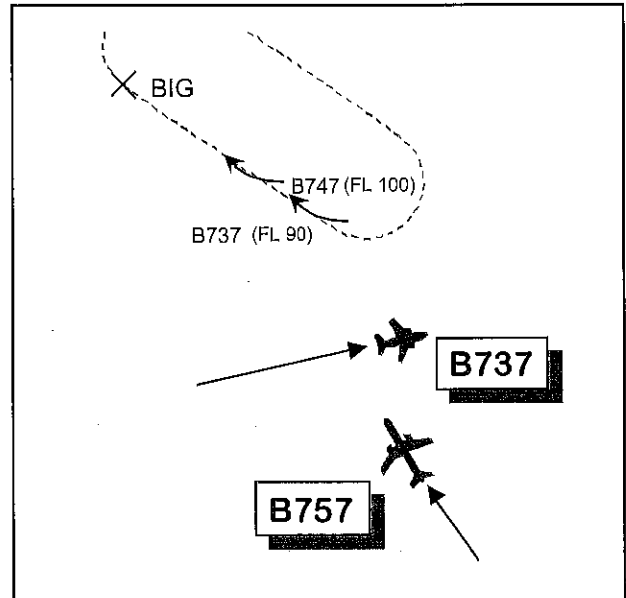
holding ac. Minimum separation between the subject ac was recorded as 2.1 NM laterally and 400 ft vertically, as the B737 passed north of the B757. The pilot of the latter ac reported the incident between his ac and the B737 as an Airprox. Separation between the holding ac reduced to about 0.6 NM horizontally and 600 ft vertically. Although an Airprox was filed for this loss of standard separation between these two ac, it was subsequently withdrawn. Lateral separation between the B737 and the B747 fell to a minimum of 2.7 NM, at which time the vertical distance was 700 ft. Standard separation, in the circumstances of this occurrence, is 3 NM laterally and 1000 ft vertically.

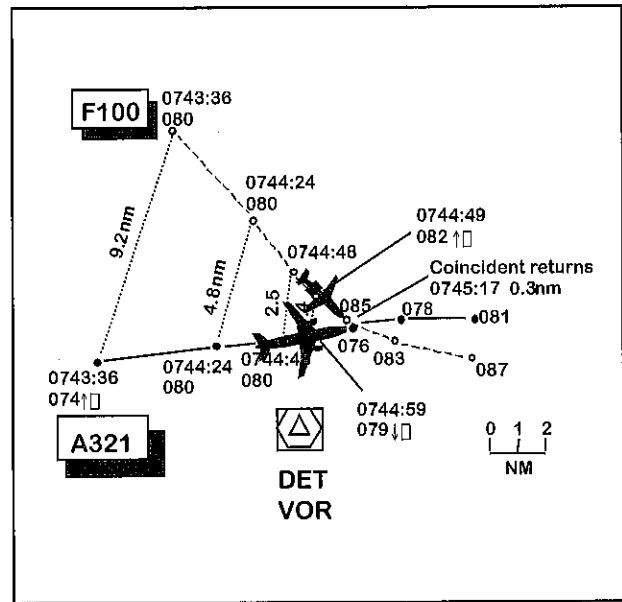
Date/Time: 14 Dec 0745  
Position: N5122 E0038 (4 NM NE Detling VOR)  
Airspace: LTMA (Class: A)  
Reporting Aircraft Reported Aircraft  
Type: F100 A321  
Operator: CAT CAT  
Alt/FL: FL 80 FL 80

Weather VMC VMC NK  
Visibility: 25 km NK  
Reported Separation:  
 Nil H, 400 ft V/ Nil H, 500 ft V  
Recorded Separation: @ 1 NM/700 ft

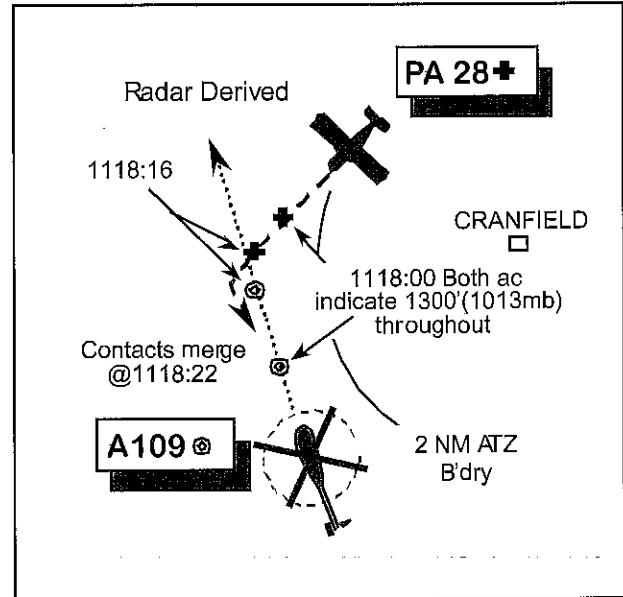
## AIRPROX REPORT No 222/99

Date/Time: 15 Dec 1118  
Position: N5204 W0042 (2.75 NM W of Cranfield - elev 364 ft)  
Airspace: London FIR (Class: G)  
Reporting Aircraft Reported Aircraft  
Type: Agusta 109E PA28-161  
Operator: Civ Comm Civ Pte  
Alt/FL: 1500 ft 1100 ft  
(QNH 1017 mb) (QFE 1004 mb)  
Weather VMC CLBC VMC CLBC  
Visibility: 7 km 8-10 km  
Reported Separation:  
2-300 ft V 200 yd H/NK  
Recorded Separation: Nil H/Nil V

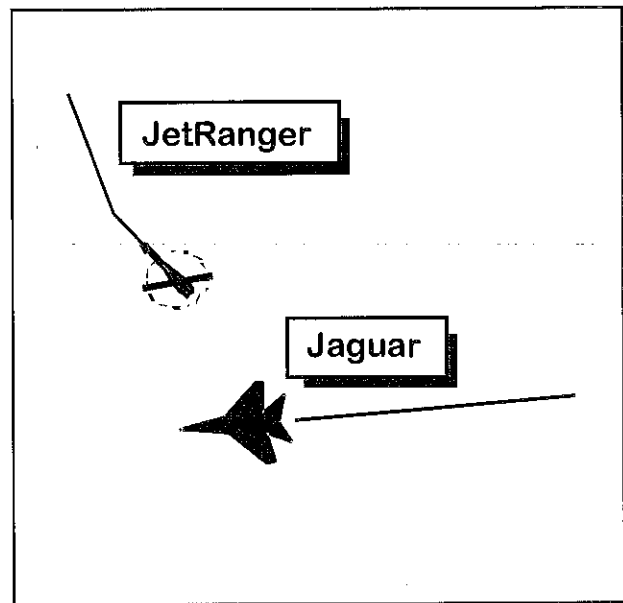
UKAB Note (1): While the helicopter pilot and his observer were convinced the jet involved was a Harrier, the incident can be seen on LATCC radar recordings exactly as described by the helicopter pilot, and the only military ac

booked into LFA 18 was a Jaguar. Its pilot confirmed that his route and timings were as shown on the radar recording. On the recording, the 2 ac show clearly and, in the area, no other is shown which could be a Harrier for many minutes either side of the time, which (with the position) agreed exactly with the details reported by the JetRanger pilot. Because of his continuing conviction, AIS (Mil) additionally checked with all Harrier operators to see if any had been S of Gatwick that afternoon; none had been.

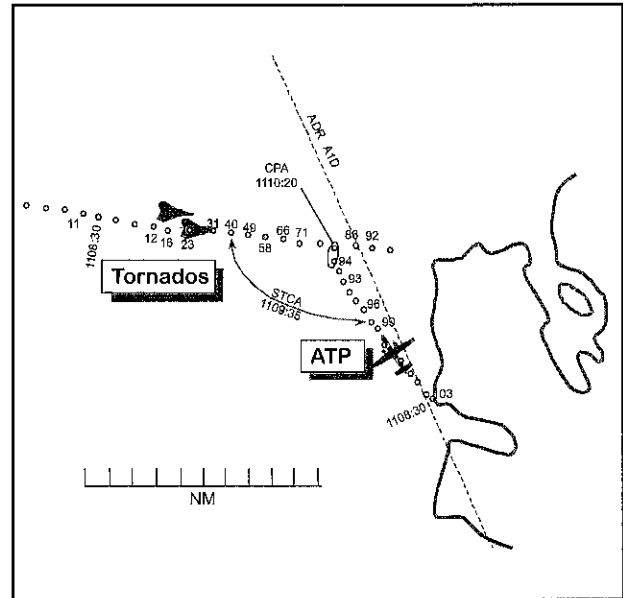
Recorded Separation: 1300 ft V, 0.5 NM H
