UK AIRPROX BOARD

**Analysis of
Airprox in UK Airspace**
Report Number 5
July 2000 to December 2000

Report by the UK Airprox Board,
'Analysis of Airprox in UK Airspace'

(July 2000 to December 2000)

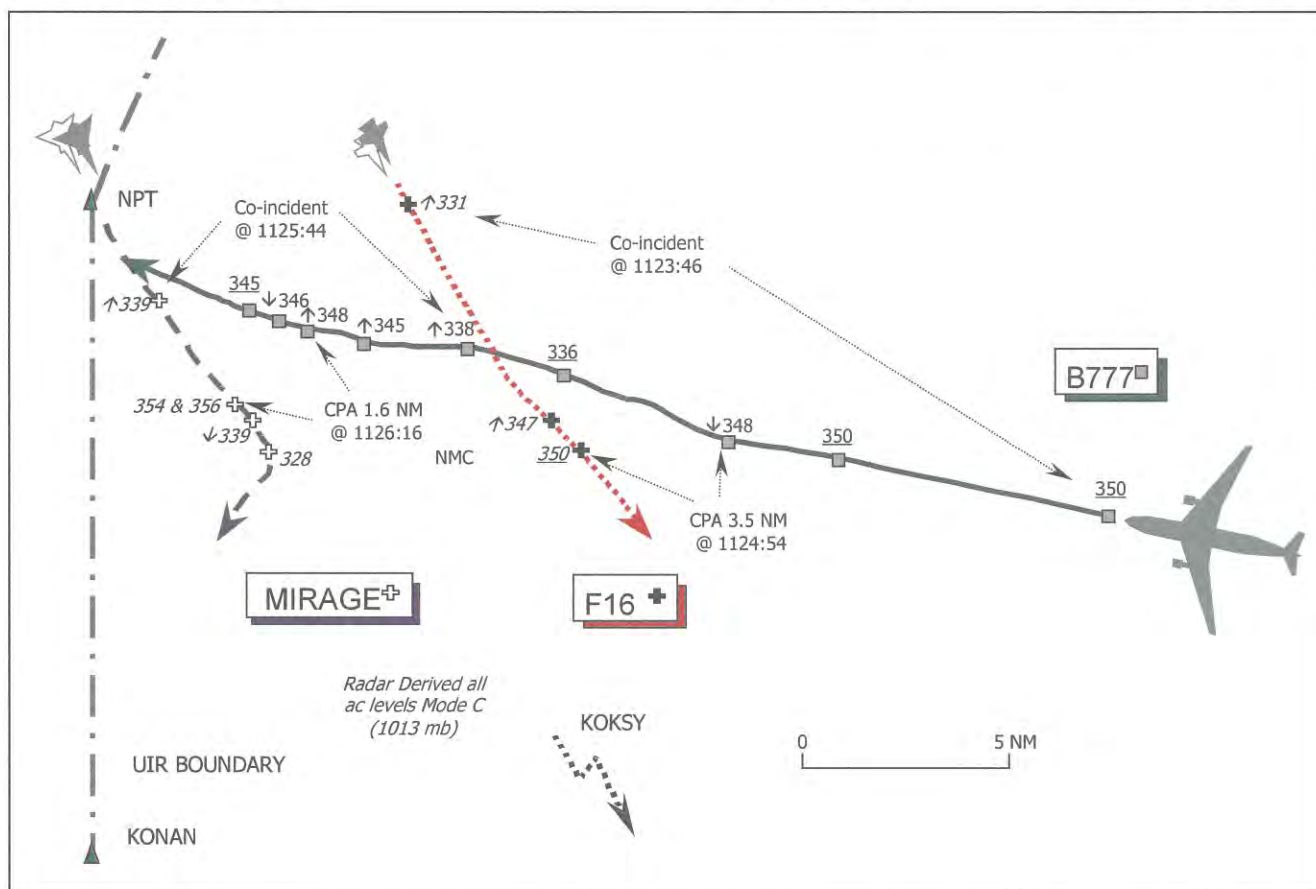
THE LATCC CLACTON CHIEF SECTOR CONTROLLER (CLN CSC) reports that FL 190 and FL 330 had been blocked because Tactical Leadership Program (TLP) NATO exercise traffic

Whether it was a TCAS RA, as reported by the B777 pilot, or, whether the crew elected to descend of their own volition and take visual separation, (as alleged from later RT conversations after the event) was unclear. However, for whatever reason, the radar recording revealed that the B777 pilot descended to FL 336, before the ac's TCAS generated a climb RA against the Mirage section. Significantly, the F16 flight leader had been correct in thinking events might "set off the airliner's TCAS" and the CLN SC found herself in a difficult position. Surprise was expressed by airline pilots on the Board that the B777 had bottomed out 1400 ft below its assigned level; they said TCAS would normally provide about 600 ft separation. Furthermore, the CLN SC had then instructed the B777 crew to climb

The second encounter, which was closer than the first, was the one on which risk should be determined. The Board agreed with the Mirage section leader's observation about the lack of traffic information; he saw the airliner at about 1.5 NM away and traffic information should have been issued if at all practicable. Furthermore, the Board noted that the phrase avoiding action was not used initially by CLN Mil or the CLN SC, but agreed that the controllers had done well in difficult circumstances. The avoiding action climb was probably the most sensible course of action of the limited options available.

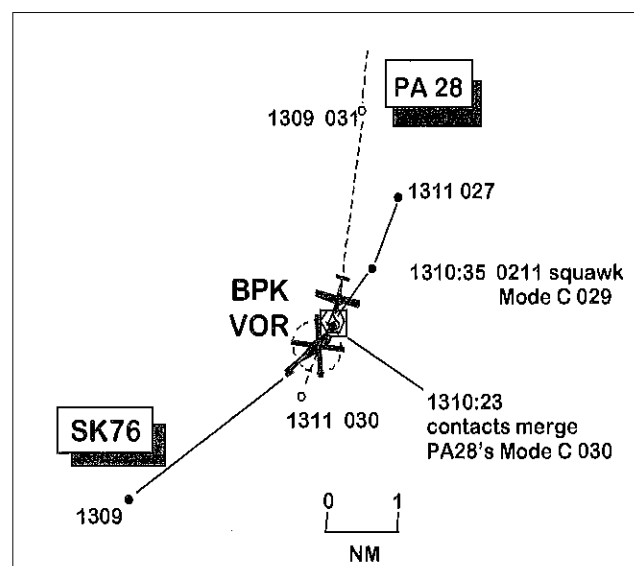
THE PA28 PILOT reports that he was returning to Elstree from Cambridge via BKY and BPK with 2 students on board following an IMC training exercise. He was receiving a RIS (limited due to weather clutter) from Luton Radar on 129.55 and squawking 4660 with Mode C. The visibility, between cloud layers, was about 1 km in heavy rain. When about 5 NM N of BPK, heading 190° at 100 kt and level at 2400 ft (QNH 991), information was passed to him on traffic at his 1 o'clock. On looking, he saw a helicopter at the same altitude on a collision course about 300 m away. He immediately took control and banked sharply L, and the helicopter passed some 100 m down his starboard side at the same altitude with no apparent avoiding action. He felt there had been a high risk of collision and reported an Airprox to Luton ATC by telephone on landing.

THE S76 PILOT reports that he was en route from a private landing site near Heathrow to Stansted at 2400 ft (QNH 991). When 10 NM W of BPK, contact was made with Essex Radar on 120.62 who issued his joining instructions which were to be at 1500 ft at Puckeridge VRP on Stansted's QNH (991). He was squawking 0211 with Mode C. Owing to controller workload and poor weather it was assumed that the ATC service would be limited to a FIS. Visibility in the area, below a broken cumulus base, was 2 – 3 km in heavy rain. After passing BPK, descent was commenced to 1500 ft in accordance with his instructions; his speed was 150 kt and ground contact was maintained throughout. A standard VFR join was made from Puckeridge and no other ac was seen at any time, nor was there any mention of traffic by the Essex radar controller, whose workload with IFR arrivals was high.

The Board noted this Airprox occurred had overhead a major navigational aid, the BPK VOR, in very poor weather conditions giving marginal visibility. Members cautioned GA pilots against the practice of navigating precisely towards such a 'honeypot' feature generally, but especially as in this instance where the extent of vertical airspace useable is limited to 2500 ft underneath the base of the LTMA. Some members thought that the S76 pilot was flying too fast for the poor weather conditions pertaining and they assessed his non-sighting of the PA 28 as a part cause of the Airprox. The PA 28 pilot saw the S76 late, having been alerted to it by Luton APC, and this was also seen as a part cause. Members unanimously commended the Luton controller whose traffic call, albeit late, enabled the PA28 pilot to spot the S76 just in time to take avoiding action; it was felt that without the

Cause: Non sighting by the S76 pilot and a late sighting by the PA 28 pilot overhead a VOR in very poor weather conditions.

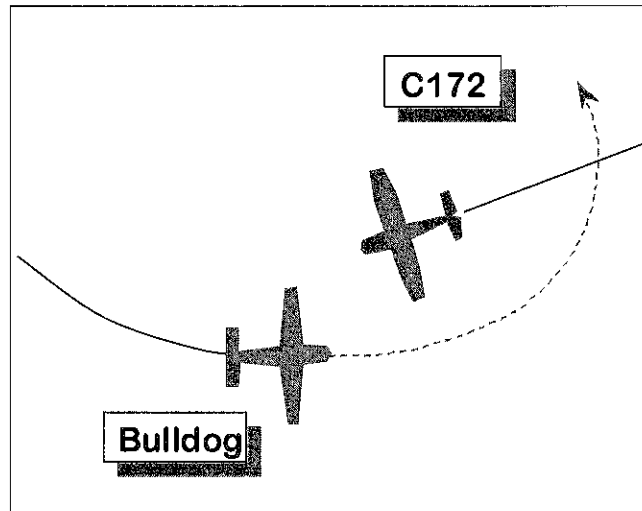
THE BULLDOG PILOT reports flying a dual instructional sortie with his student approaching 'high key' for a PFL at Badminton airstrip. While heading 340° at 75 kt in a descending L turn he saw a light civil ac on his left and 30 ft below which had just passed directly beneath. It was too late to take any avoiding action but he instinctively climbed up and away from it. The minimum separation was similar to close formation. He reported the incident to Colerne from whom he was receiving a FIS. (UKAB Note: LATCC radar recordings show that the Bulldog was tracking E as it passed the Cessna.)

It was clear to members that the cause of the incident was that neither pilot saw the other ac in time to take avoiding action. This led members to discuss the problems of seeing round parts of the ac structure which impede vision and the necessity

Cause: Neither pilot saw the other ac in time to take avoiding action.

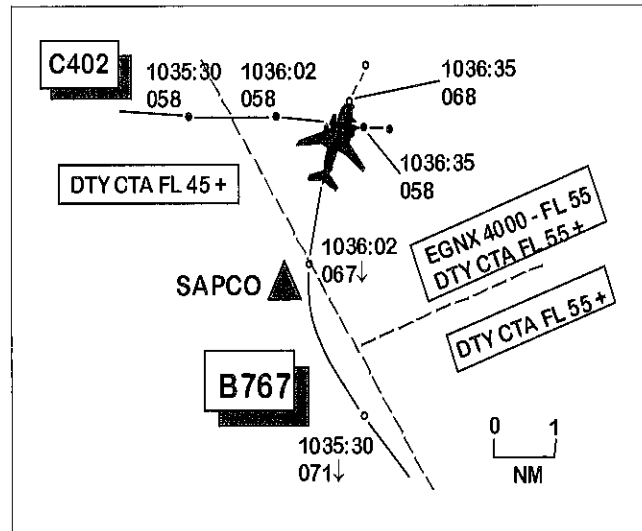
THE B767 PILOT reports heading 330° at 250 kt descending through FL 75 to a cleared level of FL 60 shortly after ATC handover to East Midlands from Manchester. The visibility was 40 km, 700 ft above cloud in VMC. A crossing ac was seen first on TCAS at 20 NM distance and subsequently acquired visually. Shortly thereafter a TCAS TA annunciation was received as the traffic indicated at his cleared level. He selected ALT HOLD and levelled off at FL 67 at the same time as East Midlands instructed him to do so. The other ac, a twin-engined type, passed L to R 700 ft below approximately 1 NM ahead in level flight. He assessed the risk as high if he had not complied with TCAS.

Initially, the Board wondered how each of the 6 ATCOs involved (5 at MACC and 1 at East Midlands) could have overlooked the presence of the C402 and why this ac was working Birmingham Approach. It was apparent that the modus operandi of the MACC STAFA sector was a significant factor in this incident. An ATSI adviser said that at 6000 ft the C402's survey detail would conflict mainly with traffic inbound to and outbound from Birmingham and this explained why it had been under the control of Birmingham Approach. Returning to events on the MACC STAFA sector, the Board noted that the oncoming Co-ordinator mentor had been relieved from an operational position so that he could monitor the trainee, and had taken the position over in a situation where the offgoing controller had given the trainee 'the picture' and then unplugged. The offgoing controller and/or the oncoming mentor may have thought this arrangement was satisfactory; the trainee Co-ordinator also held a Certificate of Competence for the STAFA Radar position, and so may have been assumed able to cope with the sector until the oncoming co-ordinator mentor could plug in. Whatever, the Board was critical of these

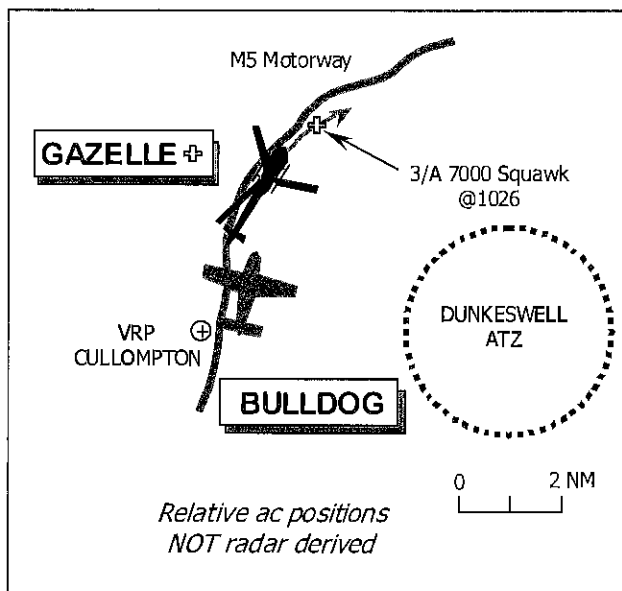
THE GAZELLE PILOT reports he was returning to Yeovilton on completion of a low-level NAVEX and to avoid Dunkeswell ATZ he was following the M5 Motorway. The helicopter was camouflage grey/green but HISLs were on; 3/A 7000 was selected but Mode C was not fitted. He had just switched from Exeter APPROACH and was about to call Yeovilton APPROACH whilst climbing from 700 ft to 1000 ft Exeter QNH (1022 mb), heading 025° at 100 kt. At a position 3 NM NNE of CULLOMPTON VRP on the S side of the motorway, a Bulldog in a PTC colour scheme overflew his helicopter by about 80 – 150 ft on the same heading. He first spotted the Bulldog when it flew over the top, it came from directly astern and its pilot appeared to be complying also with the RHD traffic rule (ie following the M5 motorway); no avoiding action was taken. He added that the visibility was 30 km with no cloud, smoke or haze and the risk of a collision was very high if the Bulldog pilot had not seen his helicopter.

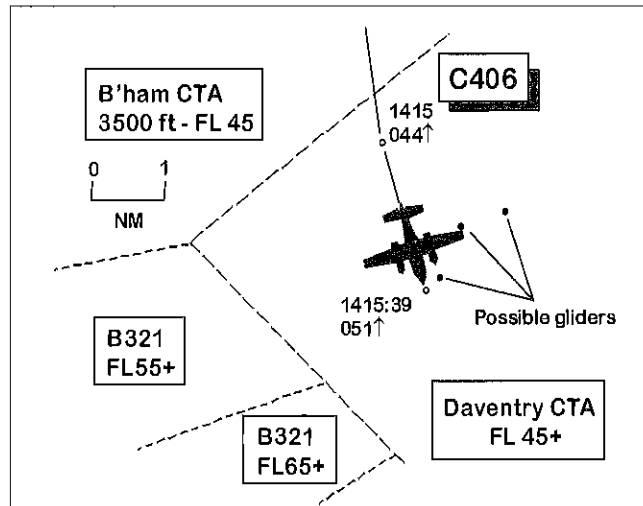
THE C406 PILOT reports that he had departed from Coventry for Porto, in his white/green Cessna with navigation and strobe lights 'ON', under radar control from Birmingham APR on 118.05. He was squawking 0545 with Mode C. The visibility, 800 ft below cloud, was over 10 km in VMC.

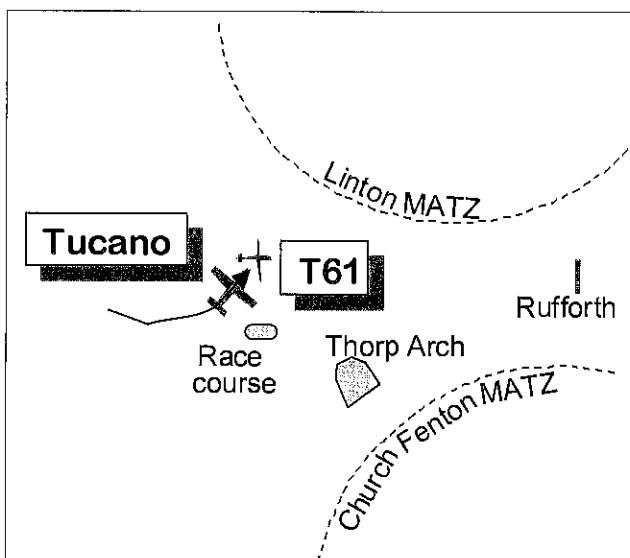
THE TUCANO PILOT, a QFI in the rear seat, reports that while positioning for a radar approach at 1800 ft, ATC warned him of a possible unknown contact in the final approach area and advised him to keep a good lookout. A few minutes later, while he was awaiting glidepath intercept, configured for landing and heading 050° at 115 kt, Talkdown (TD) reported possible traffic in his 10 o'clock, height unknown, 1 NM away. Almost immediately he spotted a motor glider at that range and bearing at the same altitude. It was on a constant bearing and closing rapidly so he selected idle power and airbrake and started a bunt underneath it. He did not wish to turn (and lose sight of it) as his turning performance was limited by his configuration. The other ac, a motor glider with its engine running, maintained level flight and passed 2-300 ft directly overhead. He considered the risk of collision had been very high and appreciated the traffic call from TD.

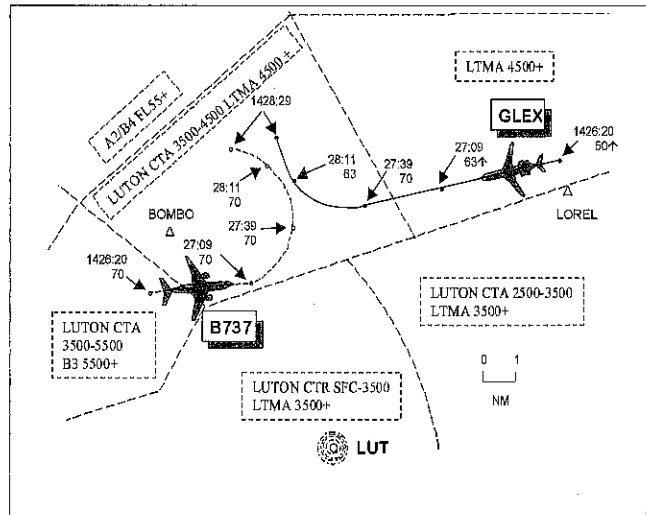
THE LATCC TC NW RADAR CONTROLLER (TC NW SC) reports that the B737 was inbound to Luton through his busy sector from the N; the TC N Co-ordinator had released the B737 at WCO FL 70 descending to FL 60. He was considering splitting the sector but thought that it would not help the traffic situation as there was little traffic routing to BNN. However, the traffic level rapidly increased, both in volume and complexity, compounded by an ac infringing CAS at FL 80 working Essex Radar. He decided then to split the sector. Meanwhile he had been unable to achieve the release on the B737 so he instructed it to fly on an easterly heading towards LOREL and to reduce speed to 220 kt; his intention was to turn it back onto a westerly track, descend it to FL 60 and renegotiate the inbound release. By now the RT was saturated and he was unable to hear the TC N Co-ordinator clearly, who mentioned "...BOMBO" and he felt at that stage the sector had become overloaded. He was unable either to handover to the oncoming BNN controller or speak to the TC N Co-ordinator owing to RT congestion. The TC N Co-ordinator had alerted him to a CPT departure from Cambridge (the GLEX) on a westerly heading that he presumed was climbing to FL 70, but on which he had received no co-ordination. He gave the B737 a L turn onto W as the TC N Co-ordinator personally informed the

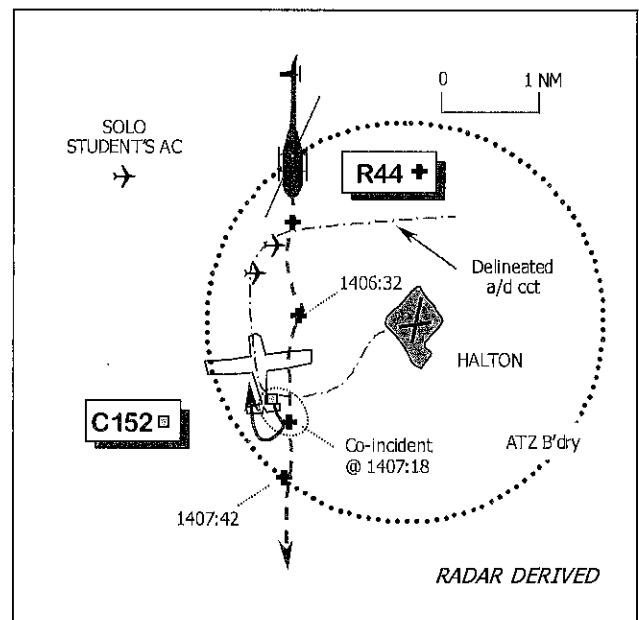
THE CESSNA 152 PILOT reports conducting a circuit training detail with a student who was the handling pilot and in communication with Halton

Radio A/G Station. The ac has a white and green colour scheme. Whilst heading 350° at 70 kt, cross-wind after take-off from RW 26 and just levelling at circuit height, 1000 ft Halton QFE, a green Robinson R44 helicopter was sighted at about 1 o'clock - 0.25 NM away, just clear of the starboard

side door pillar. He took control of the ac from the student, turned R to avoid the helicopter, which passed 2-300 m to port, he thought, with a high risk of collision. After he had passed astern of the helicopter he then reversed L and closed to about 500 m but could not identify it. He adds that his student was under a high workload and had not spotted the helicopter, which also passed just ahead of another ac (with a blue and white colour scheme) at circuit height just at the start of the downwind leg. This ac was piloted by another student conducting a 'solo' circuit detail. No calls had been heard on the A/G frequency from the helicopter pilot as it transited through the circuit area.

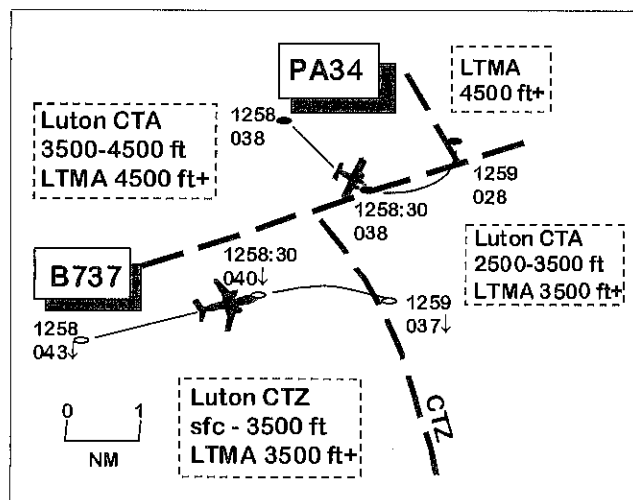
Reported Separation: not seen//not seen

Recorded Separation: 2NM / 200 ft V

THE LUTON APR reports that the B737 was radar vectored N of Luton Airport downwind RH for RW 26. On passing N abeam, descent instructions

Cause: Unauthorised penetration of Luton CTA by the PA34 pilot.

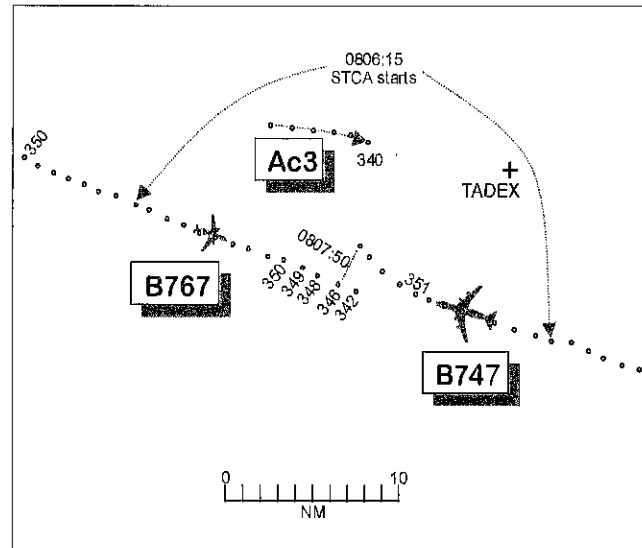
Reported Separation: 2-3 NM

Recorded Separation: 2.5 NM/500 ft

THE SCACC SW/CENTRAL SC reports that during hand-over of the banded SW/Central sectors to him it was pointed out that the westbound B747 required FL 340 but was at FL 350 because of opposing traffic at FL 340. This situation was highlighted on the FPS display. However, the eastbound B767 was also at FL 350, some 6 NM S of the traffic at FL 340. After resolving an unrelated problem near IOM, he noticed the B747 and B767 head-on (UKAB Note: STCA was flashing). He gave the B767 an immediate descent to FL 330 and a 40° R turn but the pilot did not reply. Next, he turned the B747 40° R and when its pilot acknowledged, he added that this was avoiding action. Reverting to the B767 he gave it avoiding action, R 40° and descend to FL 330 (it was clear of the other traffic at FL 340); this time the B767 pilot responded. The B747 pilot reported clear of the B767; the SC then gave further routing instructions to both ac. Just before the incident he had been distracted by the Watch Manager enquiring about some of his traffic, and his own request to split the sector owing to impending traffic.

The Board found the ATSI analysis left little else to discuss and concluded that the cause of the Airprox was that Controller B did not provide the appropriate separation between the B747 and the B767. It was suggested that one of the ac could have been left on route and the other vectored clear. However, this could only be done if Controller B had been aware of the confliction. While it was controller B's responsibility to ensure that he understood the traffic situation before accepting the position, members agreed that Controller A had contributed passively and actively to her successor's problem. First she had not pointed out the confliction, second, and more importantly, she had not annotated the FPSs as per the MATS Part 2 and third she had not ensured that the ScACC SI 13/00 was complied with.

Board felt that there should be just one phrase used by ATC to alert pilots when prompt avoiding action was necessary and that this phrase should be recognised universally and made a recommendation to this effect.

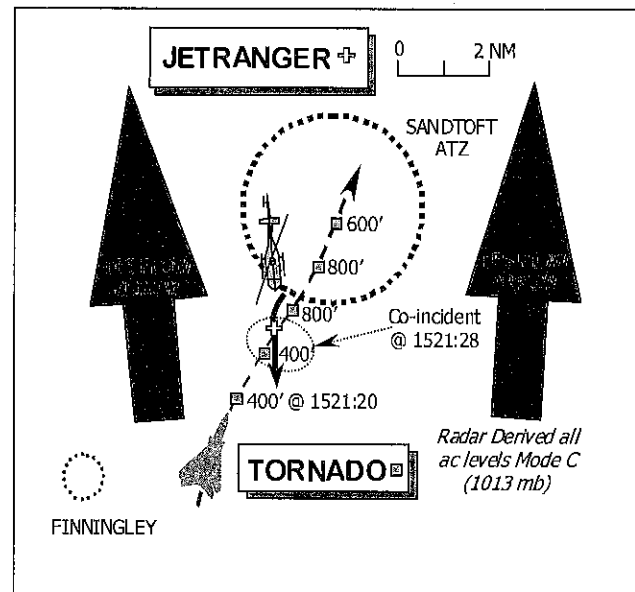
Reported Separation: 1-200 ft V & <100 M H
300ft V, Nil H

Recorded Separation: Contacts Merged

THE JETRANGER PILOT reports conducting a routine pipeline inspection flight at an altitude of 500 ft Barnsley RPS, (UKAB Note (1): reported incorrectly as 1006 mb but from the RT transcript 1004 mb) some 2000 ft below a scattered cloud layer at 2500 – 3000 ft with an in flight visibility in excess of 20 NM. The helicopter livery was red and white, HISLs and stabiliser strobes were on and a squawk of 0036 was selected with Mode C and he had just called Waddington to request a FIS. After passing Sandtoft heading 170° at 120 kt, his observer spotted a fast jet at 2 o'clock heading

Cause: Conflict in the Low Flying System resolved by both pilots

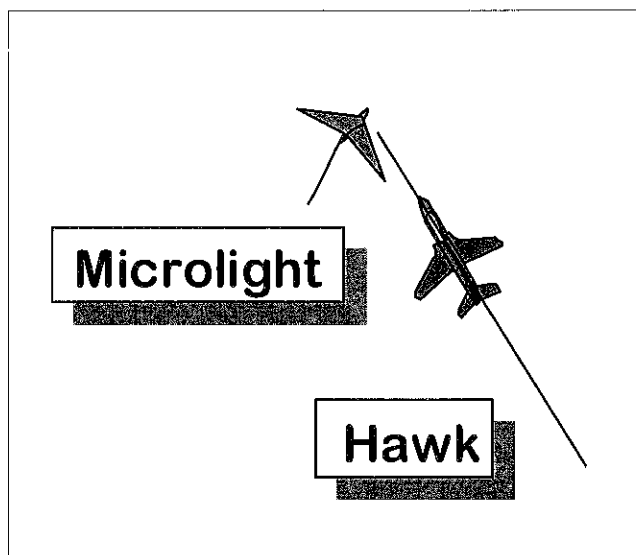
Reported Separation: 500 ft V/1 NM

Recorded Separation: < 0.25 NM

THE HAWK PILOT reports heading 350° at 350 kt on a descent into Leeming from whom he was receiving a RIS. While descending through a gap in the cloud, passing 5500 ft, he saw a microlight apparently coming out of cloud from his 11 o'clock 500 ft below and 500 yd in front; it was tracking NE. He reckoned its pilot would not have seen him coming from aft of the beam and above. He pulled up and left to avoid it, reporting the incident to Leeming. The risk of collision would have been high if he had not seen it.

HQ STC comments that although the Hawk pilot had sufficient time to take avoiding action and hence remove any risk of collision, he was clearly surprised to see the microlight operating in a broken cloud layer at FL 55, albeit technically VMC, close to a busy military airfield.

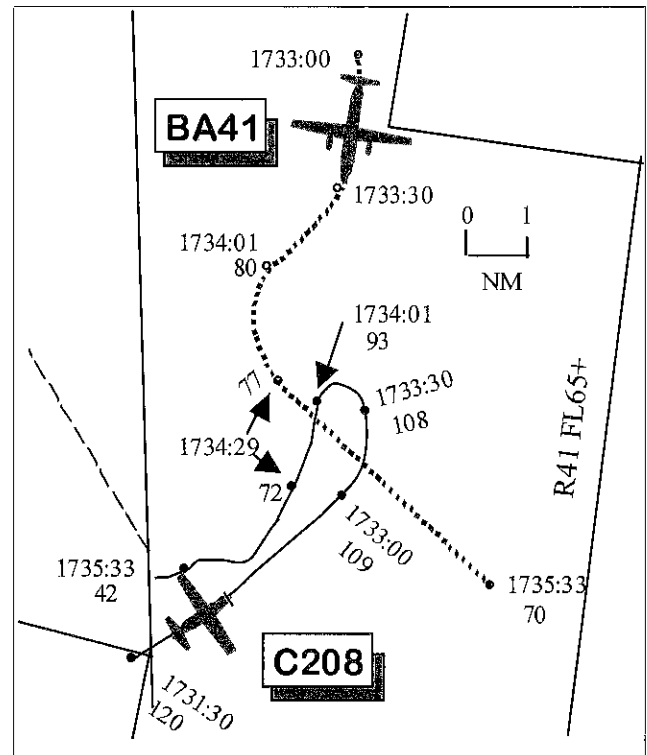
<u>Reported Separation:</u>	2 NM/NK
-----------------------------	---------

<u>Recorded Separation:</u>	1.72 NM, 500 ft
-----------------------------	-----------------

THE SOUTHAMPTON APR reports that the Jetstream 41 was transferred from LATCC on a silent handover descending to FL 80. As the Jetstream reached FL 80, the controller deselected his radar display height filter (set at FL 102) to look for another inbound ac and observed an unknown ac tracking NE at FL 105. An avoiding action R turn onto heading 240° was given to the Jetstream but the unknown ac turned W so the avoiding turn was changed to L 140°; traffic information was given to the Jetstream pilot with the unknown ac seen to be descending. The Jetstream had been cleared for descent to FL 70 and its pilot observed the unknown ac as being white in colour with a dark/black tail in

The Board were in no doubt that the incident had been caused by the unauthorised entry of CAS by the C208 pilot, but members wondered why it had occurred. The C208 pilot had been busy on a type conversion training sortie which included a practice emergency descent but he could only surmise that he had drifted further E than intended owing to strong upper winds from the W (Met archive data show medium level wind FL 120 270/30 kt). The Board noted the very high rate of descent of the C208 as it passed through the Jetstream 41's level and on down below CAS. However, the airliner's avoiding action turn R 240° and subsequent turn L 140°, in addition to the visual sighting by the Jetstream crew, led the Board to conclude that there had been no risk of collision.

Cause: Unauthorised penetration of R41 by the C208

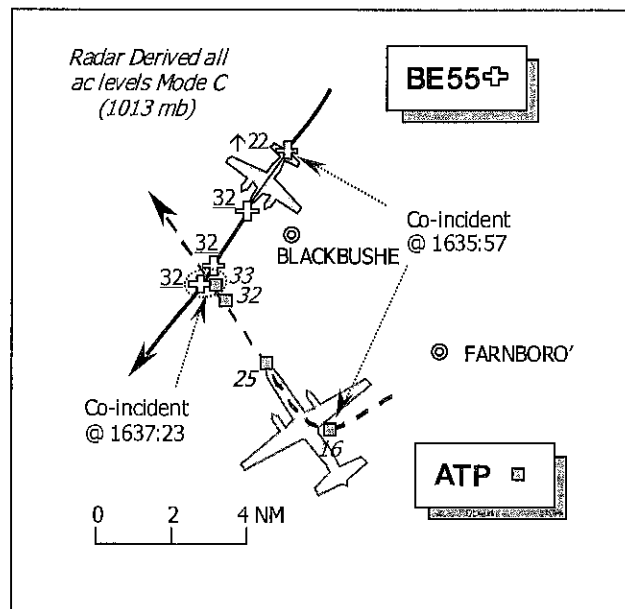
Reported Separation: 500 m H, 200 ft V 1 NM H

Recorded Separation: 0.5 NM H

THE ATP PILOT reports his ac has a white livery and anti-collision beacons, HISLs and landing lights were all on as they departed Farnborough RW 25 for Warton under IFR, but in very good VMC, climbing initially to 3400 ft London QNH (1022 mb). Following the noise abatement requirements they turned R onto a heading of 310°(M), direct Compton VOR at 160 kt and shortly after the turn they were re-cleared to 6000 ft ALT by London Control. Almost immediately thereafter, TCAS enunciated a TA "traffic - traffic". Both he and the First Officer looked out and saw a light twin piston-engined ac crossing from R – L, he thought in a continuous climbing L turn. TCAS then enunciated an RA - "climb - climb" and the VSI demanded a higher rate of climb which was complied with. The Twin, a Beech Baron, crossed "very close" 500 m ahead of and 200 ft

The Board noted that both Farnborough LARS and APR had required the BE55 and ATP pilots respectively to fly at 3400 ft London QNH initially and it was apparent that between the two controllers no co-ordination had taken place before the ATP's departure. Controller members were also concerned that the APR had not taken sufficient care to scan the area around the ATP's departure track for possible conflicts. Once again the importance of selecting Mode C with A7000 was demonstrated in this incident. The BE55's squawk of A7000 (albeit without Mode C at that stage) should have been evident to the APR and drawn his attention to it, but it seemed that he had not noticed it. Hence his decision to permit the ATP crew to call TC OCK direct. This was thought by some civilian ATCO members to be an unsatisfactory method of operation. Under IFR the ATP crew could reasonably have been expected to ask for and receive an ATS from APR whilst departing from the aerodrome, but APR's decisions effectively obviated the option. This caused great concern to several controller members familiar with operations in the confined Class G airspace below the LTMA. It was explained that this form of entry into the airways structure – routing initially to CPT at 3400 ft ALT to await entry clearance from TC OCK – very often meant that IFR traffic had to hold in the FIR at CPT before joining CAS. Members thought the APR should have allowed for this situation by giving the ATP pilot the opportunity to ask for a RIS or a RAS. Either service would have ensured traffic information was given on possible conflicts. None of this happened and the ATP had instead been transferred direct to TC OCK who provided a FIS but whom were also unaware of the approaching BE55. This Airprox had been entirely avoidable in the Board's view since all of the information relating to the two ac had been available to controllers sitting in close proximity. Moreover, the APR had been unrealistic in assuming that the LARS controller would have obtained details of the ATP's departure without a proactive injection of traffic information. Had the APR done so, it might have prompted the co-ordination that was called for. In the end, the developing conflict was recognised by the LARS controller who issued traffic information to the BE55 pilot, in accordance with the RIS and elicited a visual report from the pilot. Although LARS then alerted TC to the proximity of the BE55, there was, unfortunately,

Cause: Conflict in the FIR.

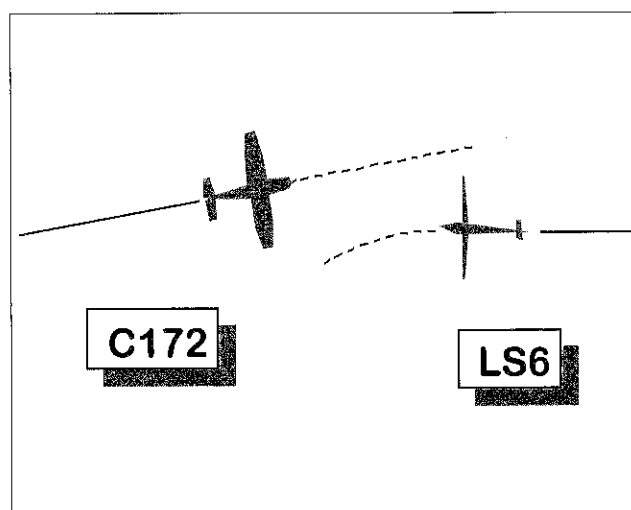
<u>Reporting Aircraft</u>	<u>Reported Aircraft</u>
<u>Type:</u>	LS6 glider	Cessna 172
<u>Operator:</u>	Civ Pte	Civ Club
<u>Alt/FL:</u>	2500 ft (QNH)	24-2500 ft (QNH 1016 mb)
<u>Weather</u>	VMC CLBC	VMC HZBC
<u>Visibility:</u>	12 NM	10 km+
<u>Reported Separation:</u>	30 m/NK	
<u>Recorded Separation:</u>	NK

THE LS6 GLIDER PILOT reports heading 270° at 70 kt in his white (with blue and red markings) glider in somewhat hazy conditions when he saw a Cessna approaching at his level from 200 yd ahead, more or less head-on, tracking to a point just off his starboard wing. He altered course to the left and kept a watch on the Cessna which passed 30 m away without any recognition of his presence. He considered the risk of collision would have been high if he had not seen it when he did. He noted the registration of the Cessna which, while he saw it only briefly, left him with a clear impression.

Members agreed that the only means of collision avoidance in this incident was for the pilots to see and avoid each other; they agreed that the cause of the Airprox was that the Cessna pilot did not see the glider, and the glider pilot saw the Cessna very late. In this case neither was helped by the 'white on white' effect; white ac against a hazy background. The conspicuity of gliders was discussed. While glider pilots in the group averred

Cause: The Cessna pilot did not see the glider, and the glider pilot saw the Cessna very late.

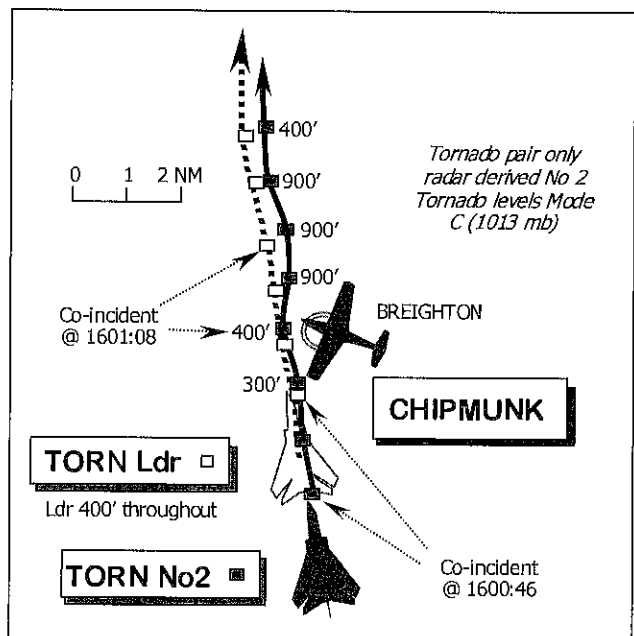
100 ft V, 100 ft H

Recorded Separation: Not recorded

THE CHIPMUNK PILOT reports that his ac has a silver colour scheme with red upper decking; neither HISLs nor SSR is fitted. After take-off from RW29 at Brighton aerodrome, heading 290° (M) climbing through 300 ft QFE (1010 mb) at 70 kt, wings level, he was scanning the circuit area to the L and suddenly spotted in his 11 o'clock a Tornado approaching at high speed at the same height, heading N. The jet passed from L - R not more than 3 – 400 ft ahead of his Chipmunk as he pushed the nose down and turned L with full aileron. As he rolled to the L a second Tornado was seen at 9 o'clock pulling up directly above, about 200 ft over the top of his ac as its pilot waggled the wings. He adds that he had to take violent avoiding action at full throttle to avoid the two jets; he did not assess the risk.

Cause: Conflict close to a light ac landing site resolved by the actions of the Chipmunk pilot and the No 2 Tornado pilot.

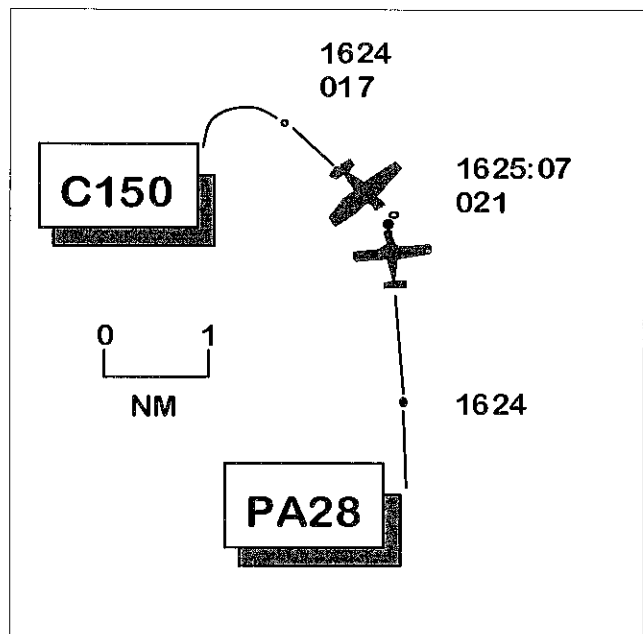
Reported Separation: 60 ft V 25m H / not seen

Recorded Separation: <100 m H

THE C152 PILOT reports that he was flying an instructional sortie from Wycombe Air Park teaching climbing and descending. The visibility, 1500 ft below cloud, was 10 – 15 km in VMC. He was receiving a FIS from Wycombe Tower on 126.55 and squawking 7000 with Mode C. His ac is light blue/white with red lines; the anti-collision beacon was on.

The Board were unanimous that this conflict in the FIR was caused by a combination of a very late and non sighting by respective pilots in conditions where both pilots should have seen each other's ac much sooner. The C152 instructor had pitched forward instinctively while the PA28 pilot had been completely unaware of the other ac. Good fortune played a large part in keeping both airframes apart and because of this it was assessed that a risk of collision had existed.

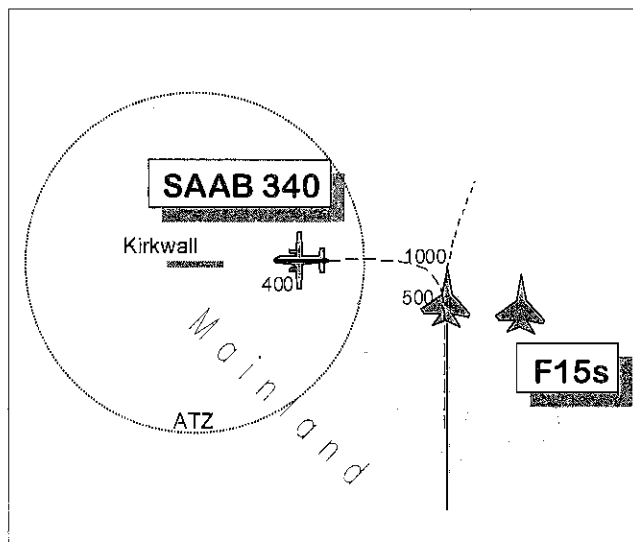
Reported Separation: Not seen/Adequate

Recorded Separation: 1.8 NM

THE SAAB 340 PILOT reports heading 270° at 140 kt and passing 400 ft on finals to RW 27 at Kirkwall when he was warned about fighters crossing, one above and one below him. TCAS confirmed that they were within 6 NM with one 100 ft above and the other 100 ft below. He could not see them but considered the risk of collision was high.

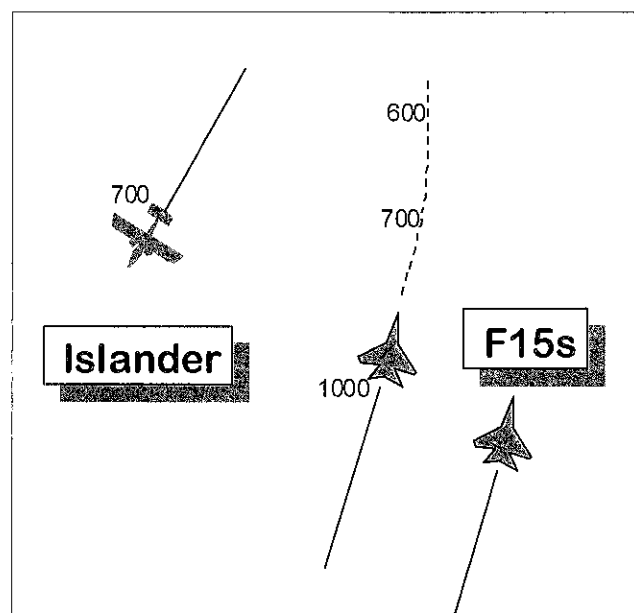
<u>First Aircraft</u>	<u>Second Aircraft</u>
<u>Type:</u>	Islander	F15 x 2
<u>Operator:</u>	CAT	Foreign Mil
<u>Alt/FL:</u>	1000 ft (QNH 1022 mb)	1200 ft (RPS)
<u>Weather</u>	VMC CLBC	VMC NK
<u>Visibility:</u>	10 km+	NK
<u>Reported Separation:</u>	2-3 NM/Adequate	
<u>Recorded Separation:</u>	1.7 NM

KIRKWALL ATC reports, with RT transcript, that the F15s were seen to pass close to a SAAB 340 that was on finals for RW 27 and then continue to the N towards the approaching Islander. The controller advised the Islander pilot "C/s traffic information pair of fast jets just passed through the 27 extended centreline to the east of the field heading northbound", adding "give or take 500 ft" in response to the pilot's query about their level. It

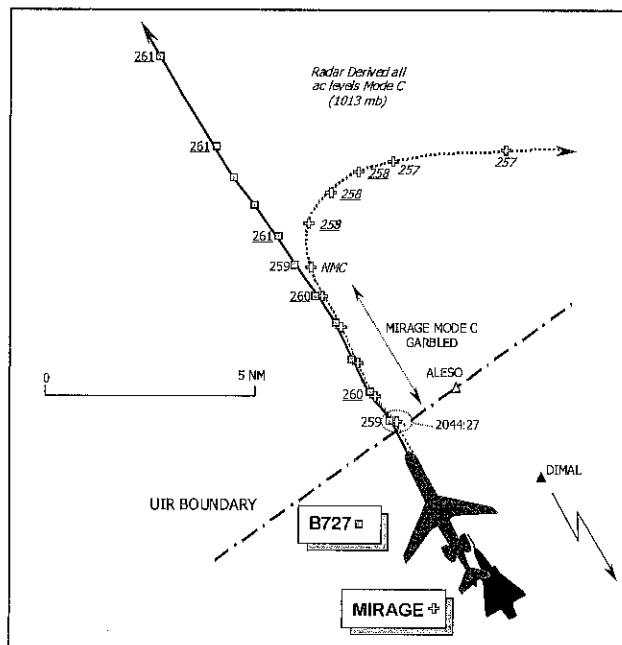
Airspace: UAR (Class: B)
Reporting Aircraft Reported Aircraft
Type: B727 Mirage 2000
Operator: CAT Foreign Mil
Alt/FL: FL 260 NR
Weather VMC CLOC VMC
Visibility: 40 km NR

Reported Separation:
 100 ft V, 1000 m H, 1000 ft V
Recorded Separation: Contacts merged, 100 ft V

THE B727 PILOT reports he was inbound to London Heathrow from Tripoli at 300 kt and under a RCS from London Control on 134.9 MHz, at FL

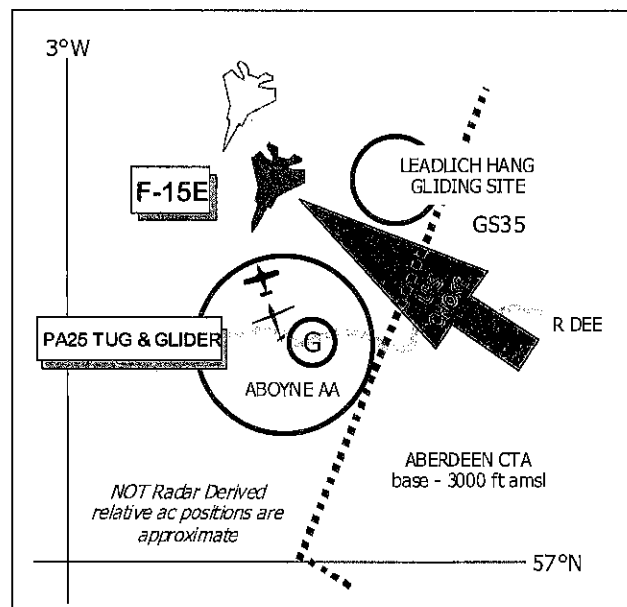
Reported Separation: 400 m H, nil V/NR

Recorded Separation: Not recorded

THE PA25 PAWNEE TUG PILOT reports he was climbing out from Aboyne Glider site with a glider under tow at 80 kt, about 2000 ft below cloud. The ac had a red/white livery and the anti collision beacon was on; SSR is not fitted.

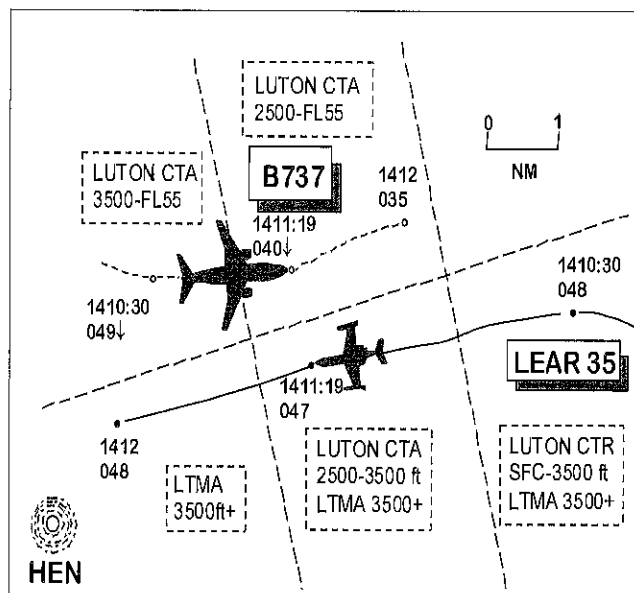
Reported Separation: 200 ft V /2 NM H, 1000 ft V

Recorded Separation: 1.1 NM/700 ft

THE B737 PILOT reports that he was heading 110° at 170 kt in a descent having been cleared by Luton APC on 129.55 for an ILS approach to RW 08 at Luton. The weather was CAVOK. When passing through about 3800 ft (QNH 1019) a TCAS RA

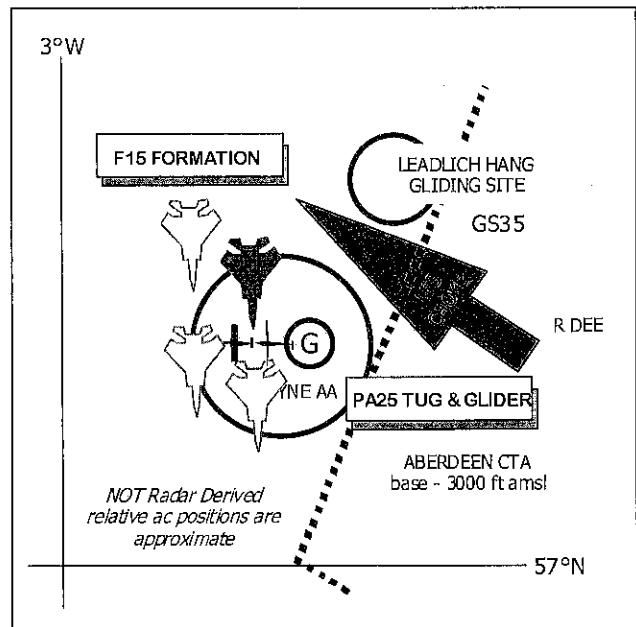
AIRPROX REPORT No 127/00

Date/Time: 29 Aug 1515
Position: 5704 N 0252 W (1 NM W of Aboyne Glider Site - elev 460 ft)
Airspace: Scottish FIR (Class: G)
Reporting Aircraft Reported Aircraft
Type: PA25 TUG/GLIDER F15C
Operator: Civ Club Foreign Mil
Alt/FL: 1000 ft 500 ft
(QNH 1022 mb) (RPS 1016 mb)
Weather VMC CLBC VMC
Visibility: >10 Km NR
Reported Separation: 300 ft V 4-5000 ft H
Recorded Separation: Not recorded

THE PA25 PAWNEE TUG PILOT reports he was climbing out from Aboyne Glider site with a glider under tow, about 2000 ft below cloud. The ac had a red/white livery and the anti collision beacon was on; SSR is not fitted.

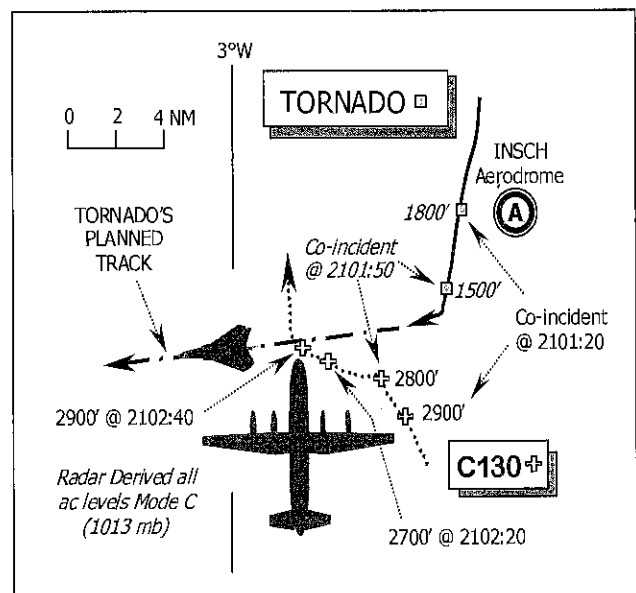
AIRPROX REPORT No 128/00

Date/Time: 16 Aug 2103 NIGHT
Position: 5714 N 0255 W (10 NM WSW of Insch aerodrome)
Airspace: Night LFS (Class: G)
Reporting Aircraft **Reported Aircraft**
Type: Tornado GR1 C130
Operator: HQ STC Foreign Mil
Alt/FL: 560 ft 2000 ft
 (Rad Alt) (Rad Alt)
Weather VMC CAVOK VMC CAVOK
Visibility: >10 Km Not reported
Reported Separation:
 5-800 m H 500-1000 ft V Not reported
Recorded Separation: Not recorded

THE TORNADO GR1 PILOT reports he was conducting a low-level Terrain Following Radar (TFR) sortie at night in the Night LFS Area 1, without Night Vision Goggles. HISLs were on and the area

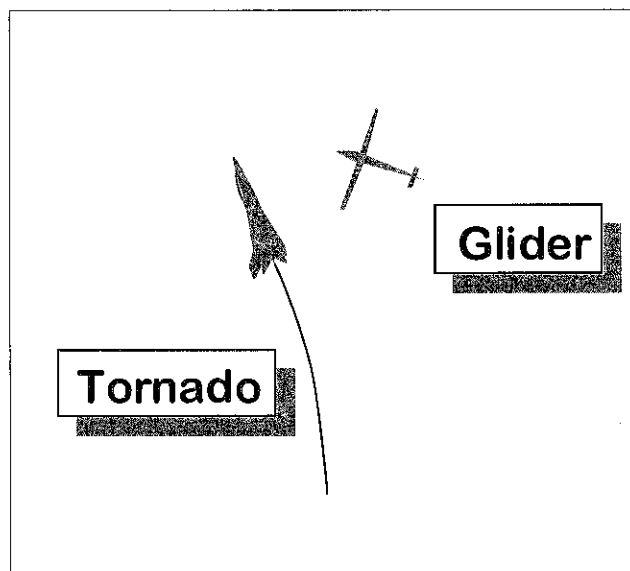
AIRPROX REPORT No 129/00

Date/Time: 30 Aug 1302
Position: 5152 N 0138 W (4 NM N of Burford)
Airspace: FIR (Class: G)
Reporting Aircraft Reported Aircraft
Type: DG202 glider Tornado GR
Operator: Civ Pte HQ STC
Alt/FL: 3300 ft ↓250 ft
(QNH) (Rad Alt)
Weather VMC CLBC VMC CLBC
Visibility: 35 km NK
Reported Separation: 100 ft H/NK
Recorded Separation: Too small to measure

THE DG202 GLIDER PILOT reports heading 300° at 70 kt, cruising below broken cloud when he heard jet noise; the belly of a vertically banked military jet then passed about 100 ft across his nose from his 8 o'clock to his 2 o'clock, at the same level, leaving him to cope with its jet efflux and severe buffeting from its wake. He therefore had no time for avoiding action and no time to identify it. It had a flat bottomed fuselage and passed so close, filling his canopy, that he could not see its wingtips, nose and tail at the same time. From the time he first heard it to the time of its disappearance in the distance took about 2 seconds, and the risk of collision had been very high.

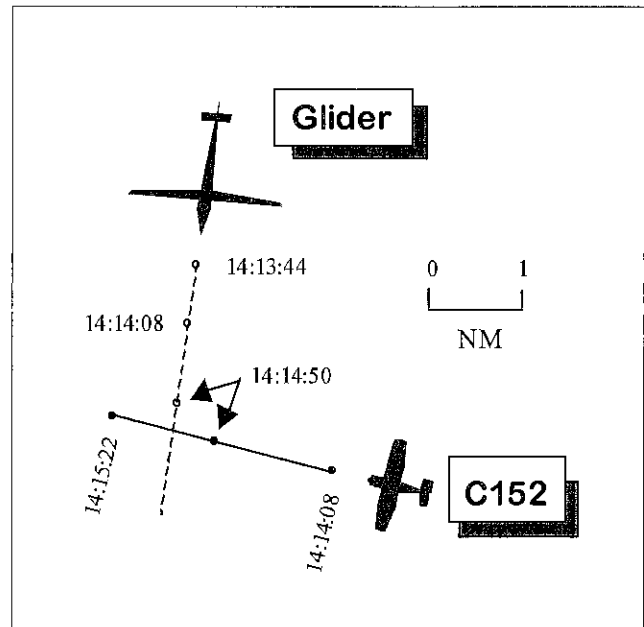
THE GLIDER K6CR PILOT reports flying solo near Great Malvern heading between 180° and 220°, at about 60 kt between 3000 and 4500 ft. The visibility was greater than 20 km, 1500 - 2000 ft below cloud, in VMC. The glider was white with red wing tips and lower fuselage and was not fitted with a radio or external lighting. Whilst in the cruise and scanning to the right, he glimpsed a movement to his L and saw a white Cessna with red and blue on its nose approaching in level flight just 100 – 200 m away. He pushed forward and passed about 100 ft vertically below the other ac which continued without taking any avoiding action. He assessed the risk of collision as very high.

THE C152 PILOT reports flying solo on a local cross country from Shobdon at 2000 ft at 90 kt receiving a listening watch with Shobdon Radio on 123.5. The ac is white with blue and red markings and the anti collision light was 'on'. He was routing from Worcester to Shobdon heading 275° at the time of the incident but did not recall seeing any conflicting glider. The visibility was good, 1000 ft below cloud, in VMC.

UKAB Note: Replay of the Cleve Hill Radar at 14.12:44 shows an intermittent primary return, believed to be the glider, tracking 190° about 9 NM NW of Great Malvern. Shortly after, a primary return appears 2.2 NM SE of the glider, believed to be the

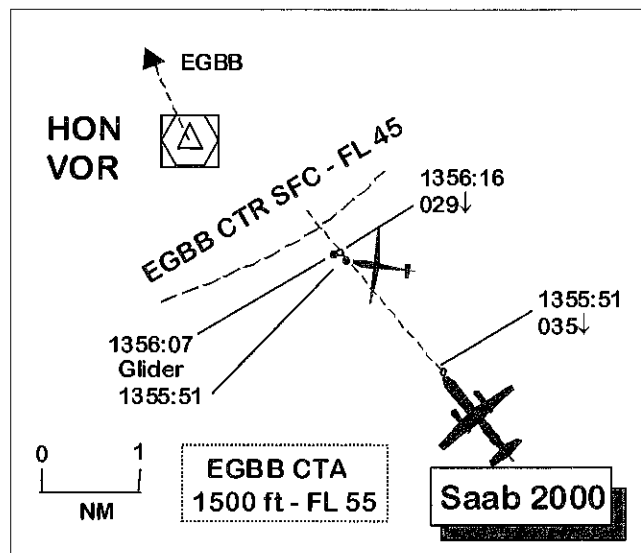
AIRPROX REPORT No 132/00

Date/Time: 29 Aug 1356
Position: 5220N 0138W (2 NM SE HON VOR)
Airspace: CTA (Class: D)
Reporting Aircraft Reported Aircraft
Type: Saab 2000 Glider
Operator: CAT NK
Alt/FL: 3400 ft ↓ NK
 (QNH 1020 mb)
Weather VMC CLBC NK
Visibility: 20 km NK
Reported Separation: 0 ft V / 0.5-1 NM
Recorded Separation: unrecorded

THE SB20 PILOT reports established on the ILS RW 33 at Birmingham at about 10 NM from touchdown. The visibility was 20 km, 500 ft below cloud in VMC. Whilst descending through 3400 ft QNH 1020 at 190 kt, he saw a glider, coloured white, in his 12 o'clock range 2 NM in level flight crossing R to L. He maintained visual contact whilst continuing the approach; the glider passed 0.5-1 NM on his port side on a steady track 260° at the same level, 3000 ft QNH. He informed Birmingham APR who reported seeing a small primary return but the pilot did not see any target on TCAS. He assessed the risk of collision as high.

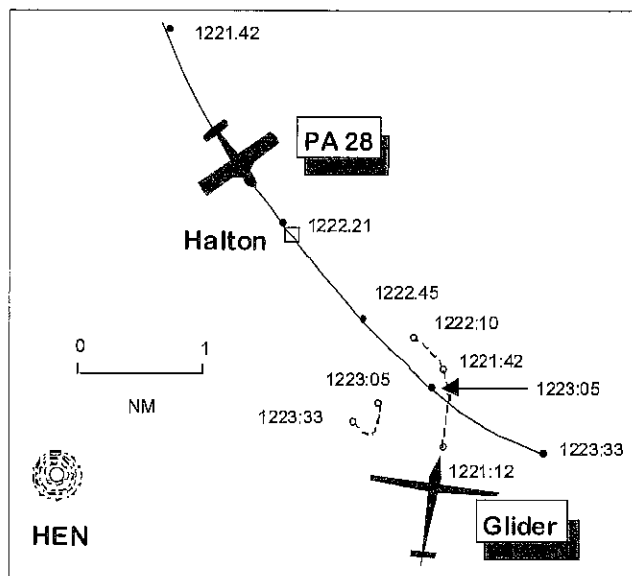
Reported Separation: 100 ft V 0 H/ 500 ft

Recorded Separation: not recorded

THE LS6C GLIDER PILOT reports circling in a slight climb 1 NM SE of Halton airfield at 1700 ft QFE 996, (2070 ft QNH) at 47 kt. The visibility, 1200 ft below cloud was >10 km in VMC. The glider was white with blue marks and was receiving a listening watch with Halton Radio on 130.42. On passing through heading 040° (he thought) turning L, he looked over his L shoulder into the turn direction and saw a powered ac with retractable u/c 70 m away flying straight and level which passed directly over him by <100 ft heading SE. He had insufficient time to take any avoiding action, except momentarily levelling off. He had not heard any transmissions from the ac as it flew through the Halton ATZ.

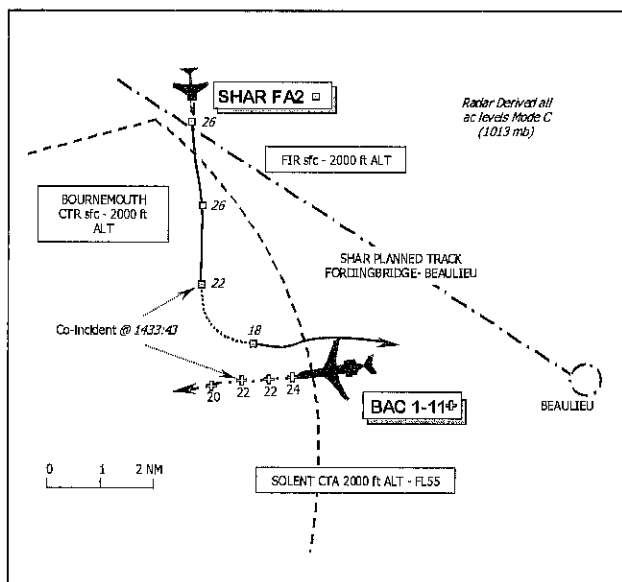
3-500 m H & nil V 2000 m H

Recorded Separation: CPA not recorded

THE BAC1-11 PILOT reports that he was returning to Bournemouth Airport on completion of a maintenance airstest. The ac has a red/white livery and full landing lights were on during the ILS approach to RW26, whilst in communication with Bournemouth TOWER, squawking A7721 with Mode C.

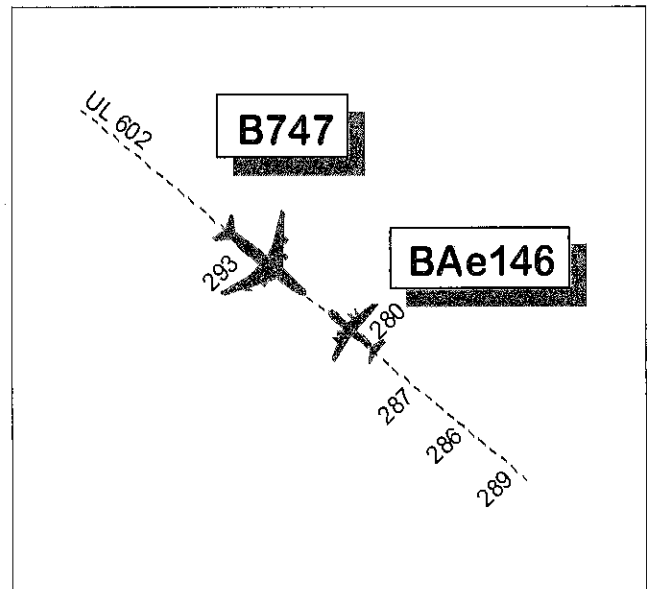
Reported Separation: 900 ft

Recorded Separation: 600 ft V, 3-8 NM

THE LATCC NS WEST SC reports that the controller involved was mentor to a trainee sector controller on Sector 10. Traffic loading was described as heavy. The B747 was inbound to Amsterdam from N America while the BAe 146 was inbound to Newcastle.

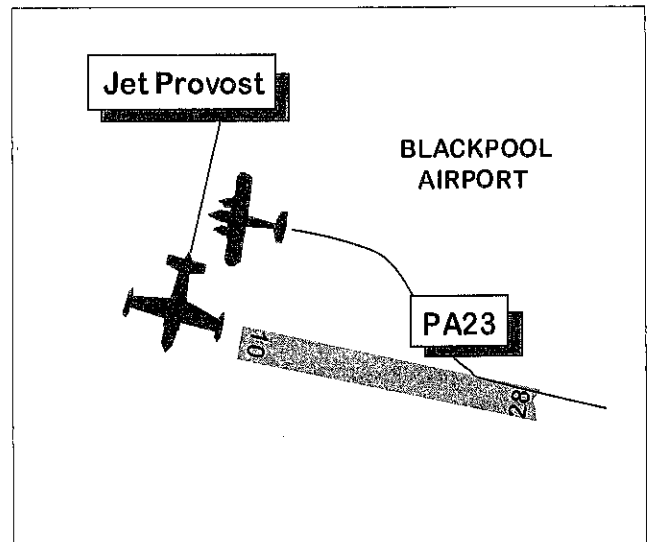
Reported Separation: 300 m, 300 ft/ not seen

Recorded Separation: Not recorded

THE AZTEC PILOT reports that he was on a dual training sortie with his student flying a simulated asymmetric ILS approach and go around to RW 28 at Blackpool. The duty RW was 10 LH and the visibility was 8 NM in VMC. He was receiving an ADC service from Blackpool Tower on 118.4. Following the go around at 250 ft QFE (1004) he turned R and climbed to 1000 ft to position at the end of the downwind leg for RW 10 LH. At 500 ft he took control and returned both engines to normal power for landing, which enabled the ac to reach 1000 ft QFE by late downwind. When about 0.75 NM abeam the RW 10 threshold, heading 280° at 150 kt, a Jet Provost (JP) was seen 300 m to his L and 300 ft below on a southerly heading. Its speed was estimated at 250 – 300 kt. He felt there had been a high risk of collision because had he not powered up the dead engine when he did, or done so later, his ac might have been at a similar height to the JP. He informed ATC of the presence of the JP and heard its pilot announce that he was "joining in the overhead at 2000 ft".
